# Kitsumkalum River Flood Mitigation Plan

September 29, 2022 | Rev 1

Submitted to: City of Terrace Prepared by McElhanney

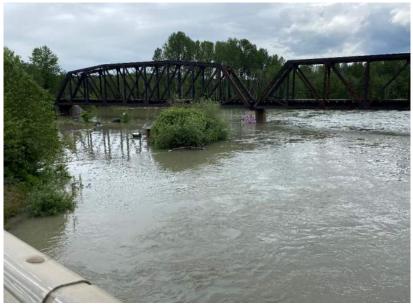
Figure 3.2-1: 2022 Spring Freshet – June 6, 2022

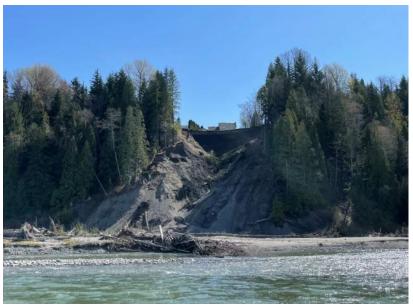
This section has been identified as a potential for erosion as recent erosion of the toe has initiated the land slide that has occurred at 5412, 5414, & 5416 McConnell Crescent and is identified within the planning overview plan as the red line. This section is considered to be a high priority due to the slope failure along with potential damage to residential property and public infrastructure.

Figure 5.2-1: Slide overview – May 13, 2022

The debris continued downslope for about 90 to 95m, reaching the Kitsumkalum River.

The proposed remediation for this section will be broken down into multiple areas, 1. Toe Erosion Protection, 2. Slide Toe Stabilization, and 3. Upper Slope Stabilization. The proposed design for this mitigation titled C-200 to C-202 can be found in Appendix B.

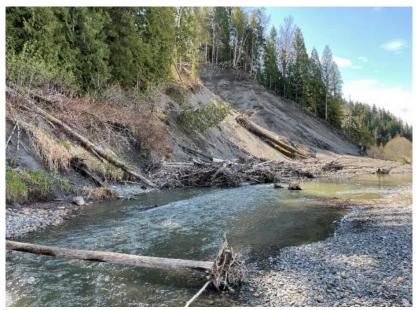
Hydraulic modeling indicates that predicted water velocities at the toe of the slide vary between 2 and 3 m/s. The maximum velocities are experience during moderate extreme event (10-20yr return period), as opposed to the 200-year event, due to additional flow and hydraulic conditions that are present under the larger event, which cause the local water velocities to reduce slightly.

Figure 5.2-2: Slide Toe – May 13, 2022

The proposed remediation for the toe erosion protection is to install Class 1000 kg riprap with a minimal nominal thickness for a length of 200 m. For full protection of the slope, an estimate length of riprap is 650 m but only 200 m is essential for the direct impact of the slide area, the remaining 450 m would be considered a lower priority. Due to the small granular material within the back, it is recommended to provide a layer of non-woven geotextile fabric to provide a separation layer and minimize migration of materials. Access for construction is proposed to be from Bohler Road and require a temporary bridge installed over Spring Creek. An alternative access was assessed through the downstream gravel pit, but this access will require access through private property. Depending on where the rock will be supplied from, this will be the preferred option due to the travel time and minimal road/bridge construction required.

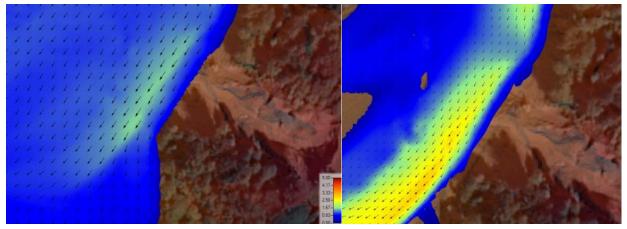
Figure 5.2-3: Left - 200-year flood velocities, Right – 2-year flood velocities

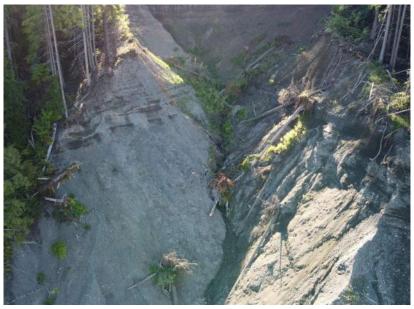
Figure 5.2-1: Toe Stabilization Section – Aug 19, 2022

Based on the geotechnical recommendations from Taylor Geotechnical from their Geotechnical Investigation and Slope Stability Analysis Report dated August 10, 2022, the recommended remediation for this section is to install a riprap buttress to stabilize this section of the slope. The riprap buttress would consist of a minimum 550 mm thick riprap section over the slope at an angle of 2:1. The riprap material size can vary from 150 mm in diameter to 1000 mm in diameter. The extent of this riprap buttress should extend to a minimum of the 90 m elevation but would be required to extend to 96 m in elevation if the slope regrading option below is utilized. Access for construction for this section would be from both Bohler Road or the gravel pit and from McConnell. Upper slope stabilization is required prior to construction at along the mid section due to safety concerns. An access to the 90 m elevation will be required to transport rock down the slope and not damage any of the upper slope remediation. Multiple excavators would be required on the slope to allow for passing material up/down the slope.

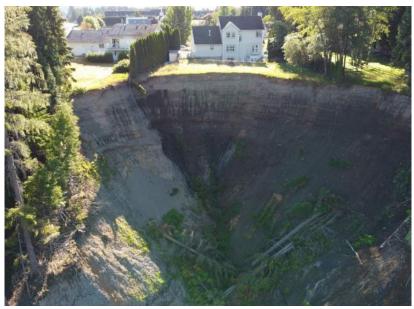
Figure 5.2-4: Upper Slope Section – Aug 19, 2022

Based on the geotechnical recommendations from Taylor Geotechnical from their Geotechnical Investigation and Slope Stability Analysis Report dated August 10, 2022, there are four different options of slope mitigation, Option 1 – Slope Armouring, Option 2 – Slope Regrading, Option 3 – Shotcrete and Soil Nailing, and Option 4 – Retaining Wall.

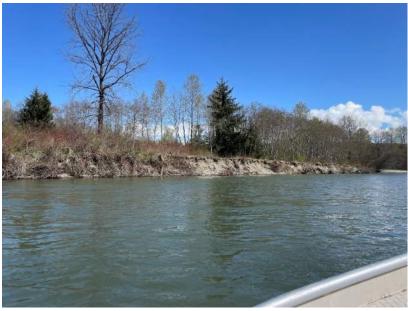
This section has been identified as a potential for erosion and a loss of land and infrastructure within this area and was highlighted in orange within the planning overview plan. This area is located along the west bank of the river just north of Highway 16 (upstream from the bridge). This area was identified to have a high risk of erosion due to the sandy gravel material within the banks and is located on the outside bend of the river where velocities area elevated. The West Kalum FSR is currently within 40 m of the river and the Kalum quarry rail loading facility is roughly 60 m setback from the riverbank.

Figure 5.3-1: Riverbanks along Kitsumkalum South Mitigation – May 13, 2022

The proposed remediation for this section is to install Class 500kg riprap with a nominal thickness of 1.5 m for a length of 400 m with an opening at Eneeksaguilaguaw Creek. Due to the small granular material within the back, it is recommended to provide a layer of non-woven geotextile fabric to provide a separation layer and minimize migration of materials. Access for construction is proposed to be from West Kalum FSR for the portion north of Eneeksaguilaguaw Creek and off Highway 16 for the south portion. Interior access roads within the project area may be required to minimize truck backup time to keep costs down. The proposed design for this mitigation titled C-301 can be found in Appendix B.

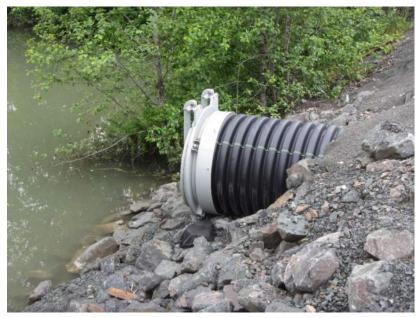
Currently the culvert on West Kalum Road for Eneeksaguilaguaw Creek gets blocked off during high water events to help protect against flooding. With the high fishery value of the slough, maintaining fish access under all flow conditions is ideal. We examined options to remove the culvert flap gate while not increasing the risk of flooding in the village. Note that this assessment did not review or assess flooding issues that may occur to underground infrastructure such as basements.

Figure 5.4-2: Existing culvert – June 21, 2022

The proposed remediation for the village flooding to the south of the slough is to install a berm between the Kalum Road and the newly constructed Kitsumkalum school pad. This berm should be constructed out of a compacted fine grained material to restrict water flow. The berm should be either seeded or covered with small rock to stop any potential surface erosion. A new culvert should be installed to allow for fish passage with a manual gate valve that can be closed during the desired highwater time.

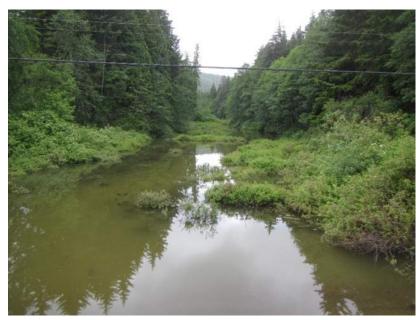
The slough provides excellent rearing and high water refugia habitat for juvenile salmonids (coho [Oncorhynchus kisutch], Chinook, rainbow [O. mykiss] and cutthroat trout [O. clarkii]), as well as habitat for coarse species (e.g., stickleback [Gasterosteus aculeatus]). It is not known if the slough provides suitable overwintering habitat, as water depths are largely controlled by backwatering from the Kitsumkalum River, and the slough may not have sufficient depths during low water conditions to avoid freezing to the bottom or encountering anoxic (lack of oxygen) conditions. It should be noted that ample overwintering habitat exists downstream in both the Skeena and Kitsumkalum Rivers.

Figure 5.5-3: Kitsumkalum Slough – June 21, 2022

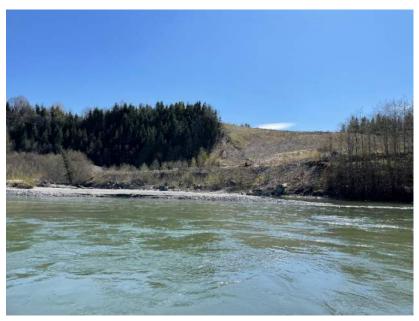
The section was identified within the Overview Plan (C-100 in Appendix B) as the yellow line. Upon review by the project team and discussion with the project partners, this area was identified as low priority for erosion protection and therefore no mitigation design was completed for this section. This section's banks do consist of high erodible material but currently the mainstem of the river is located 100 m from the bank although a side channel is directly against the bank. No infrastructure is located within this area and therefore any mitigation would strictly be protecting against loss of land and river movement. It would be recommended to complete an additional review of this section prior to construction of any infrastructure within this area.

Figure 5.5-1: Gravel Pit Mitigation Site – May 13, 2022

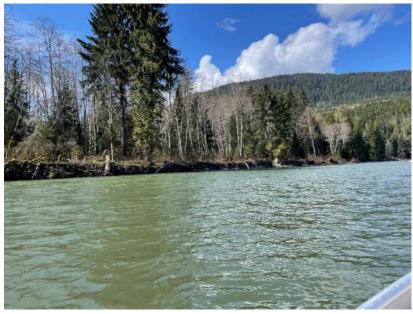
The section was identified within the Overview Plan (C-100 in Appendix B) as the purple line. Upon review by the project team and discussion with the project partners, this area was identified as low priority for erosion protection and therefore no mitigation design was completed for this section. This section's bank does consist of high erodible material but currently the river's is location is being directed by the existing riprap placed just off the West Kalum FSR. This section also contains some river back channels that have potential fish spawning habitat. No infrastructure is located within this area. Therefore, any mitigation would strictly be protecting against loss of land and river movement and with the potential for spawning habitat it was felt best to leave it as is until this section became a higher priority. It would be recommended to complete an additional review of this section prior to construction of any infrastructure within this area.

Figure 5.6-1: Kitsumkalum North Boundary Mitigation Site – May 13, 2022

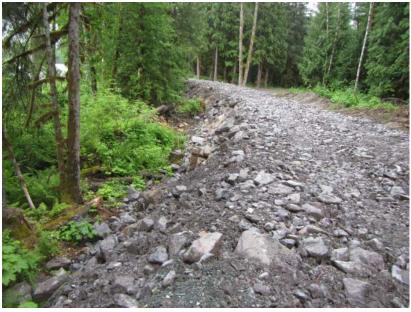
Figure 5.6-2: Existing Riprap Protection– June 21, 2022

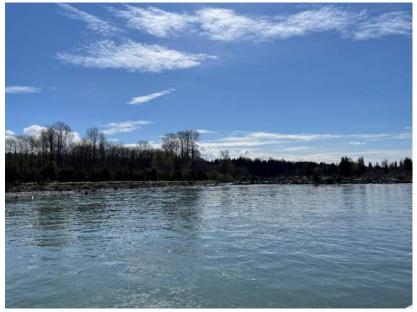
Although Dutch Valley is outside the study area it's proximity to the area warranted a review. Between 2009 and 2015 large sections of Dutch Valley have been riprap providing erosion protection. The blue section within Dutch Valley on the Overview Plan (C-100 in Appendix B) has not had any notable erosion since the upstream protection was installed in 2012. Although it was noted during the site review that a log jam has formed within this area that has started to channelize the water towards the unprotected bank. This could potentially cause the river to shift and put that bank in jeopardy. Potential mitigation for

Figure 5.7-1: Log jam pushing water towards the bank – May 13, 2022

this would be to remove the log jam and this could slow or stop the channelization and the need to riprap this section of the bank.

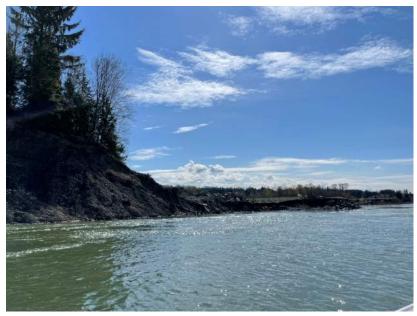
Significant erosion has occurred at the North end of Dutch Valley that has started to put the erosion works installed in 2014 and 2012 at risk of eroding away. Designs for this mitigation have been proceeding through the RDKS.

Figure 5.7-2: North end erosion in Dutch Valley – May 13, 2022
