KITSUMKALUM RIVER CHANNEL STABILITY ASSESSMENT

AERIAL AND GROUND INSPECTION APRIL 22 to 23, 2009 COMPILATION OF DIGITAL AND VIDEO IMAGERY

May 6, 2009

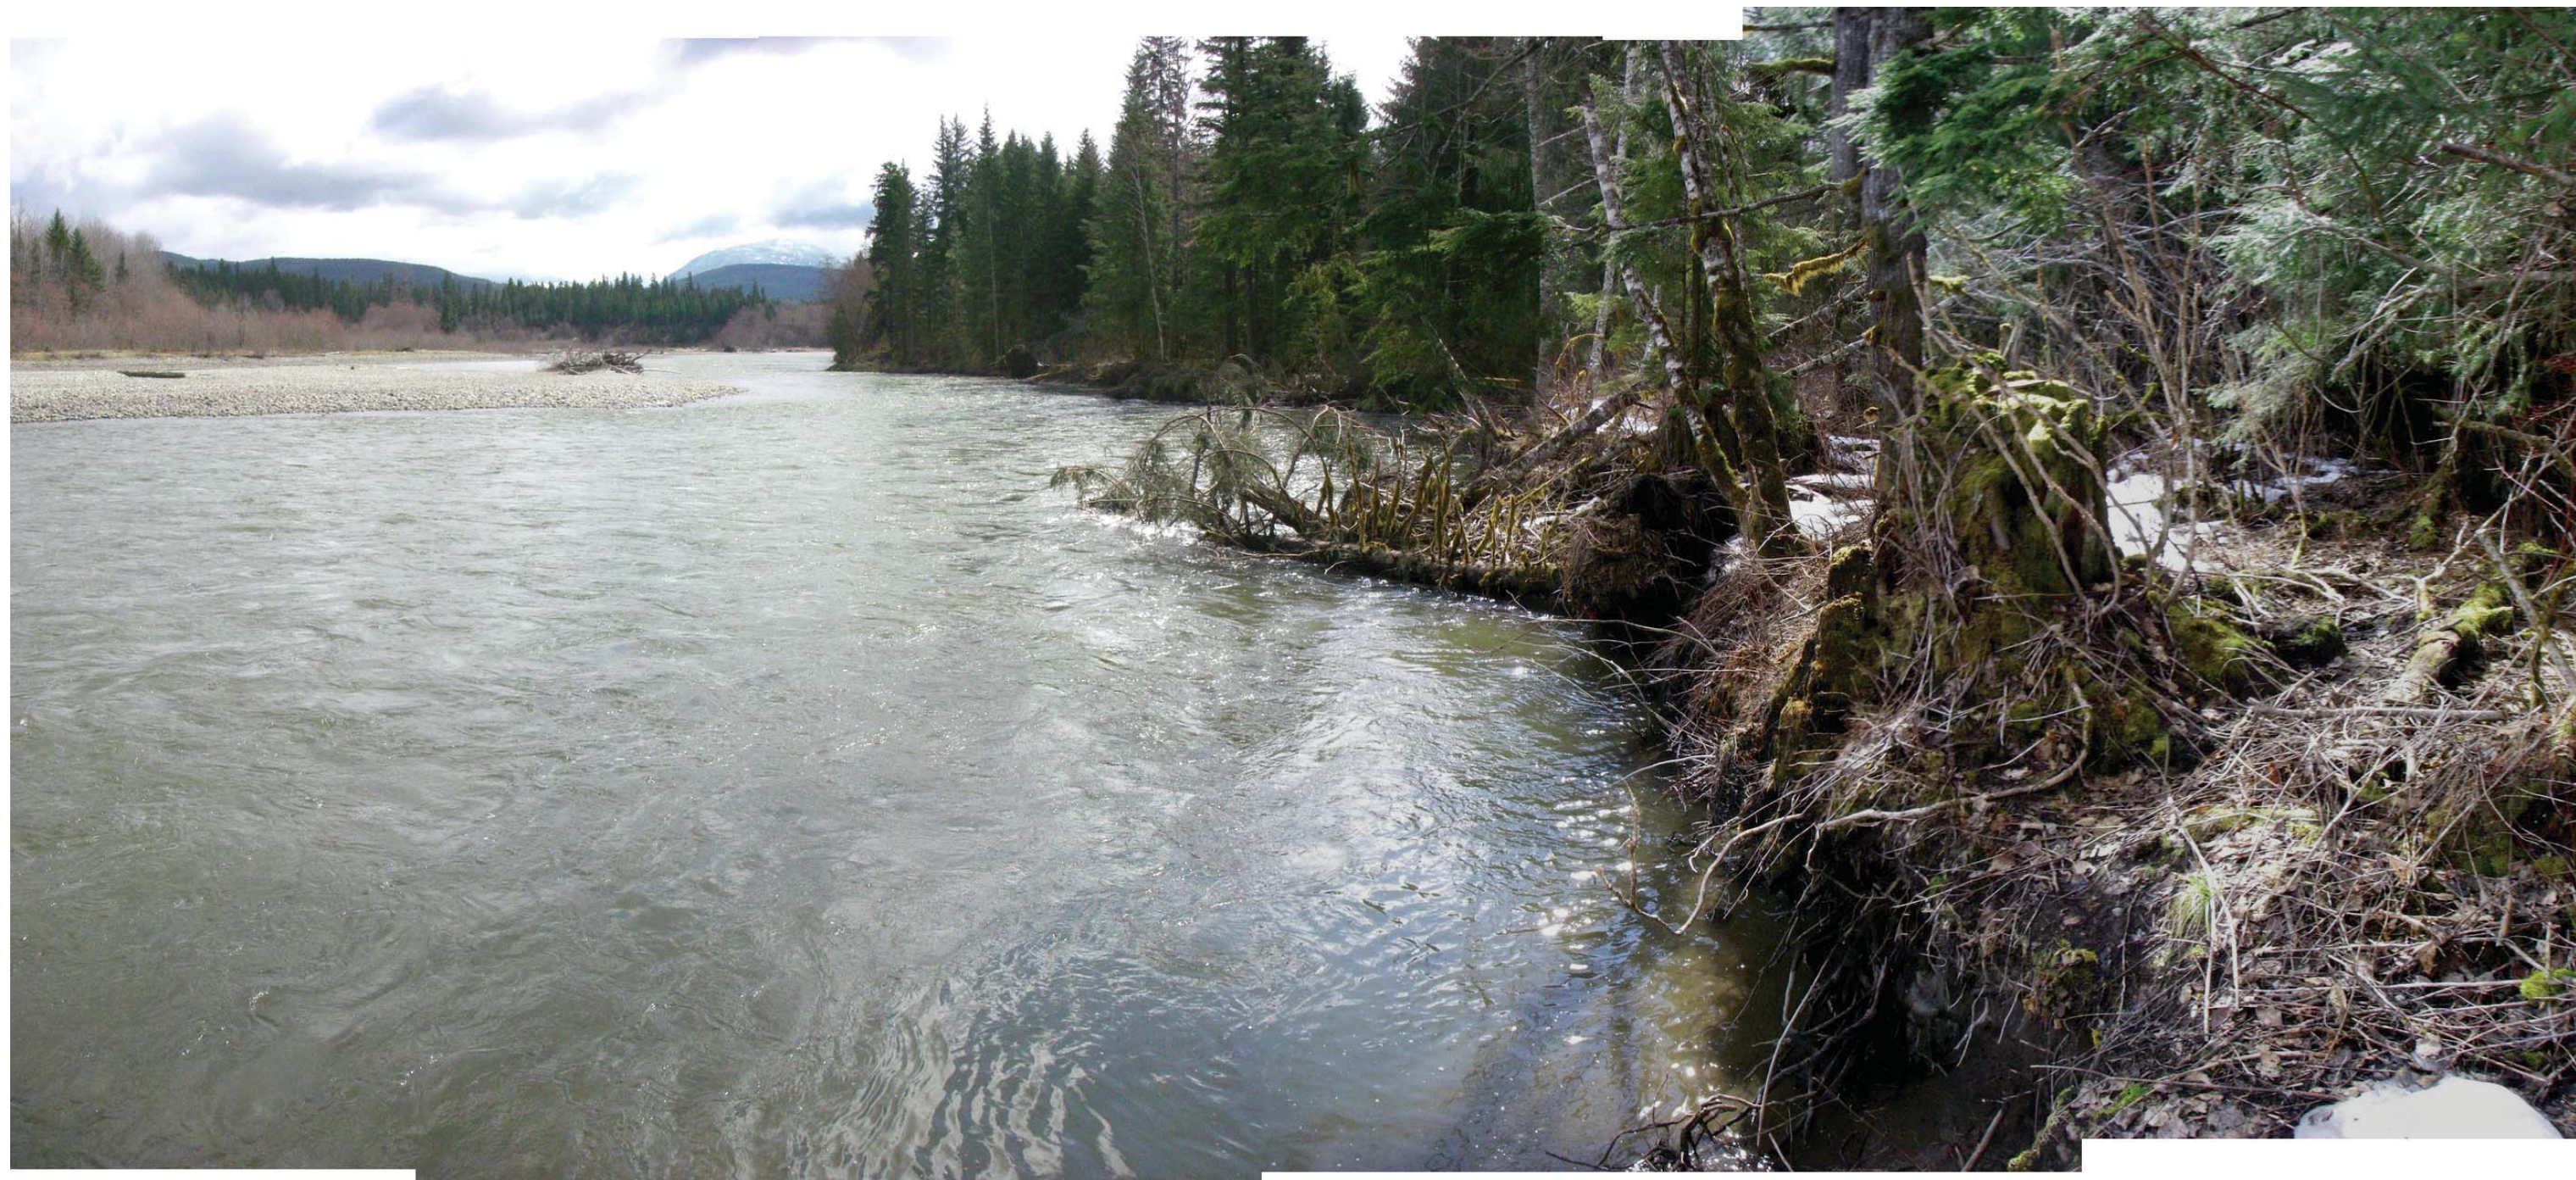
MM 09 5362 to 5366

GPS Mark 140. This is at the nose of a short spur and the closest point between the Kitsumkalum River and the Nass Road. Time is 11:25 am.

Panorama looking downstream. There are three fir trees which have recently fallen into the water. Don tells me that this bend has eroded rapidly over the last few years and that in 2007 the water level was up to the road, or the small spur we are standing on, but did not overtop the road.

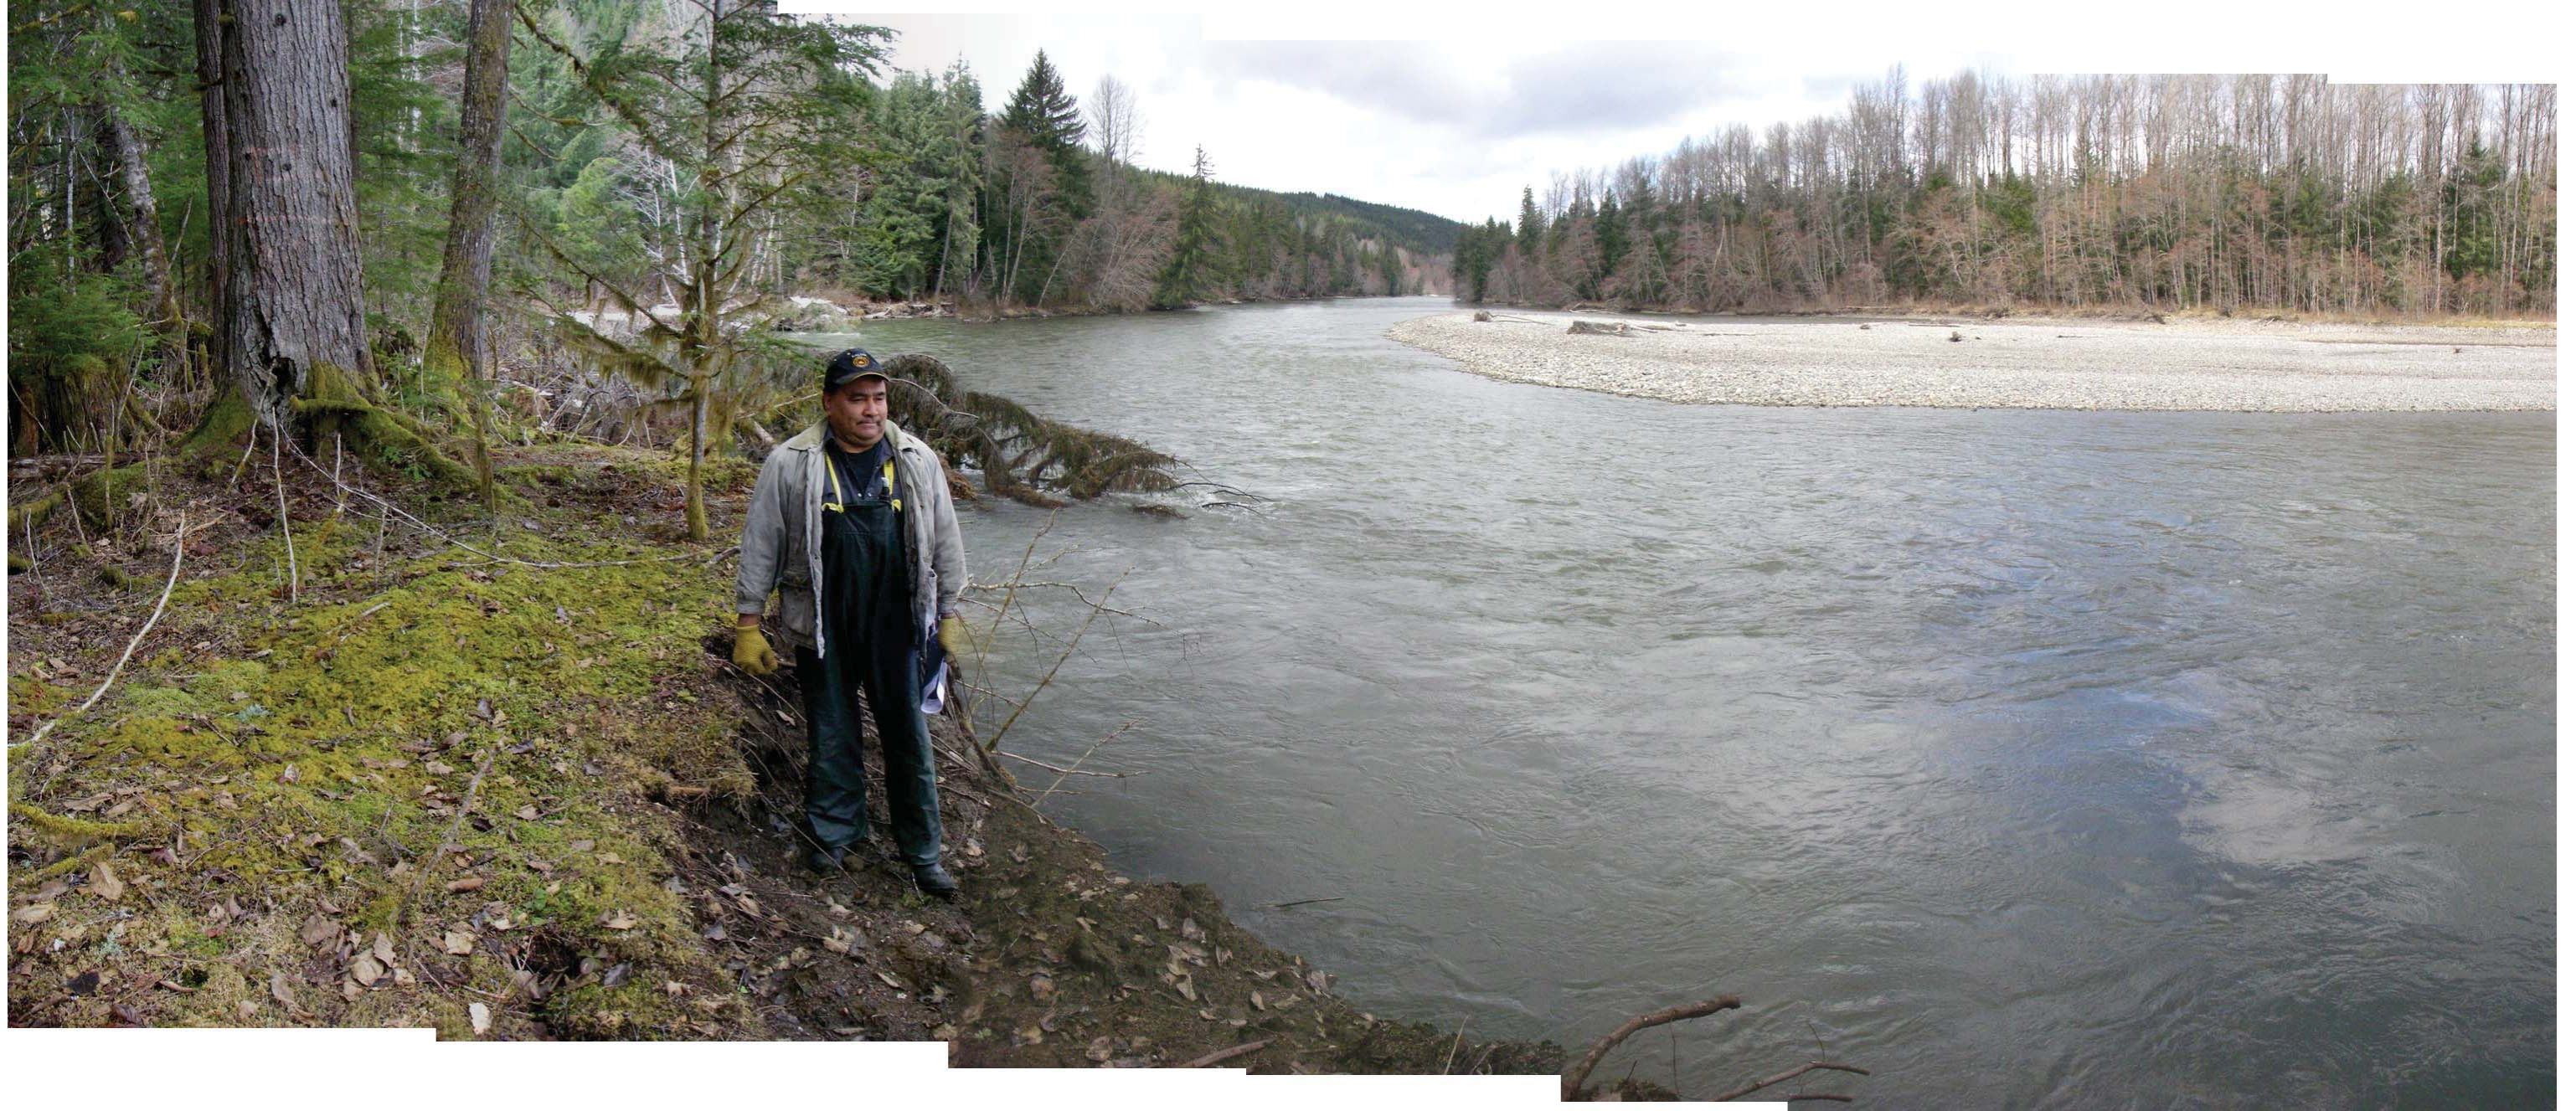
MM 09 5367 to 5372

Looking upstream along the same eroding bend as the previous photo with Don in the center of the photograph. Note the scour level on the top of the bank which is about 1.5 m higher than the adjacent flood plain.

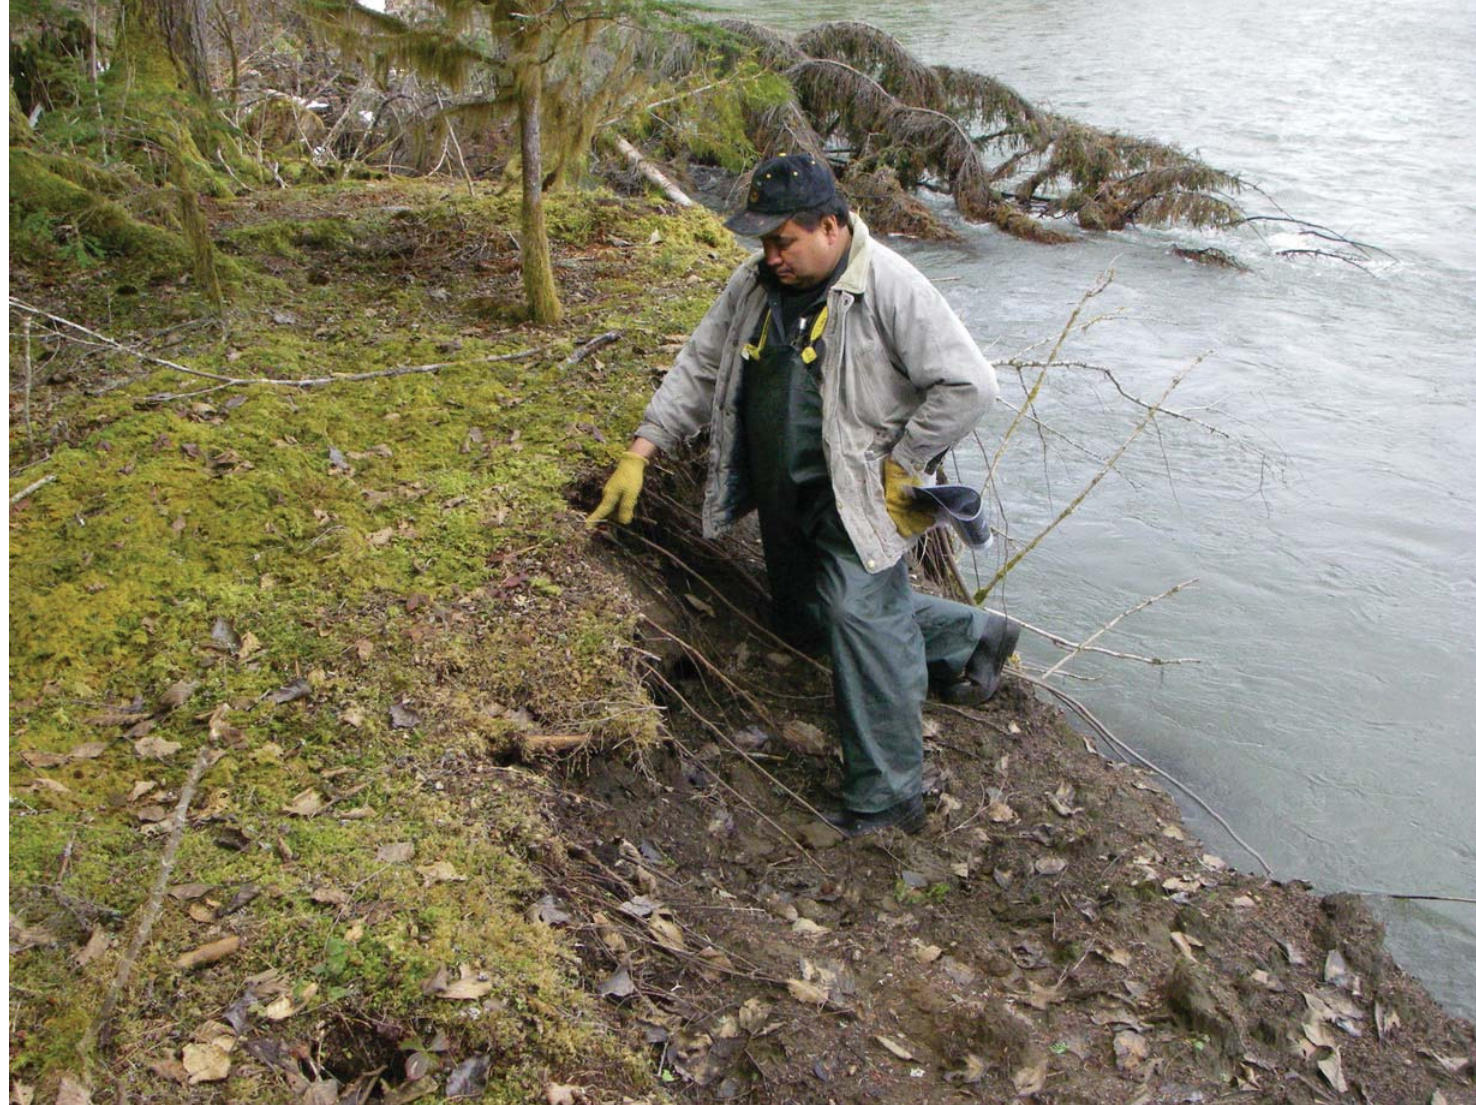
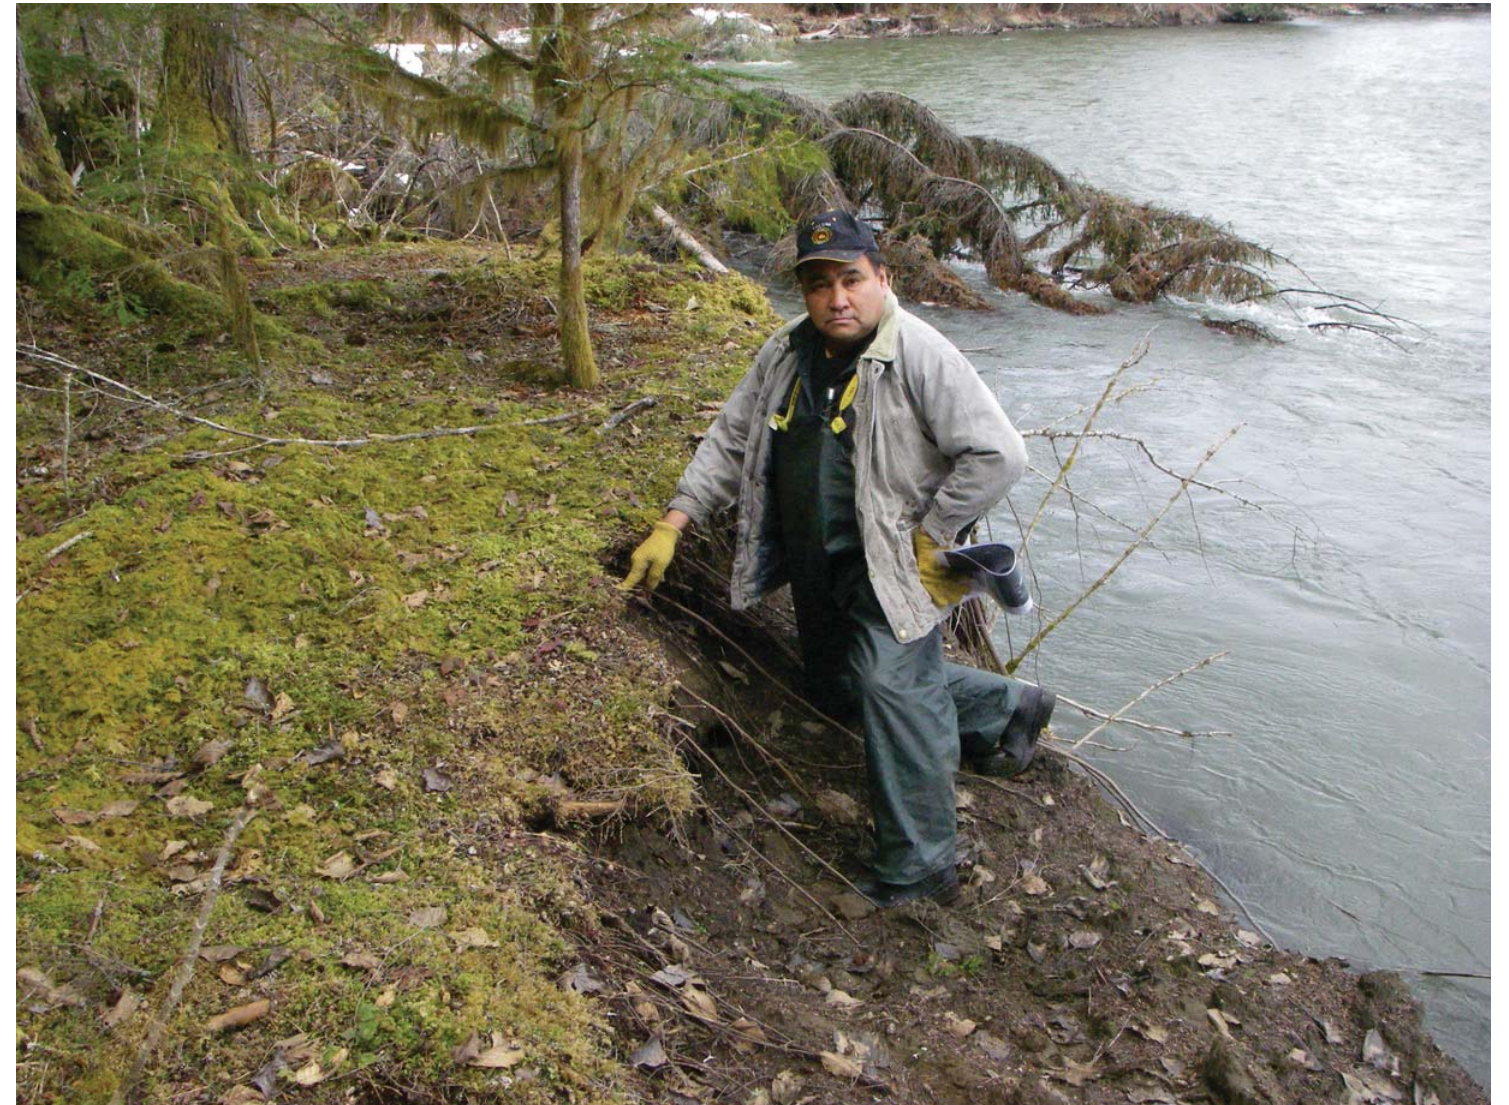
MM 09 5373 & 5374

GPS Mark 141

Two photos of Don showing the erosion scour lines on the bank. Mitch Drews of DFO suggested a set-back berm could be placed 50 ft from the river in this area. The river is now very close (3 to 4 m) from the flagging that has been put up to mark the outside edge of the proposed revetment. This indicates how much erosion has recently occurred. The flagging was put in during April 2007 before the June flood.

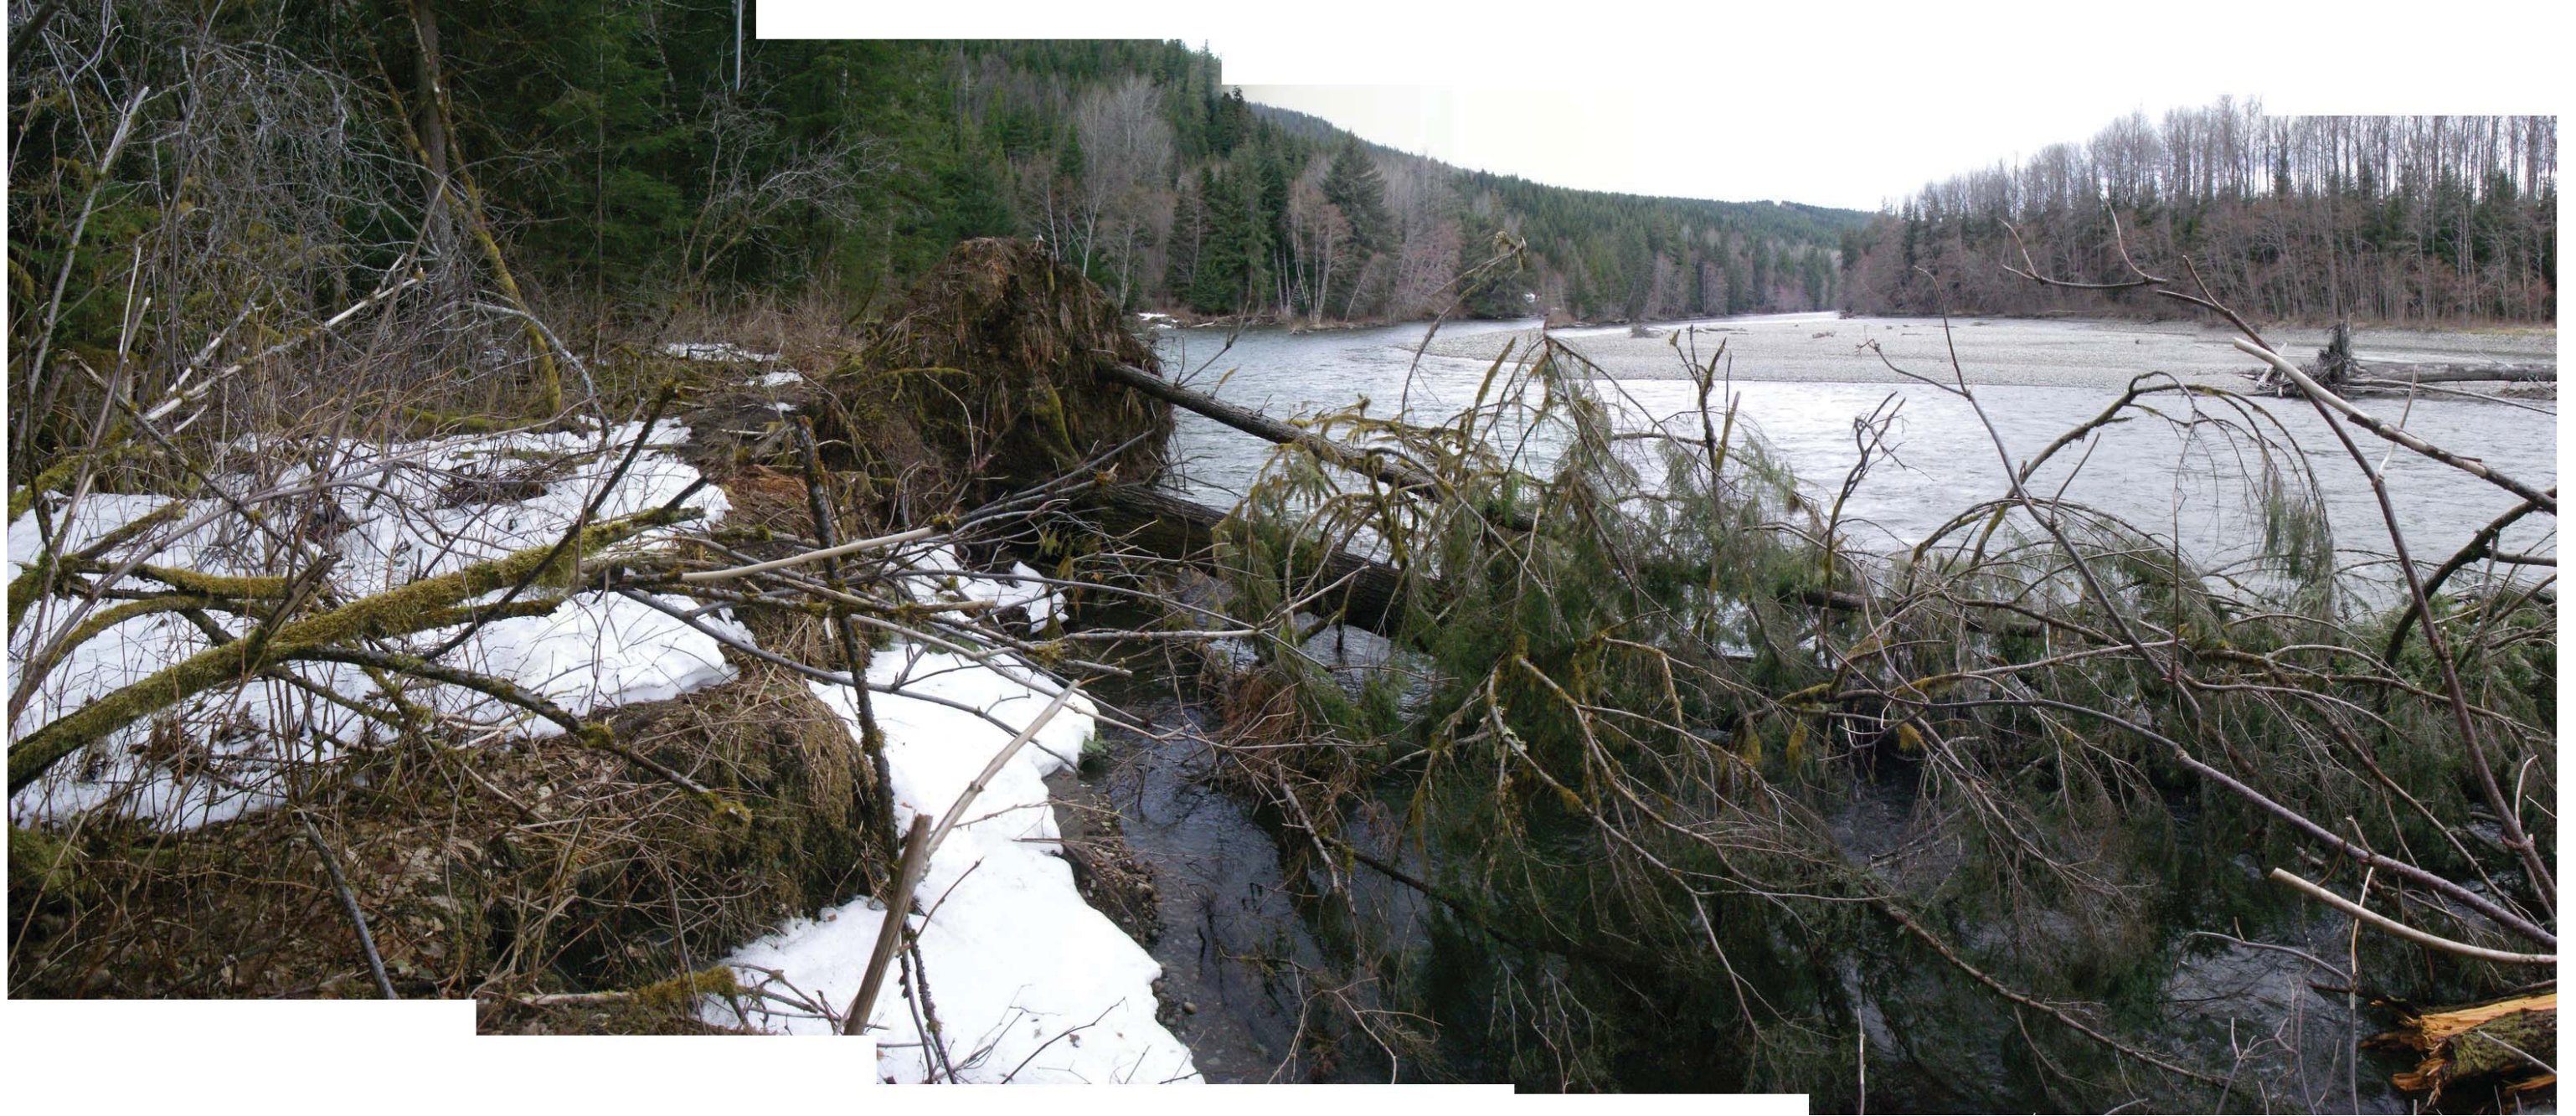
MM 09 5375 to 5380

Looking upstream over a 50 cm diameter tree that has fallen into the river. Note the prograding point bar on the left bank.

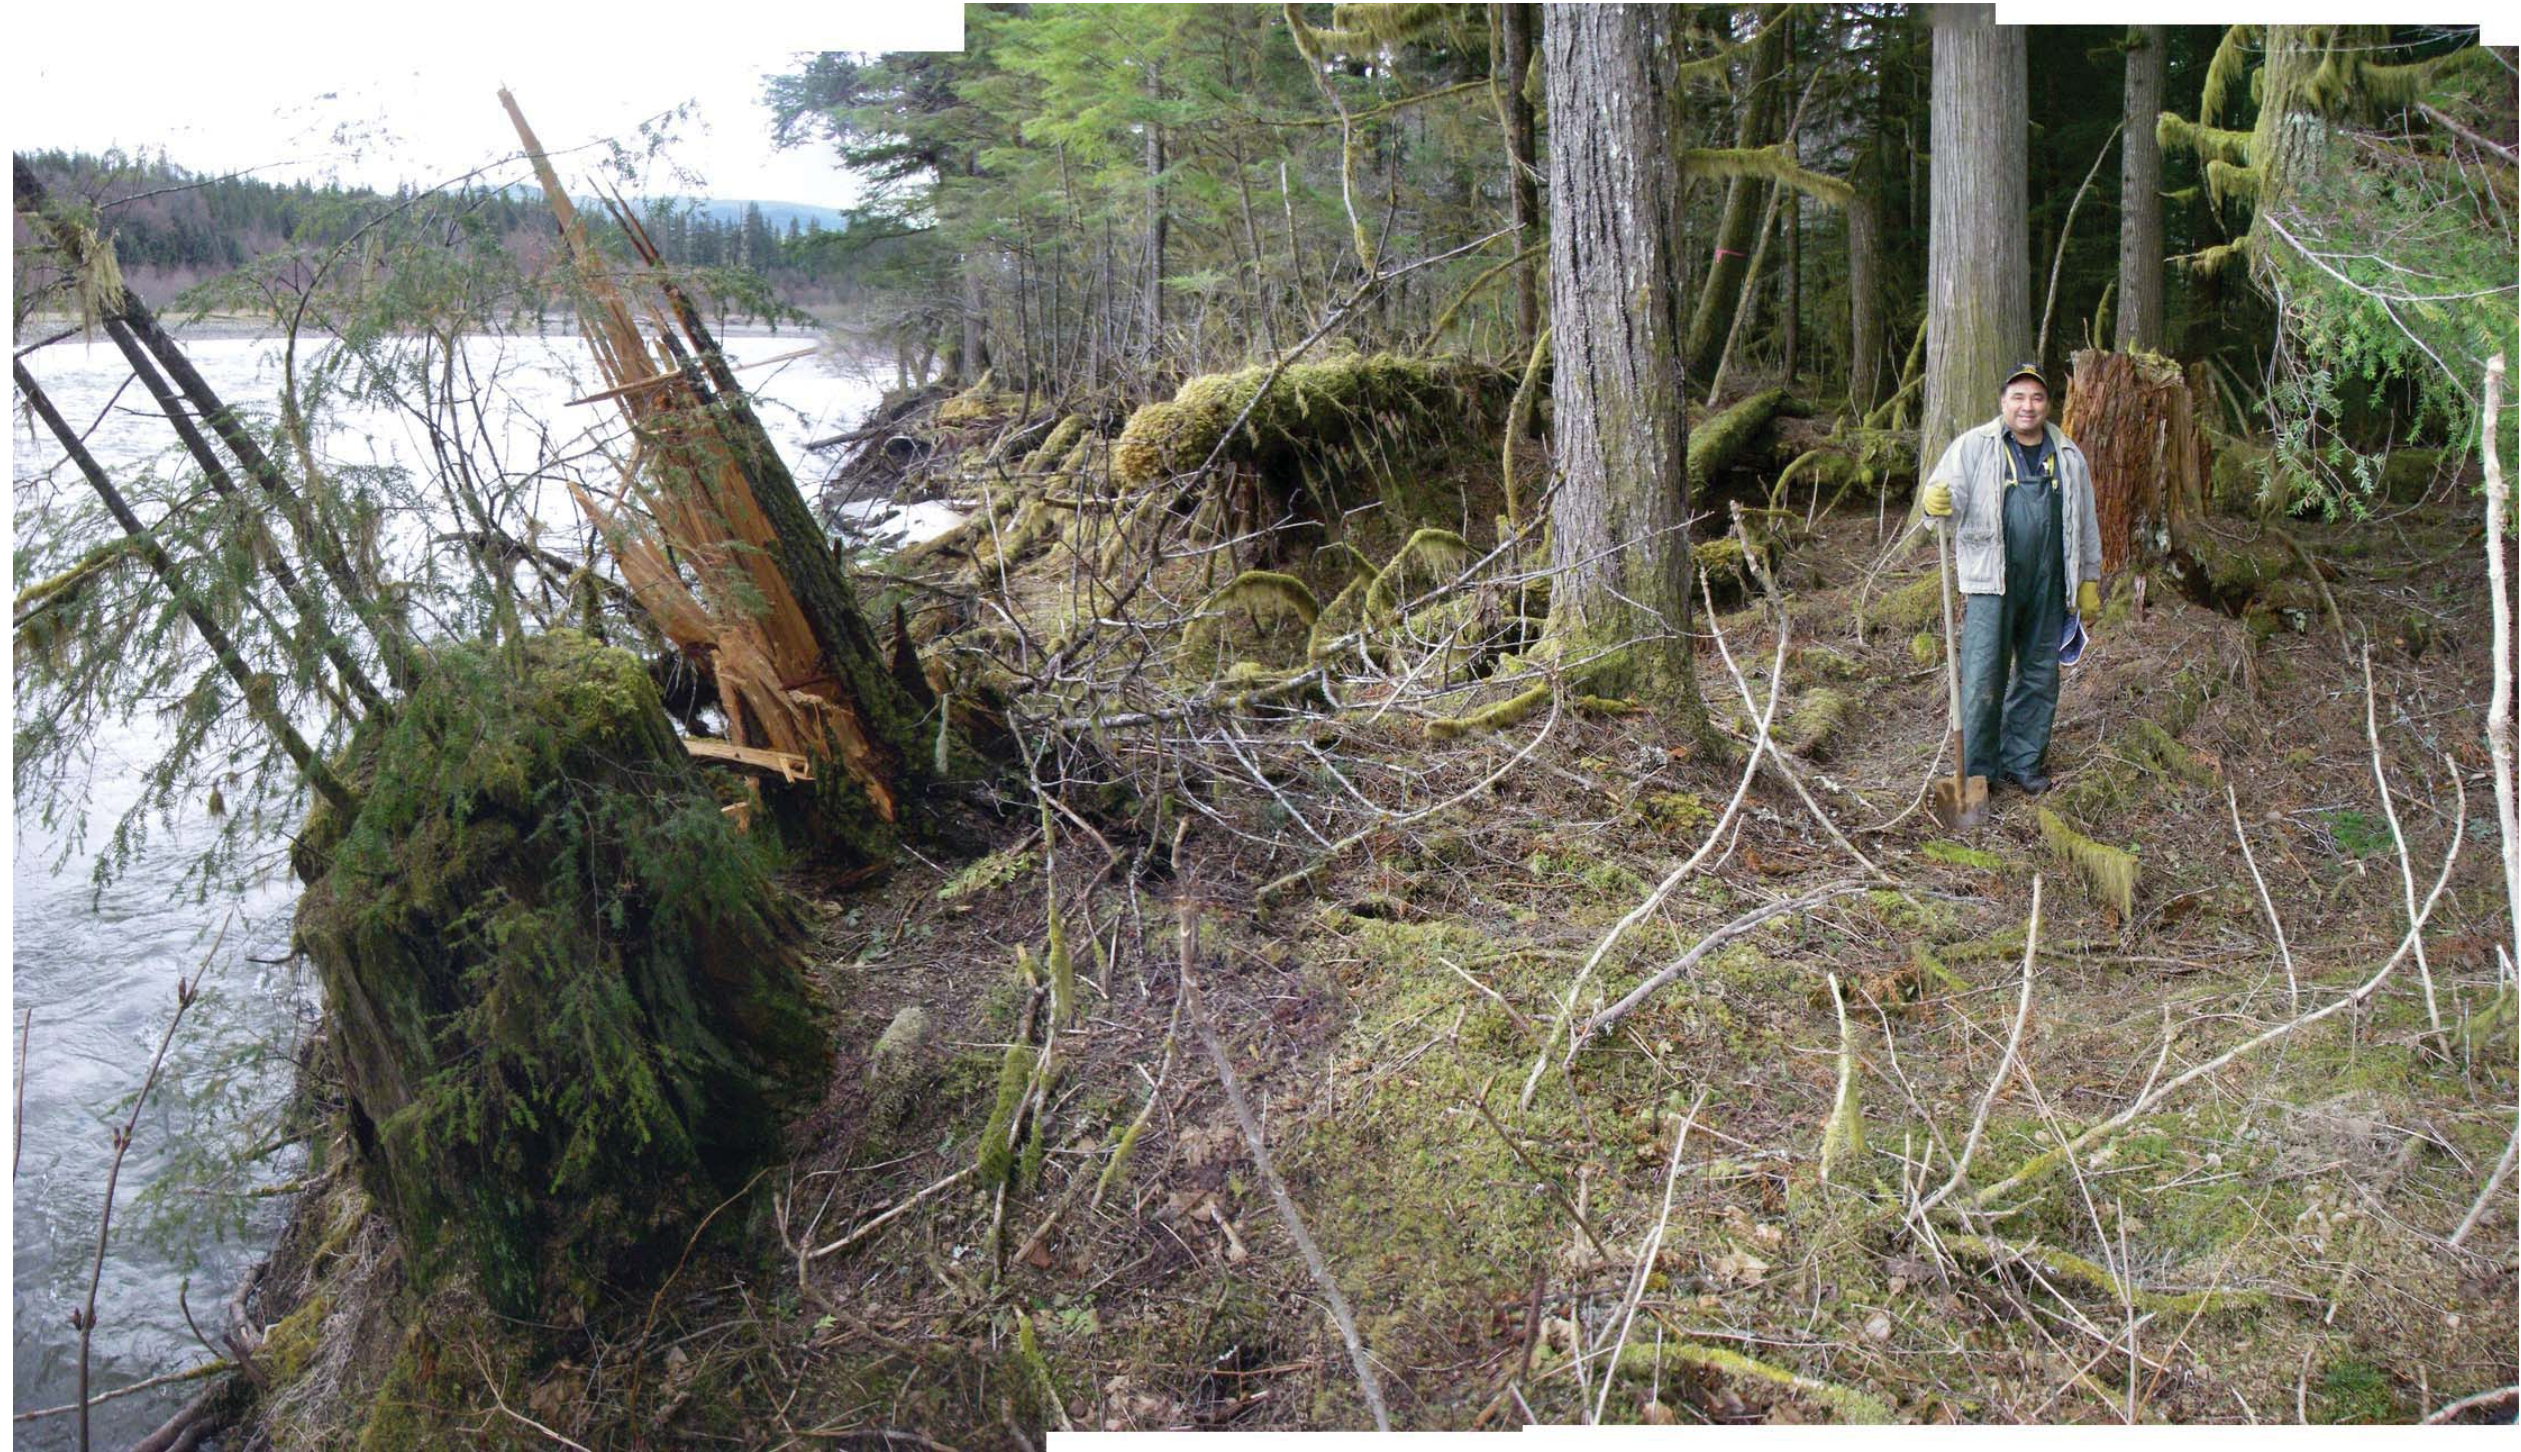
MM 09 5381 to 5385

Looking downstream with Don holding the shovel for perspective right beside the pink flagging marking the previously proposed revetment location. It is 7.8 m from the flagging to the hemlocks on top of the small stump by the river. Don mentioned that he placed the flagging 50 ft (15 m) from the bank edge in April 2007.

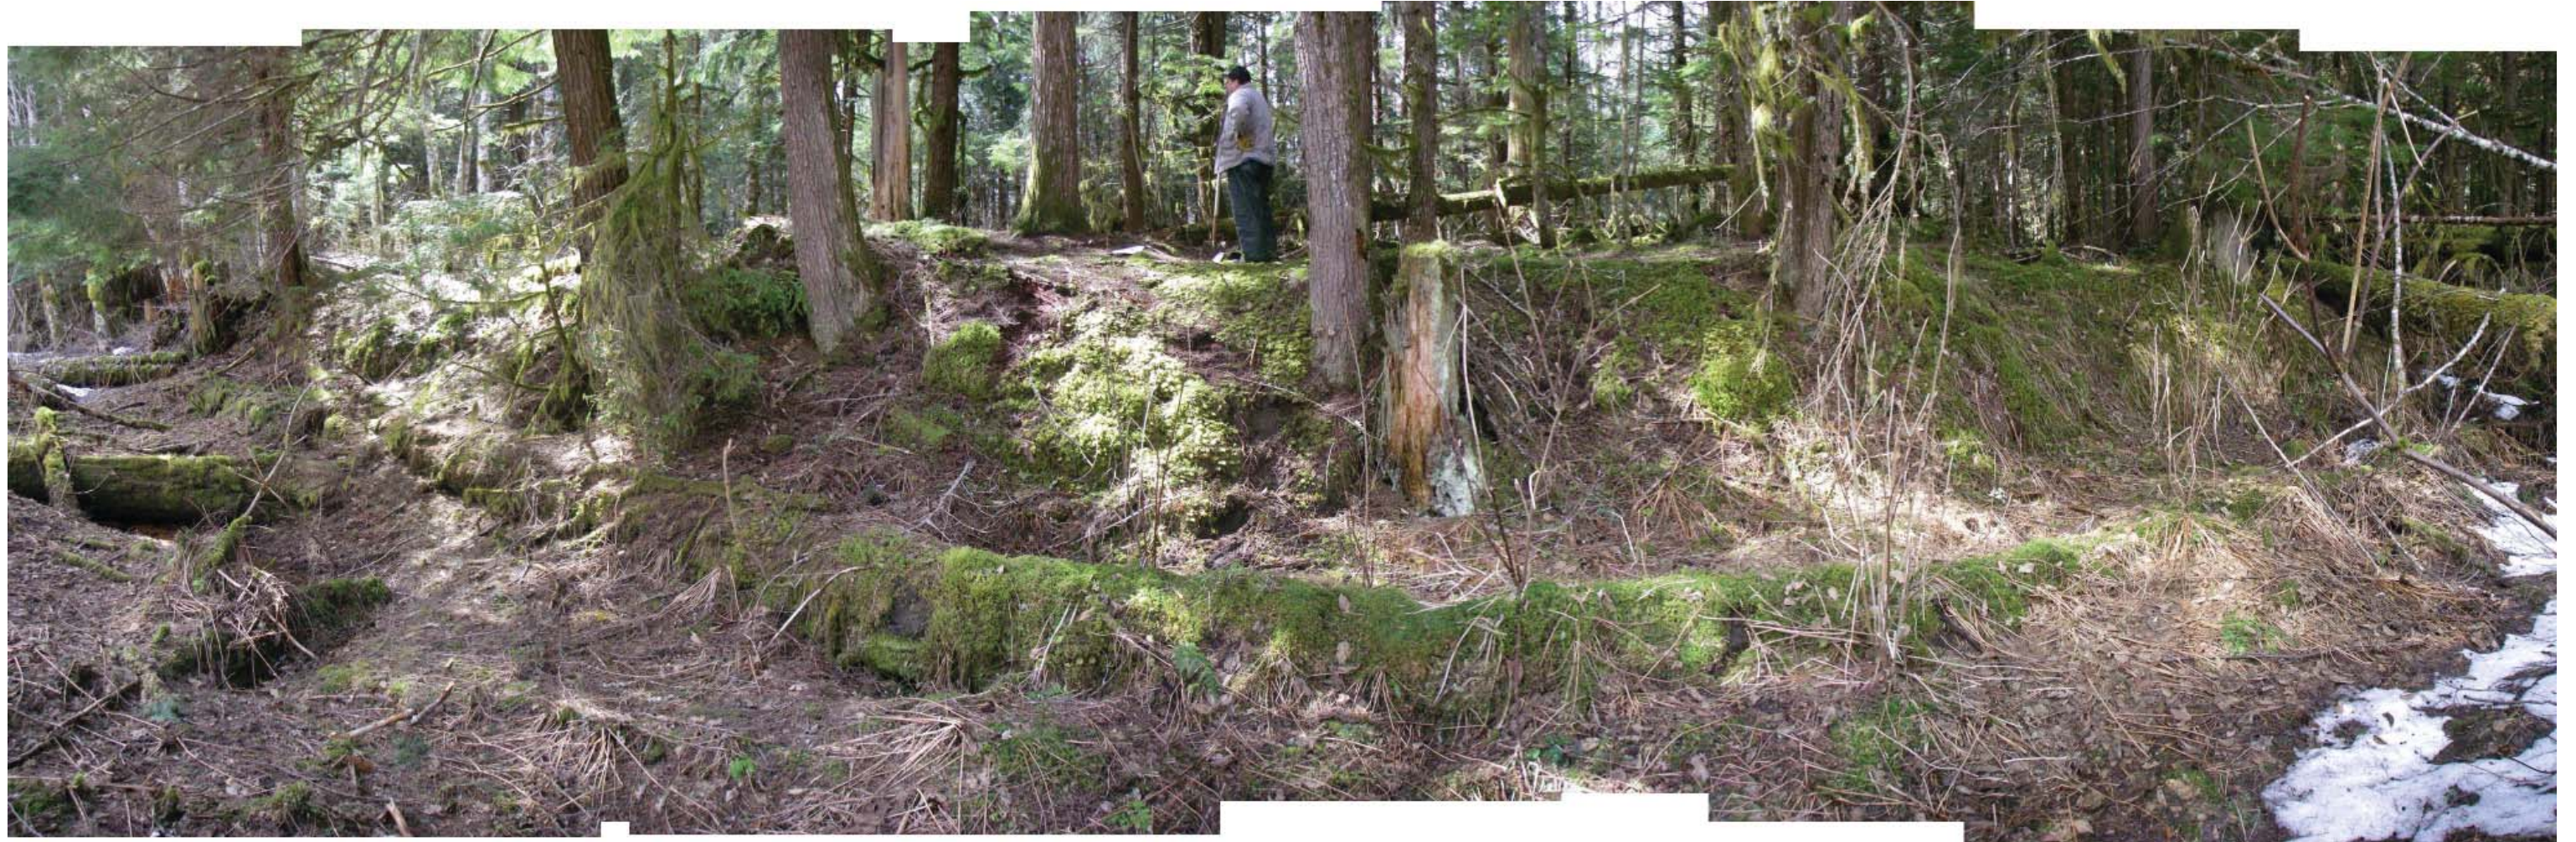
MM 09 5386 to 5392

GPS Mark 142 is standing in a small seasonally wetted channel and is just opposite the areas we might consider for starting the set-back berm.

GPS Mark 143 is at the base of the right bank below the fluvial terrace. Flood waters have recently flowed through this area. The terrace is about 1.5 m high at this point. This would probably be quite a good place to use as a defensive line for what you might want to protect or might not.

Panorama shows the edge of the terrace with Don in the middle of the photograph.

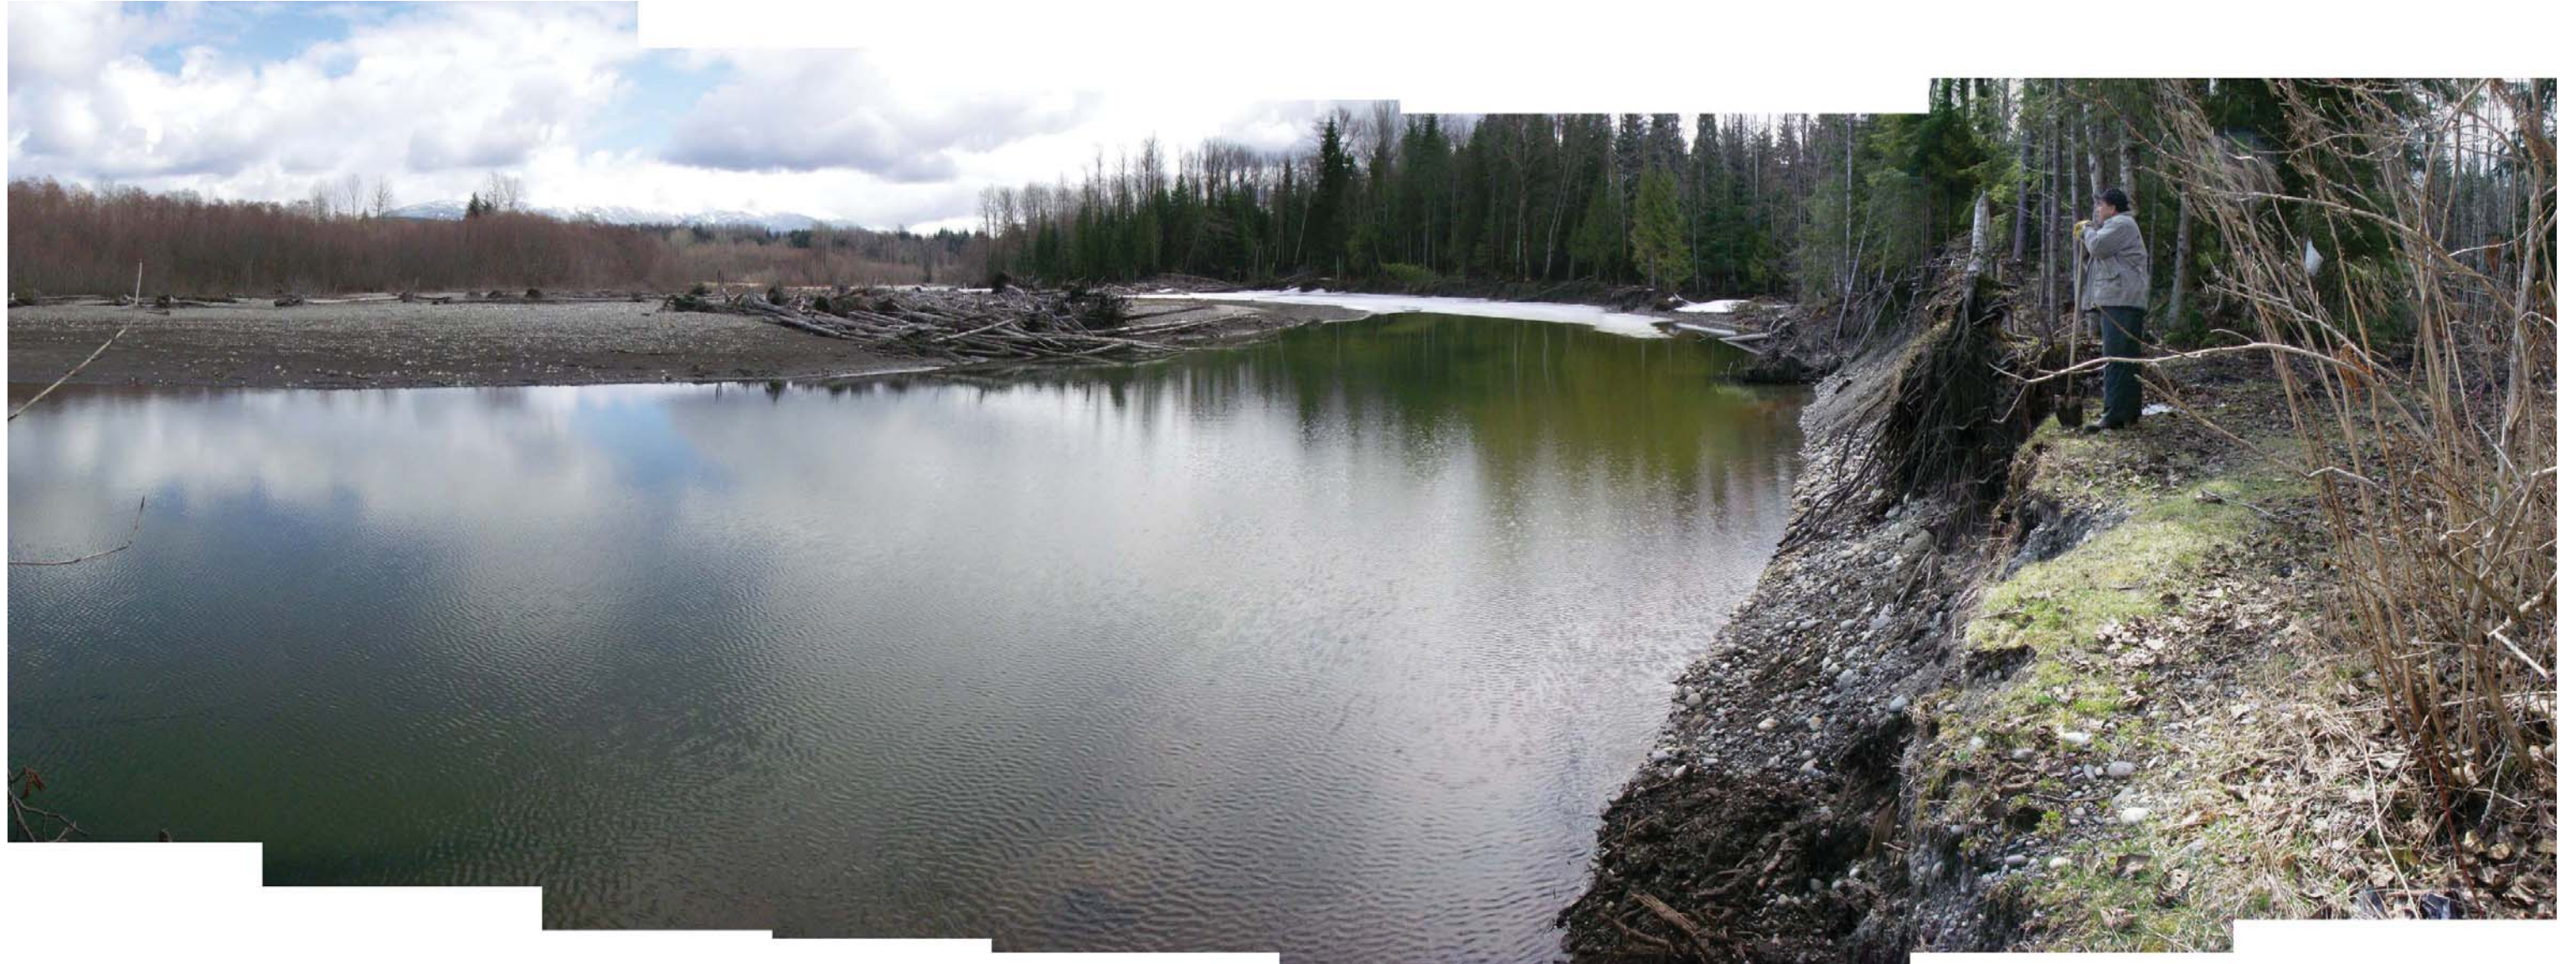
MM 09 5398 to 5405

Panorama looking downstream over the recently abandoned channel. Don is standing on the bank with his shovel indicating height. Note the reddish brown algal mat at the toe of the cut-slope.
