KITSUMKALUM RIVER CHANNEL STABILITY ASSESSMENT

AERIAL AND GROUND INSPECTION APRIL 22 to 23, 2009 COMPILATION OF DIGITAL AND VIDEO IMAGERY

May 6, 2009

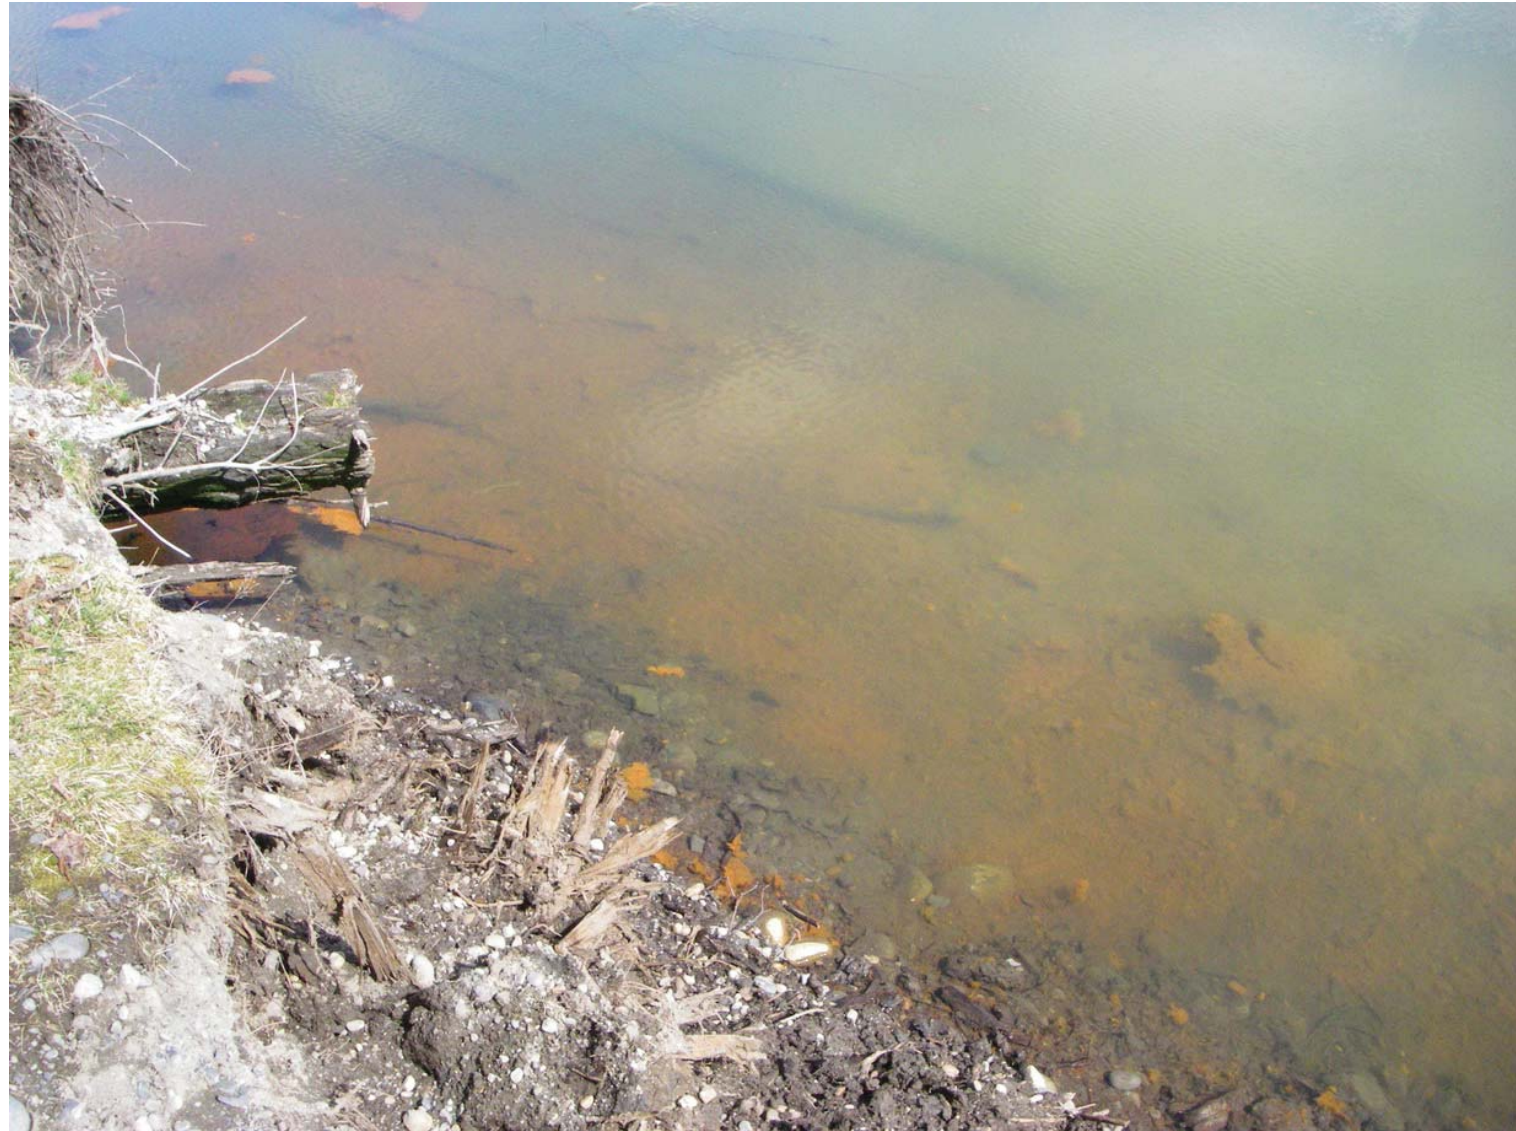
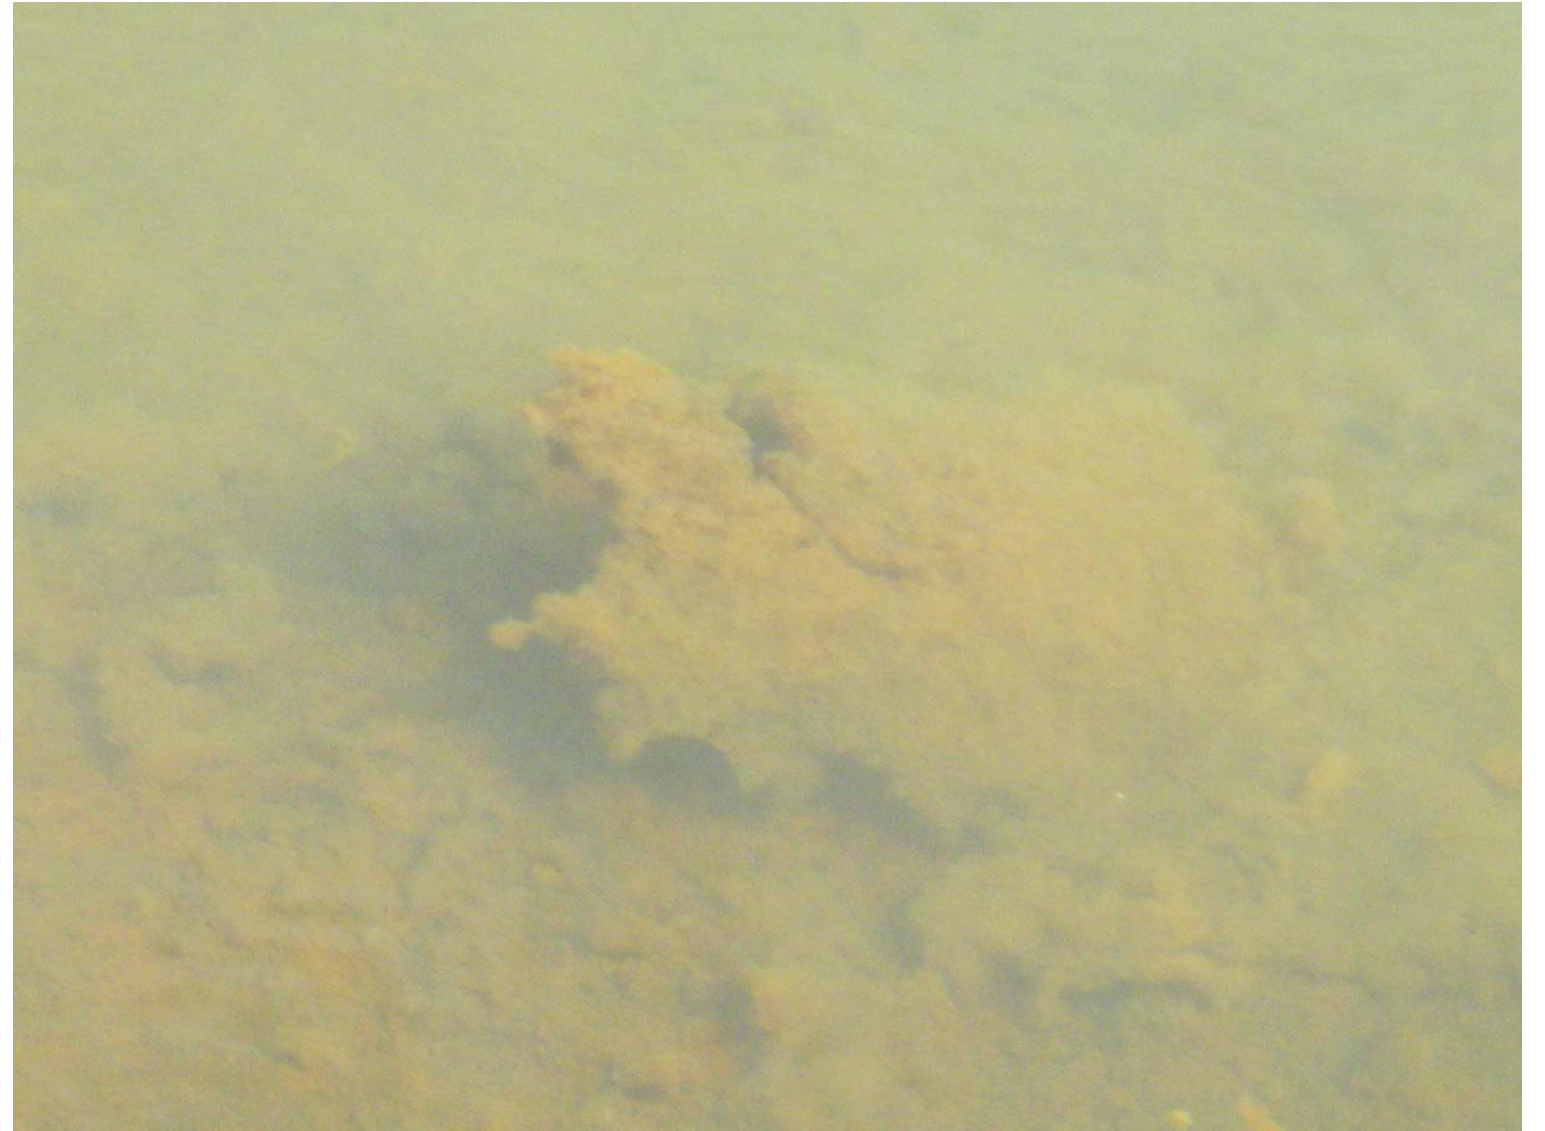
MM 09 5406 & 5407

Two photos showing the reddish brown algal mats in the abandoned channel.

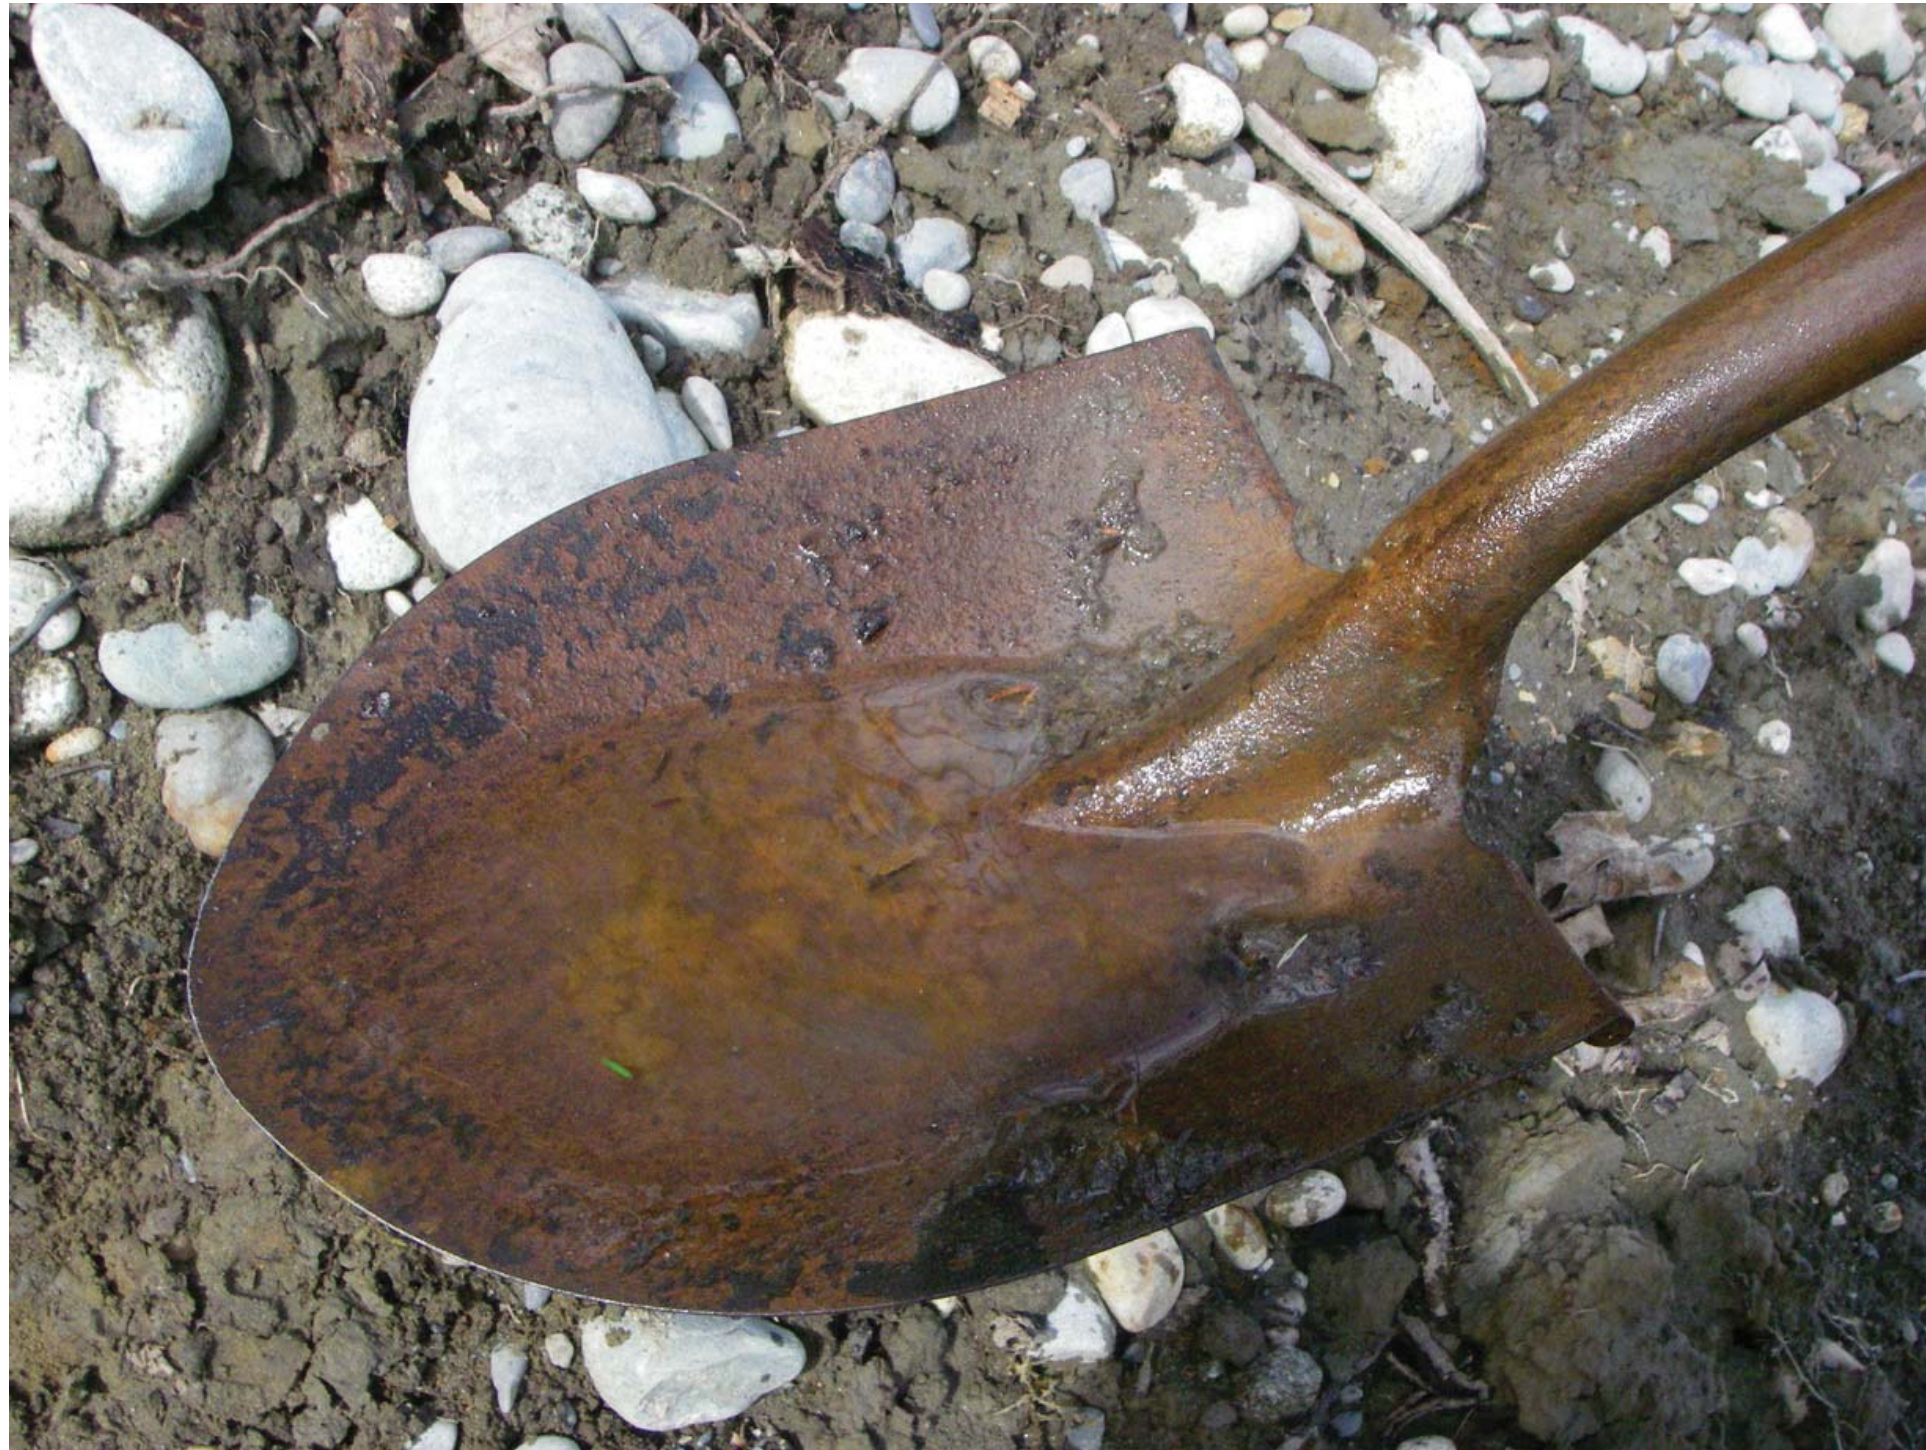
MM 09 5408

Photo of the shovel with a sample of the reddish brown algal mat in it. This site was formerly a gravel pit which is why it was used as a swimming hole.

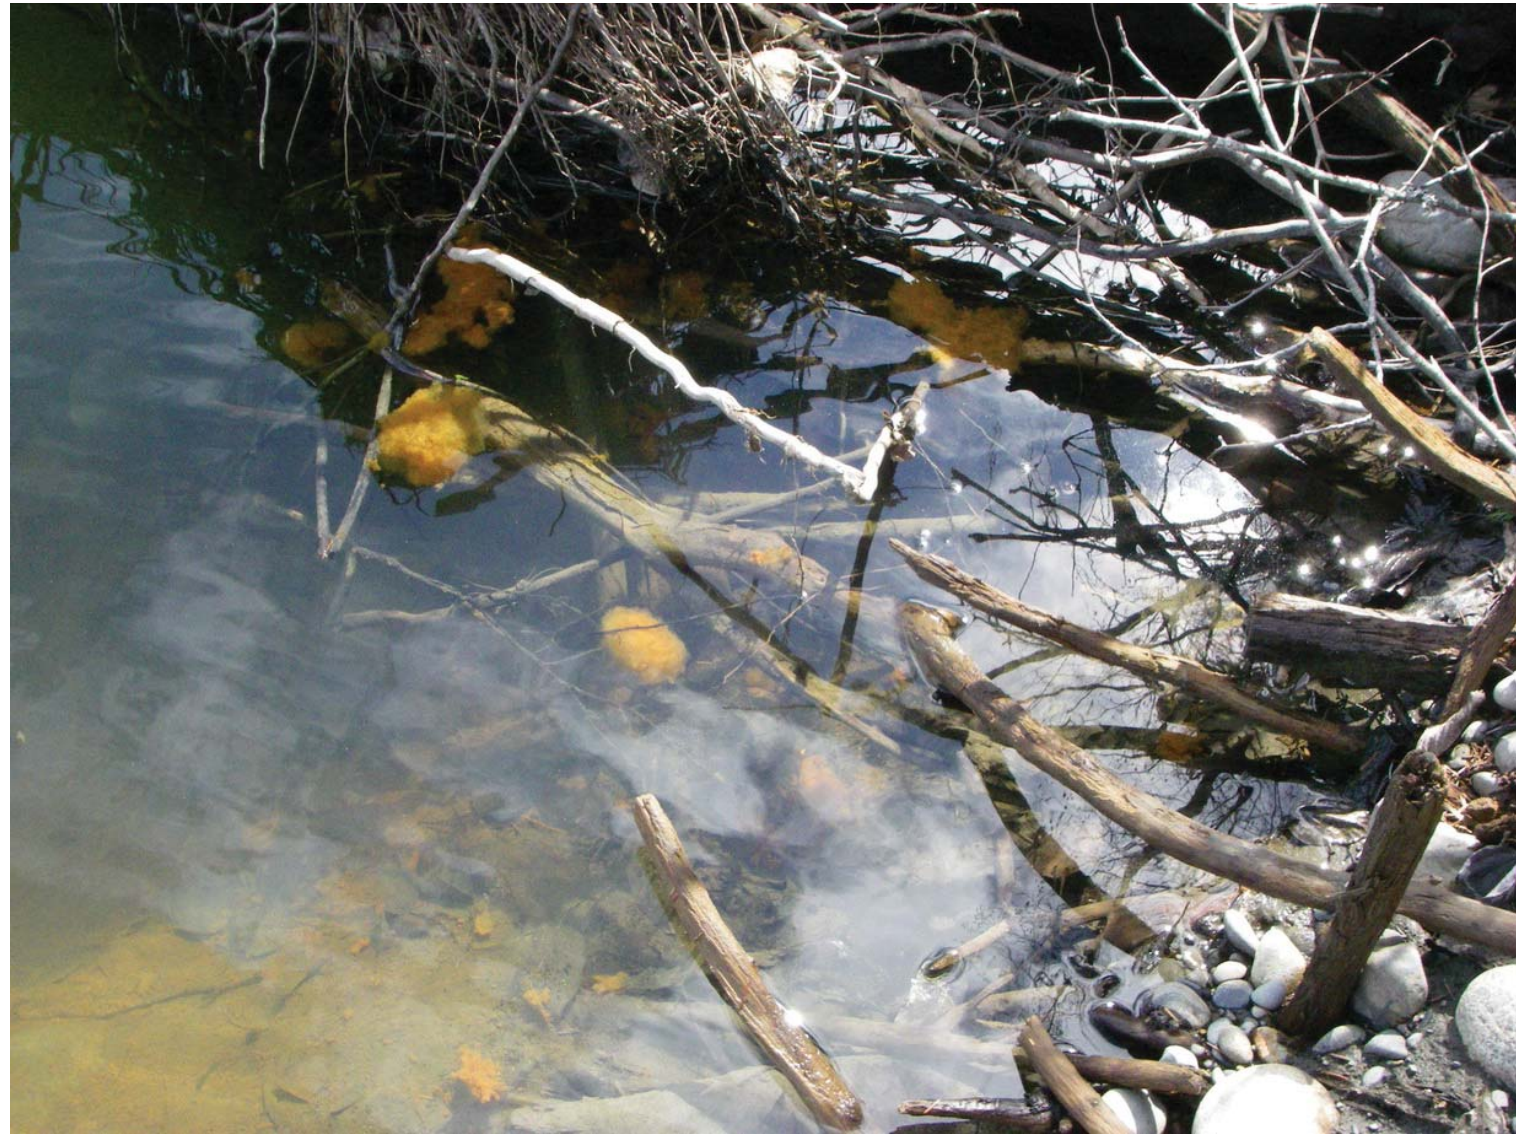
Looking at algal mats around a root wad.

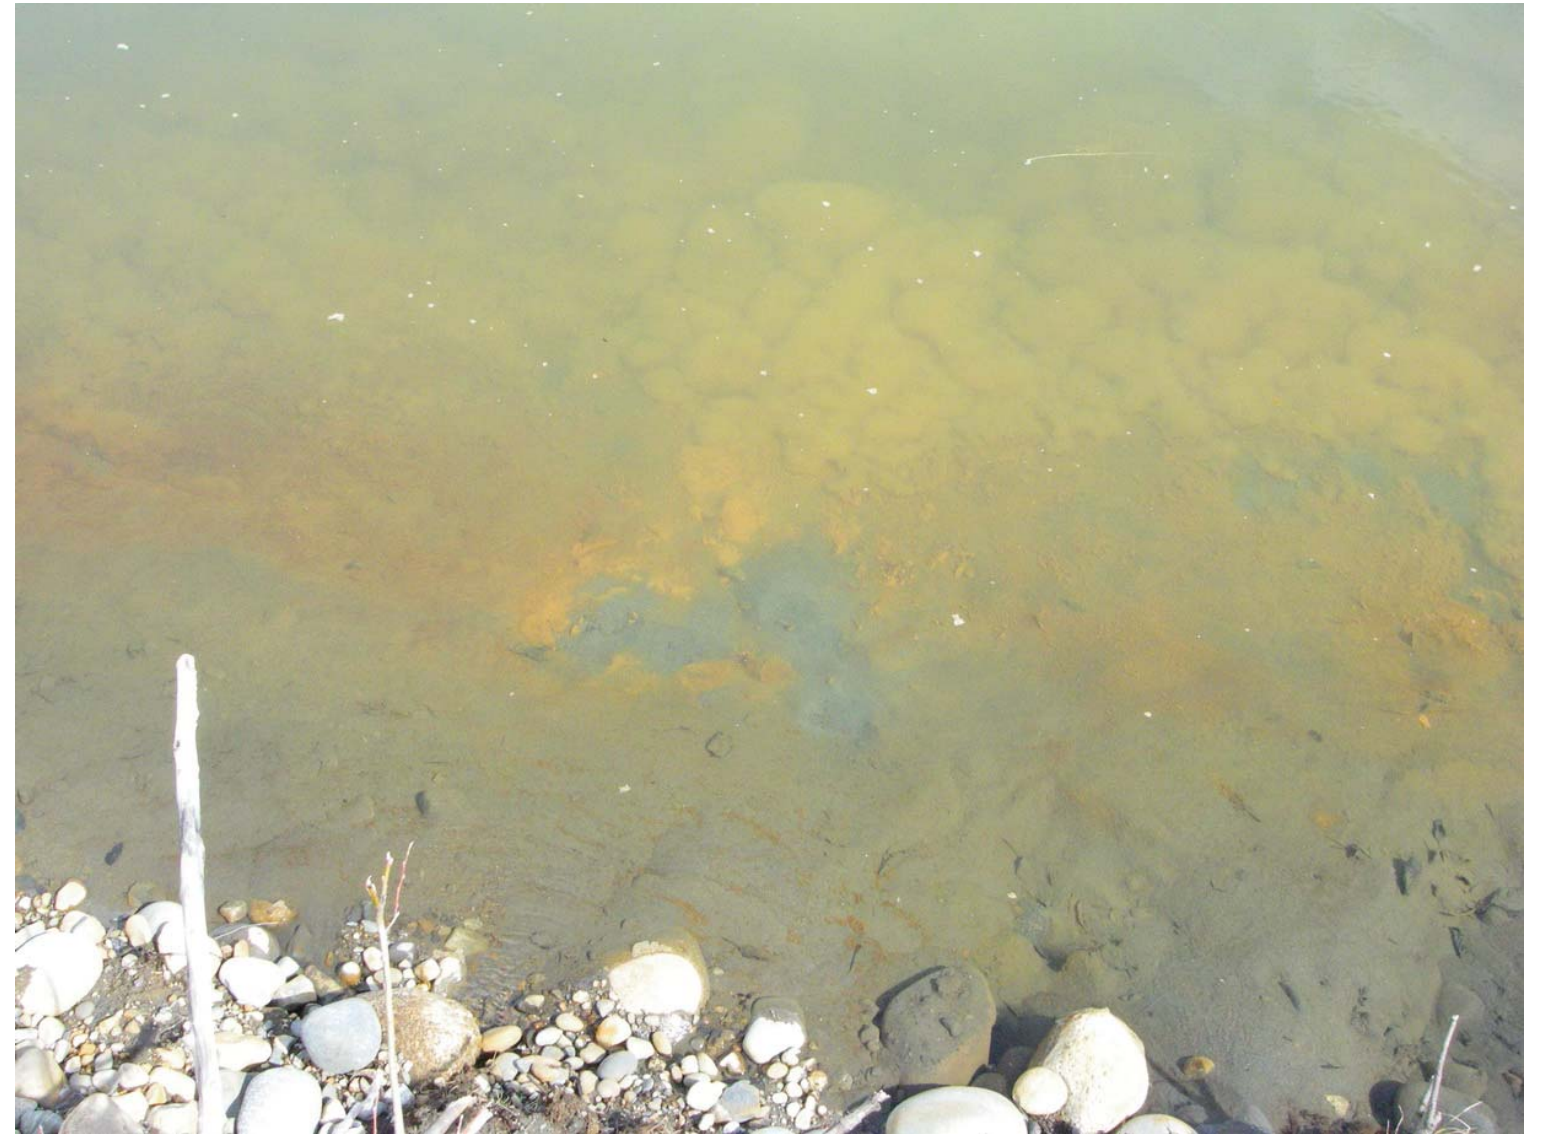
MM 09 5409 & 5410

GPS Mark 145

Looking at a sand boil where ground water is perculating up out of the river bed over a distance of about 40 cm. There are noticeable concentrations of reddish brown material around the small sand boil.

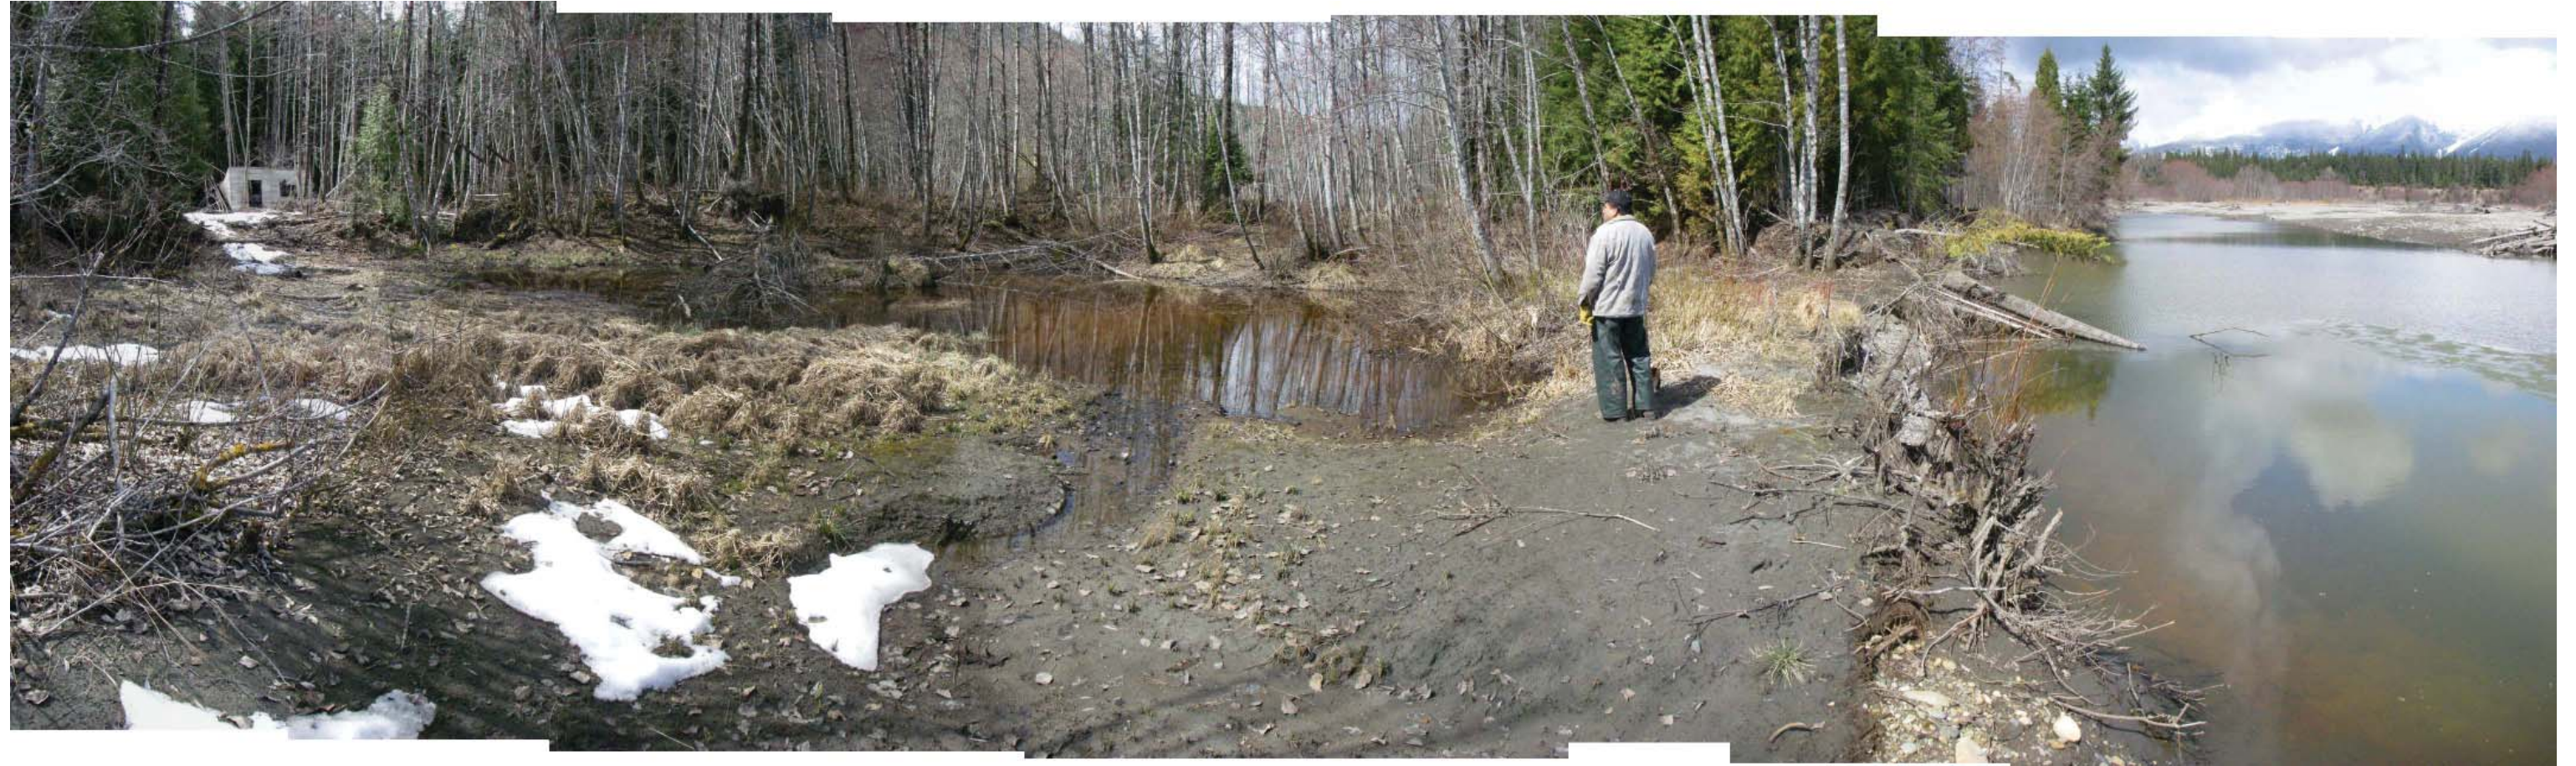
MM 09 5411 to 5418

Looking at the small residual beaver pond at the toe of the landfill. There is a tire in the foreground and several others scattered in the former wetland.

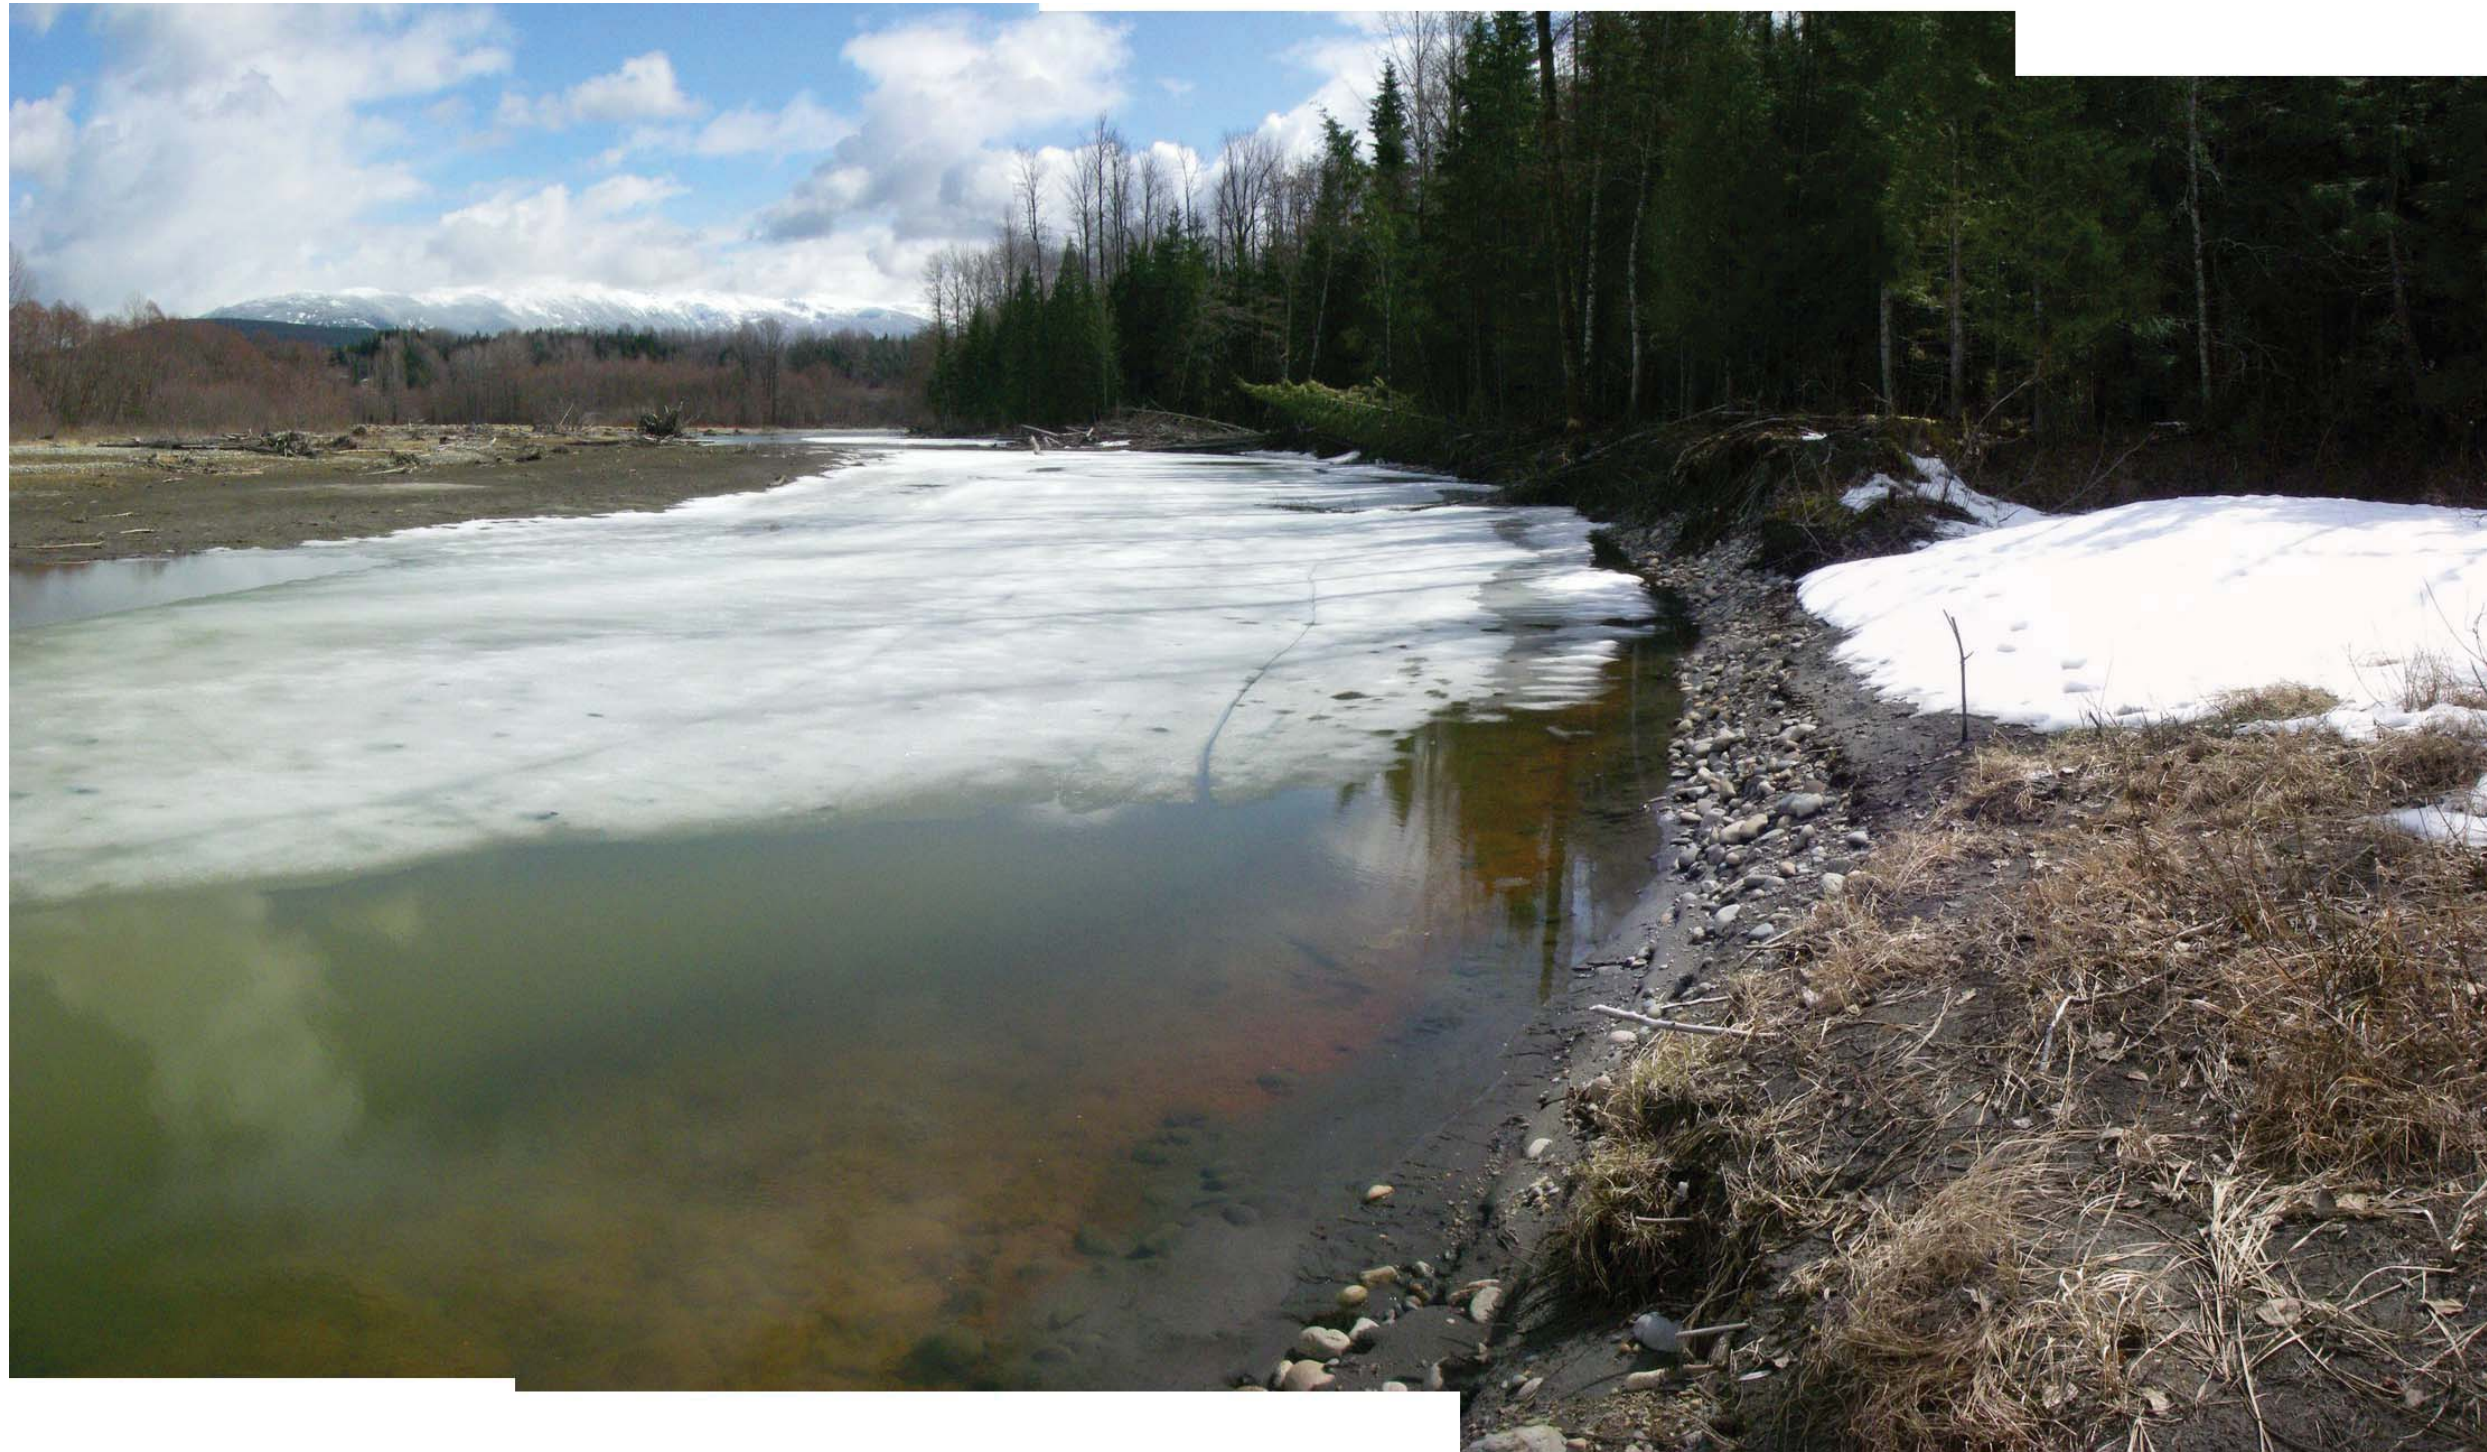
MM 09 5420 to 5423

Looking downstream to the outlet of this cut off bend. There is a field on the left bank and a white mound along the edge of the bank which I suspect are sandbags.

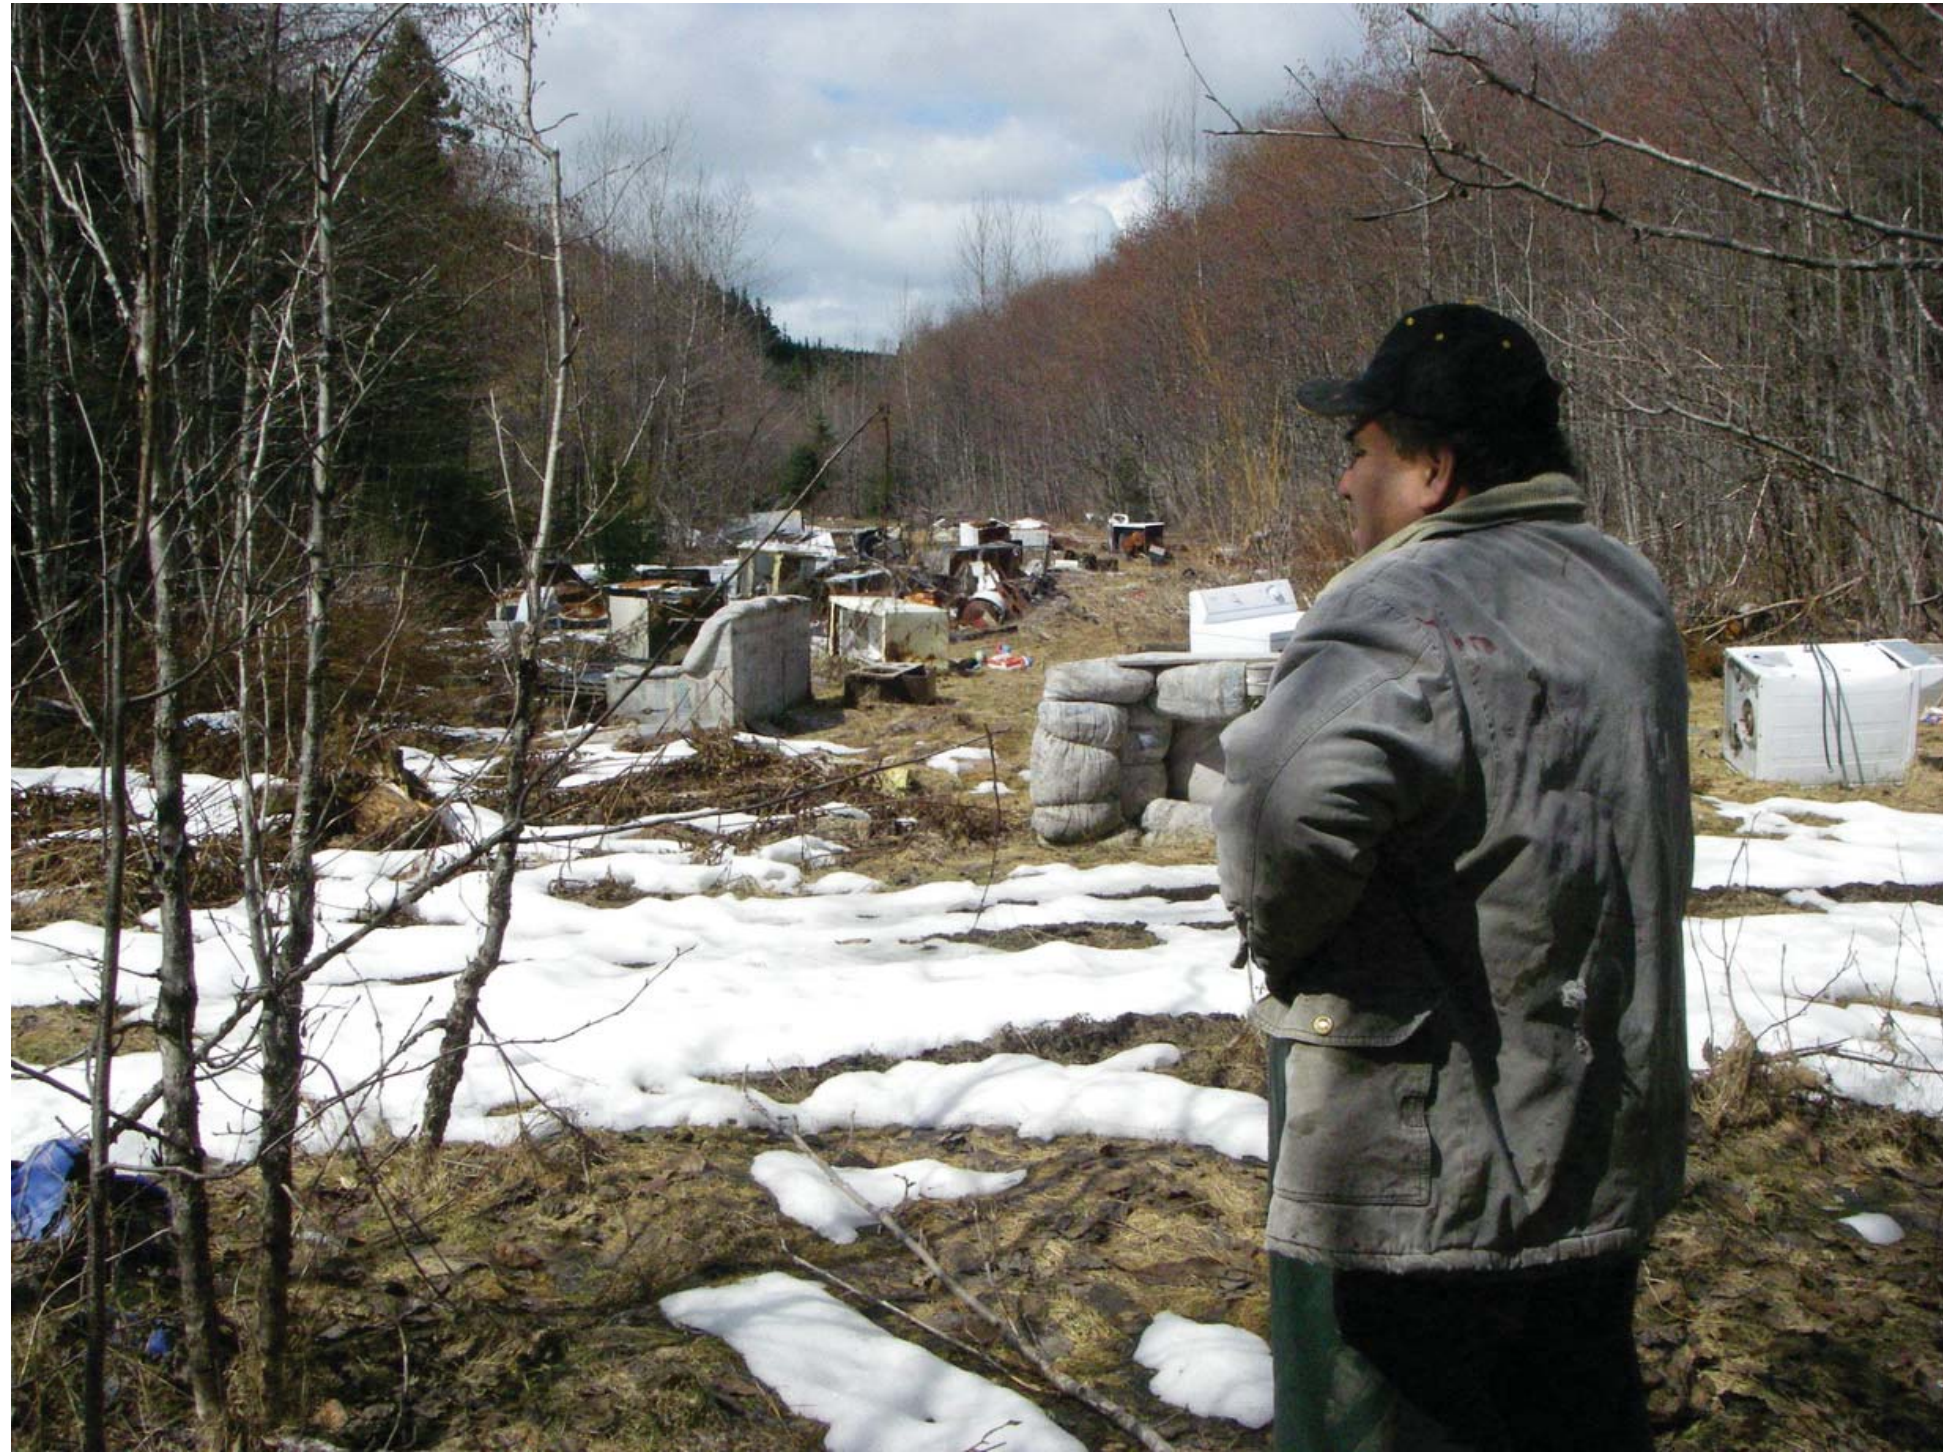
MM 09 5424

Looking up valley over the active garbage dump. This former wetland pond was top dressed with river gravels and seeded by Skeena Cellulose. Don indicates bears come here to grass and clover in the spring.

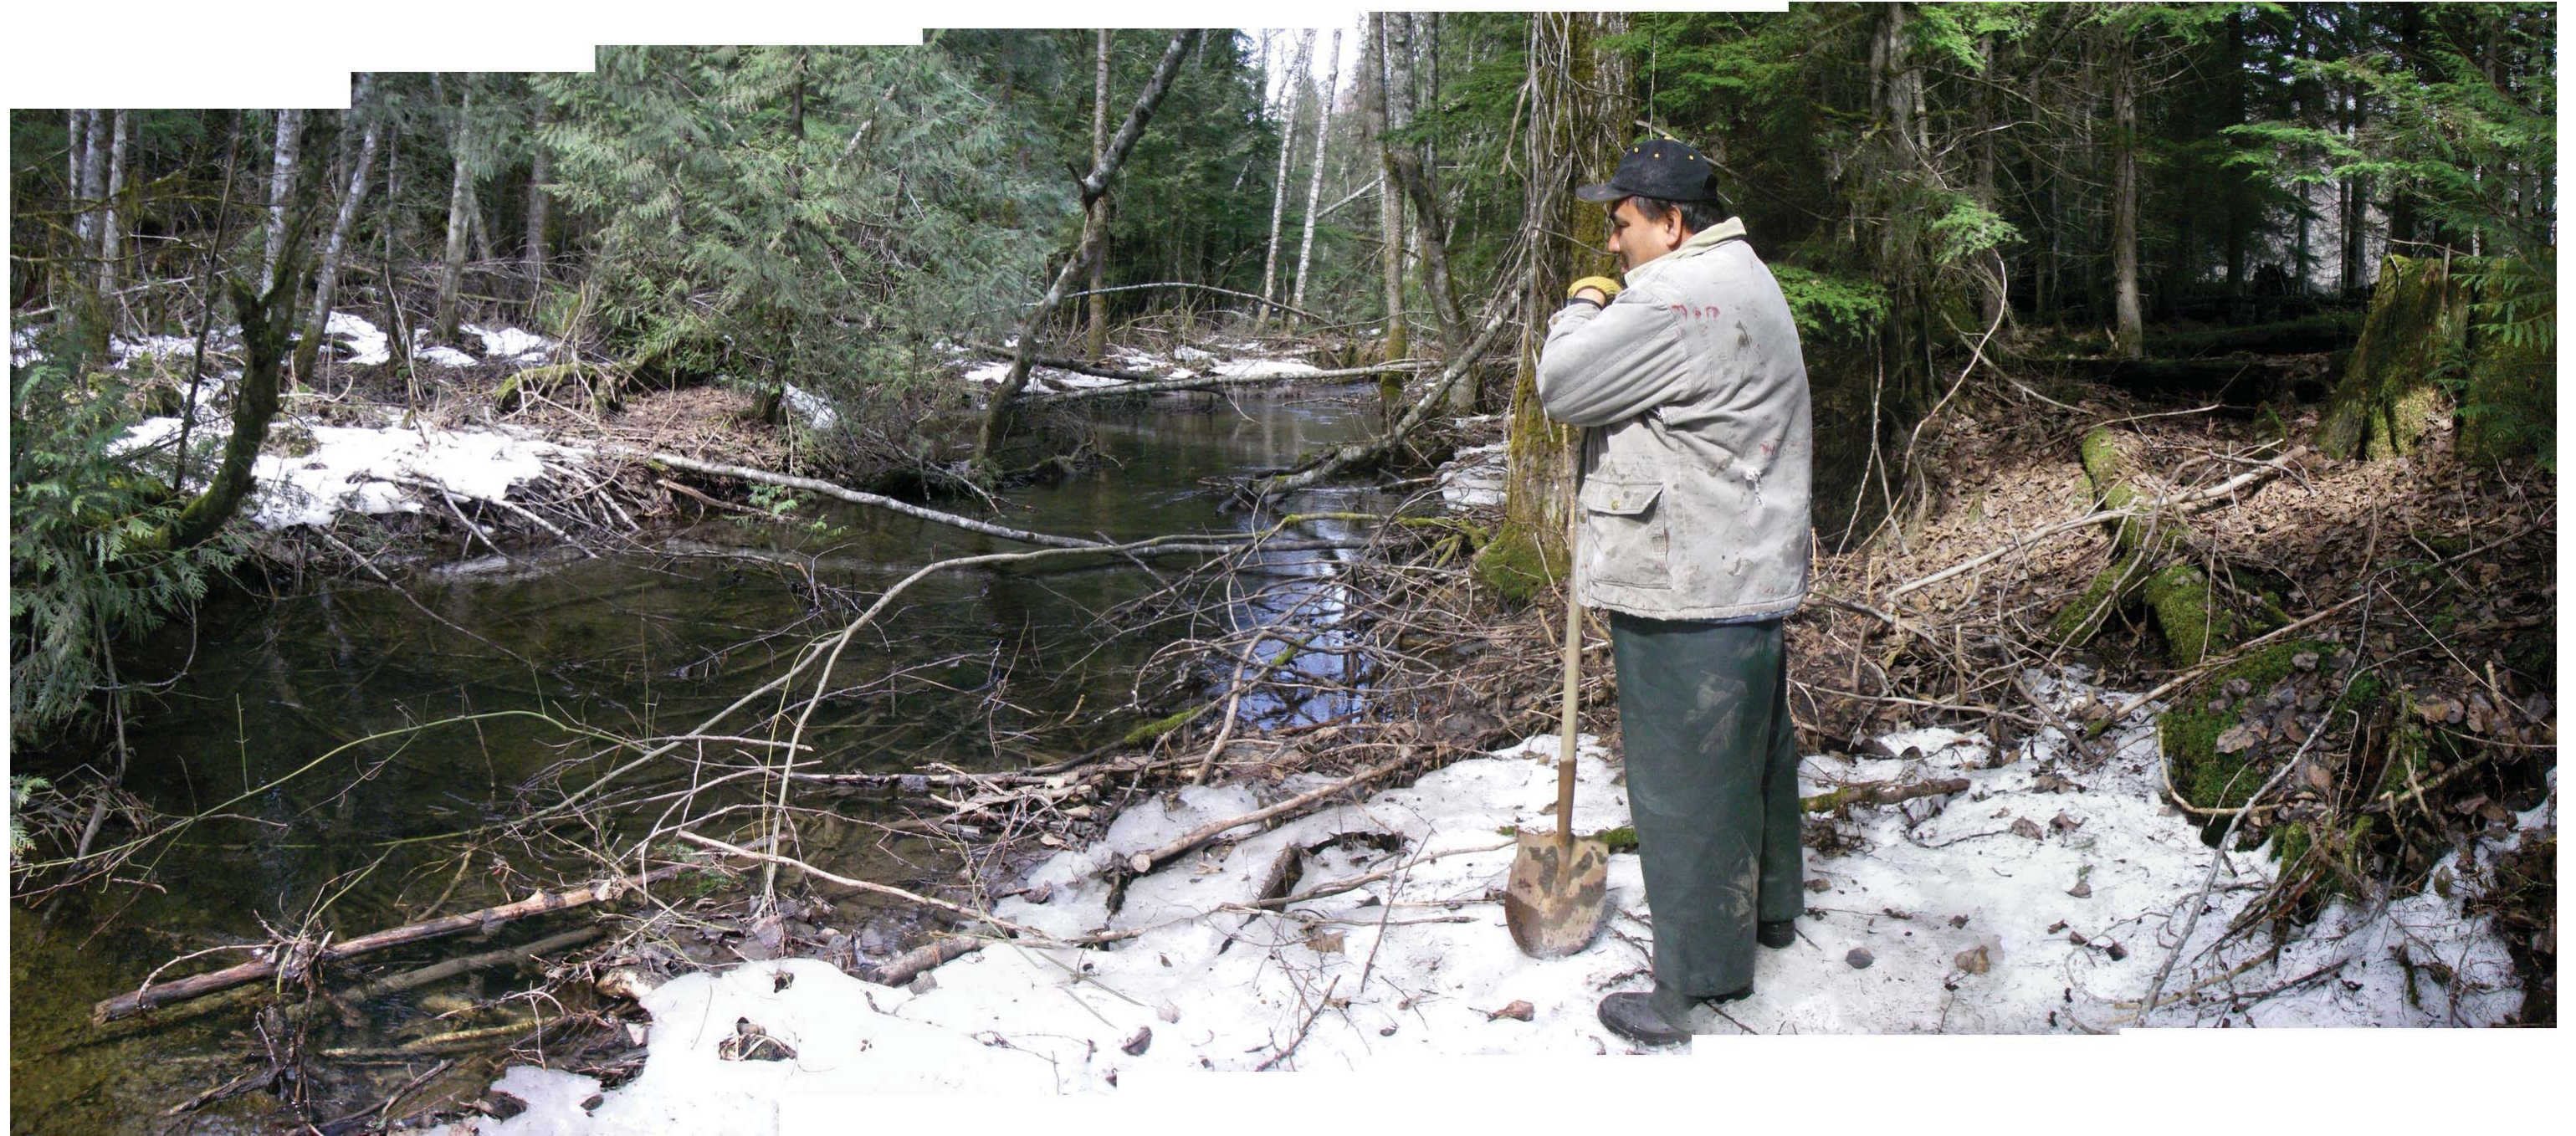
MM 09 5425 to 5430

GPS Mark 146 Now on the west side of the Nass River road directly opposite abandoned Kalum Wood Products Ltd. Mill.

There is an approximately 20 cm deep, 10 m wide stream flowing on the right bank side of the valley. This stream is flowing around alders, cottonwoods and various conifers. The stream may have been diverted along the valley wall side of the road following road construction. This may be the source of flood waters which flowed down the road into Kalum Village during the June 2007 flood (rather than water derived from Kalum River). We need to follow this channel upstream to see where it originally enters the valley bottom and see if we can find where it formerly crossed the road and entered Kitsumkalum River. It obviously wasn't originally in this location as there are too many mature trees with water now flowing around their roots.

Panorama looking upstream on the channel with Don standing with the shovel on the left bank. At this point the channel is constricted to about 3 to 4 m in width with a maximum depth of about 30 cm. There is fine sediment and organic material on the channel bed. Some skunk cabbage is beginning to grow so there may have been some water in this area prior to road construction.
