KITSUMKALUM RIVER CHANNEL STABILITY ASSESSMENT

AERIAL AND GROUND INSPECTION APRIL 22 to 23, 2009 COMPILATION OF DIGITAL AND VIDEO IMAGERY

May 6, 2009

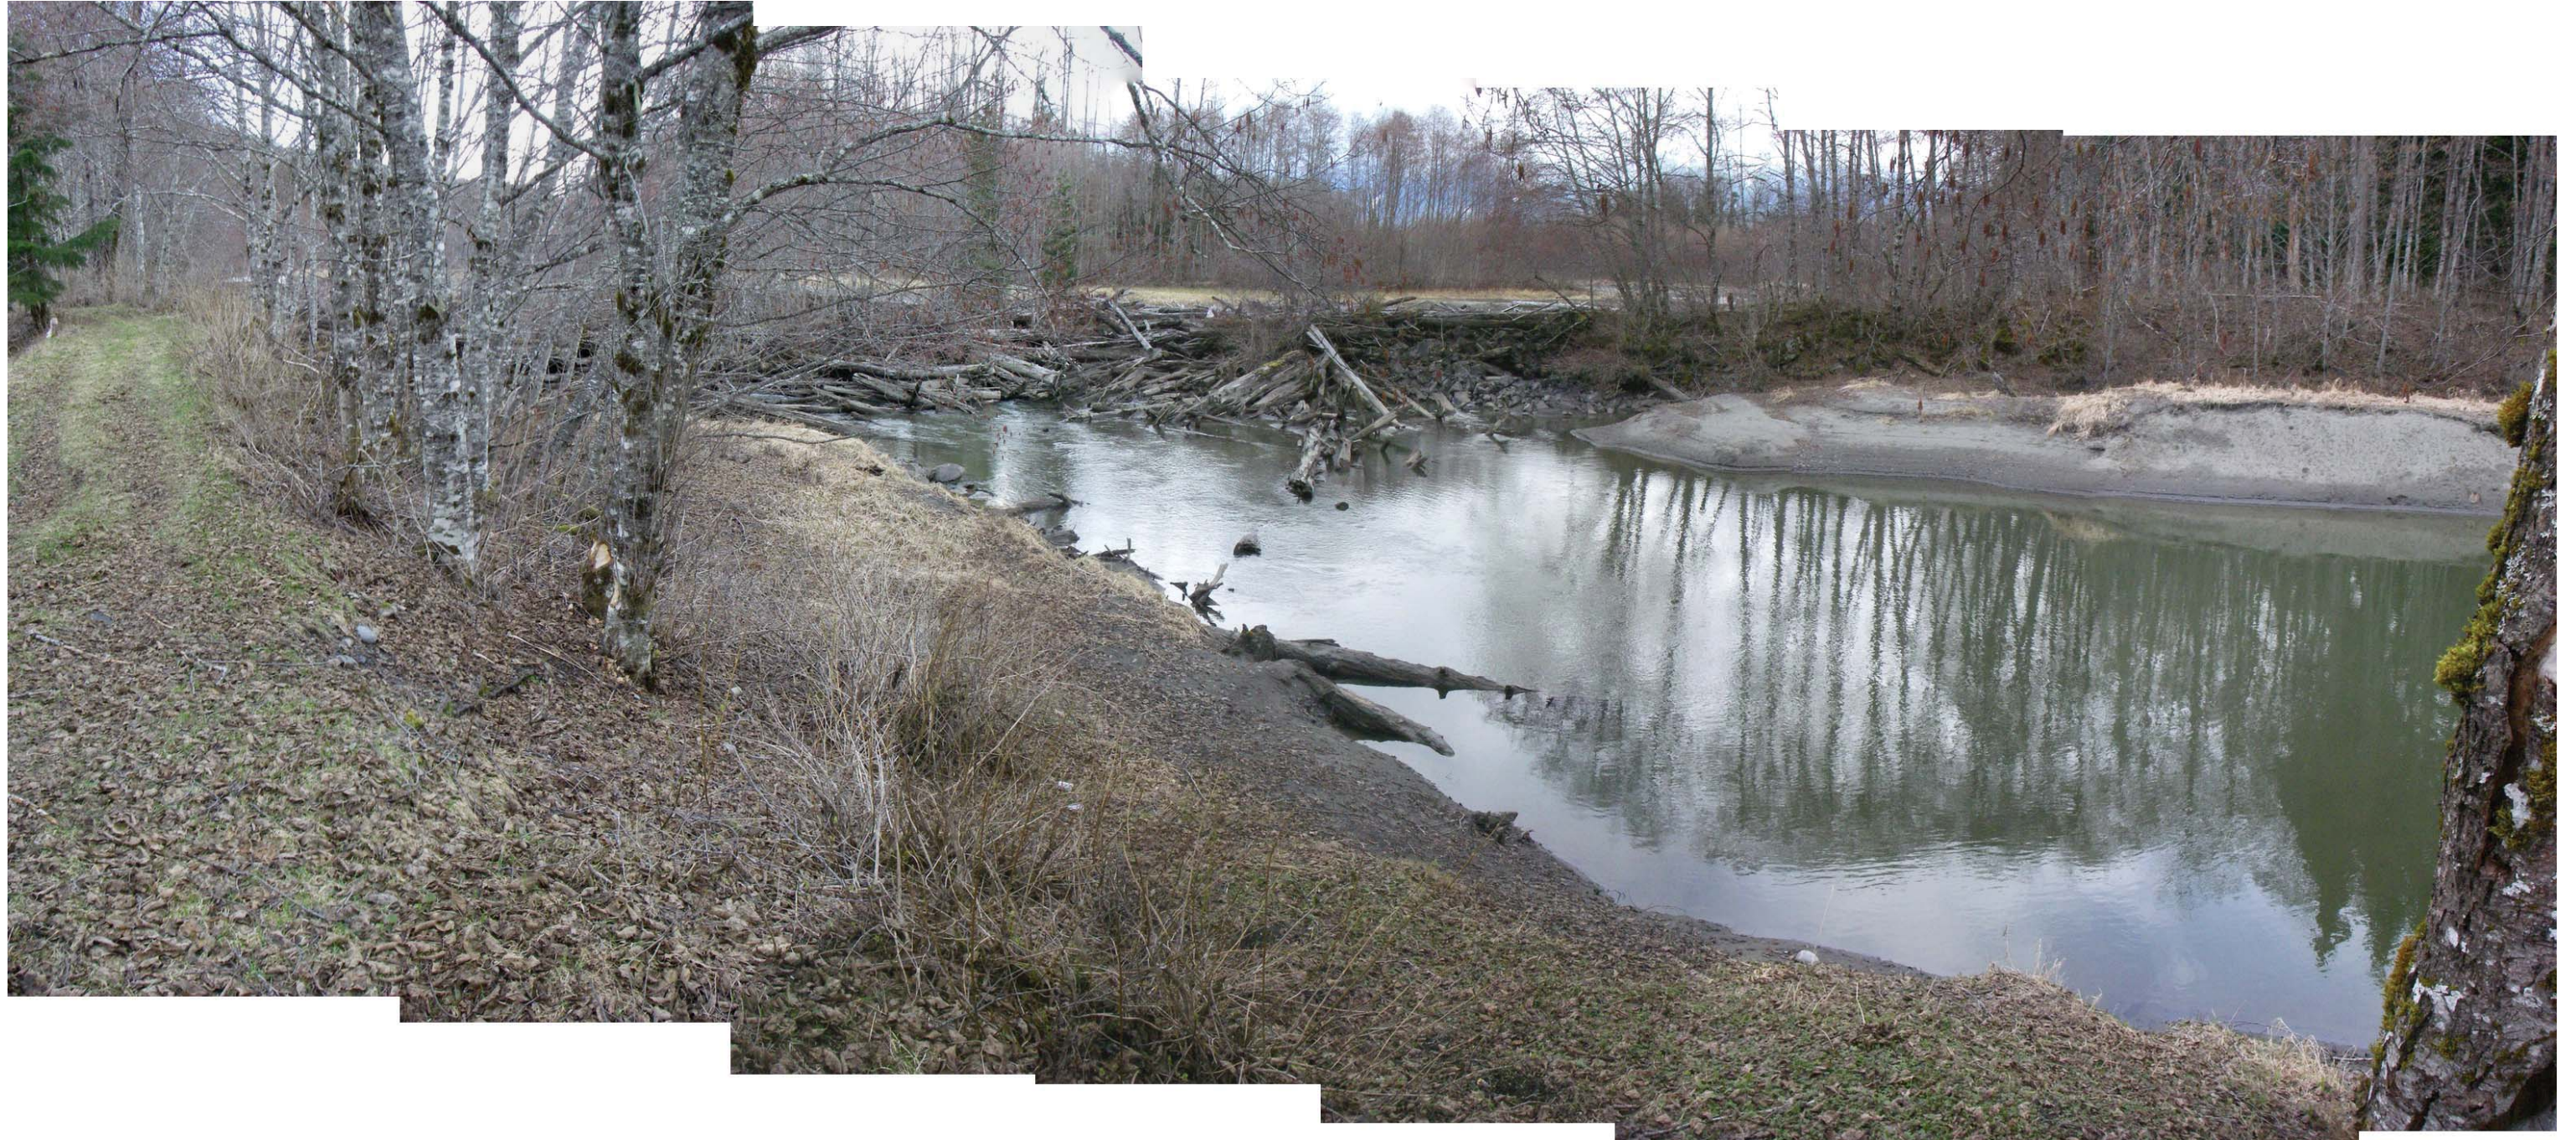
MM 09 5442 to 5448

Looking upstream showing a stable log jam in which most of the logs are saw cut. There is an approximately 500 Kg class rip-rap berm on the left bank of the residual channel downstream of the log jam. There are fresh beaver-cut alders in the foreground. This site has not operated since 1964.

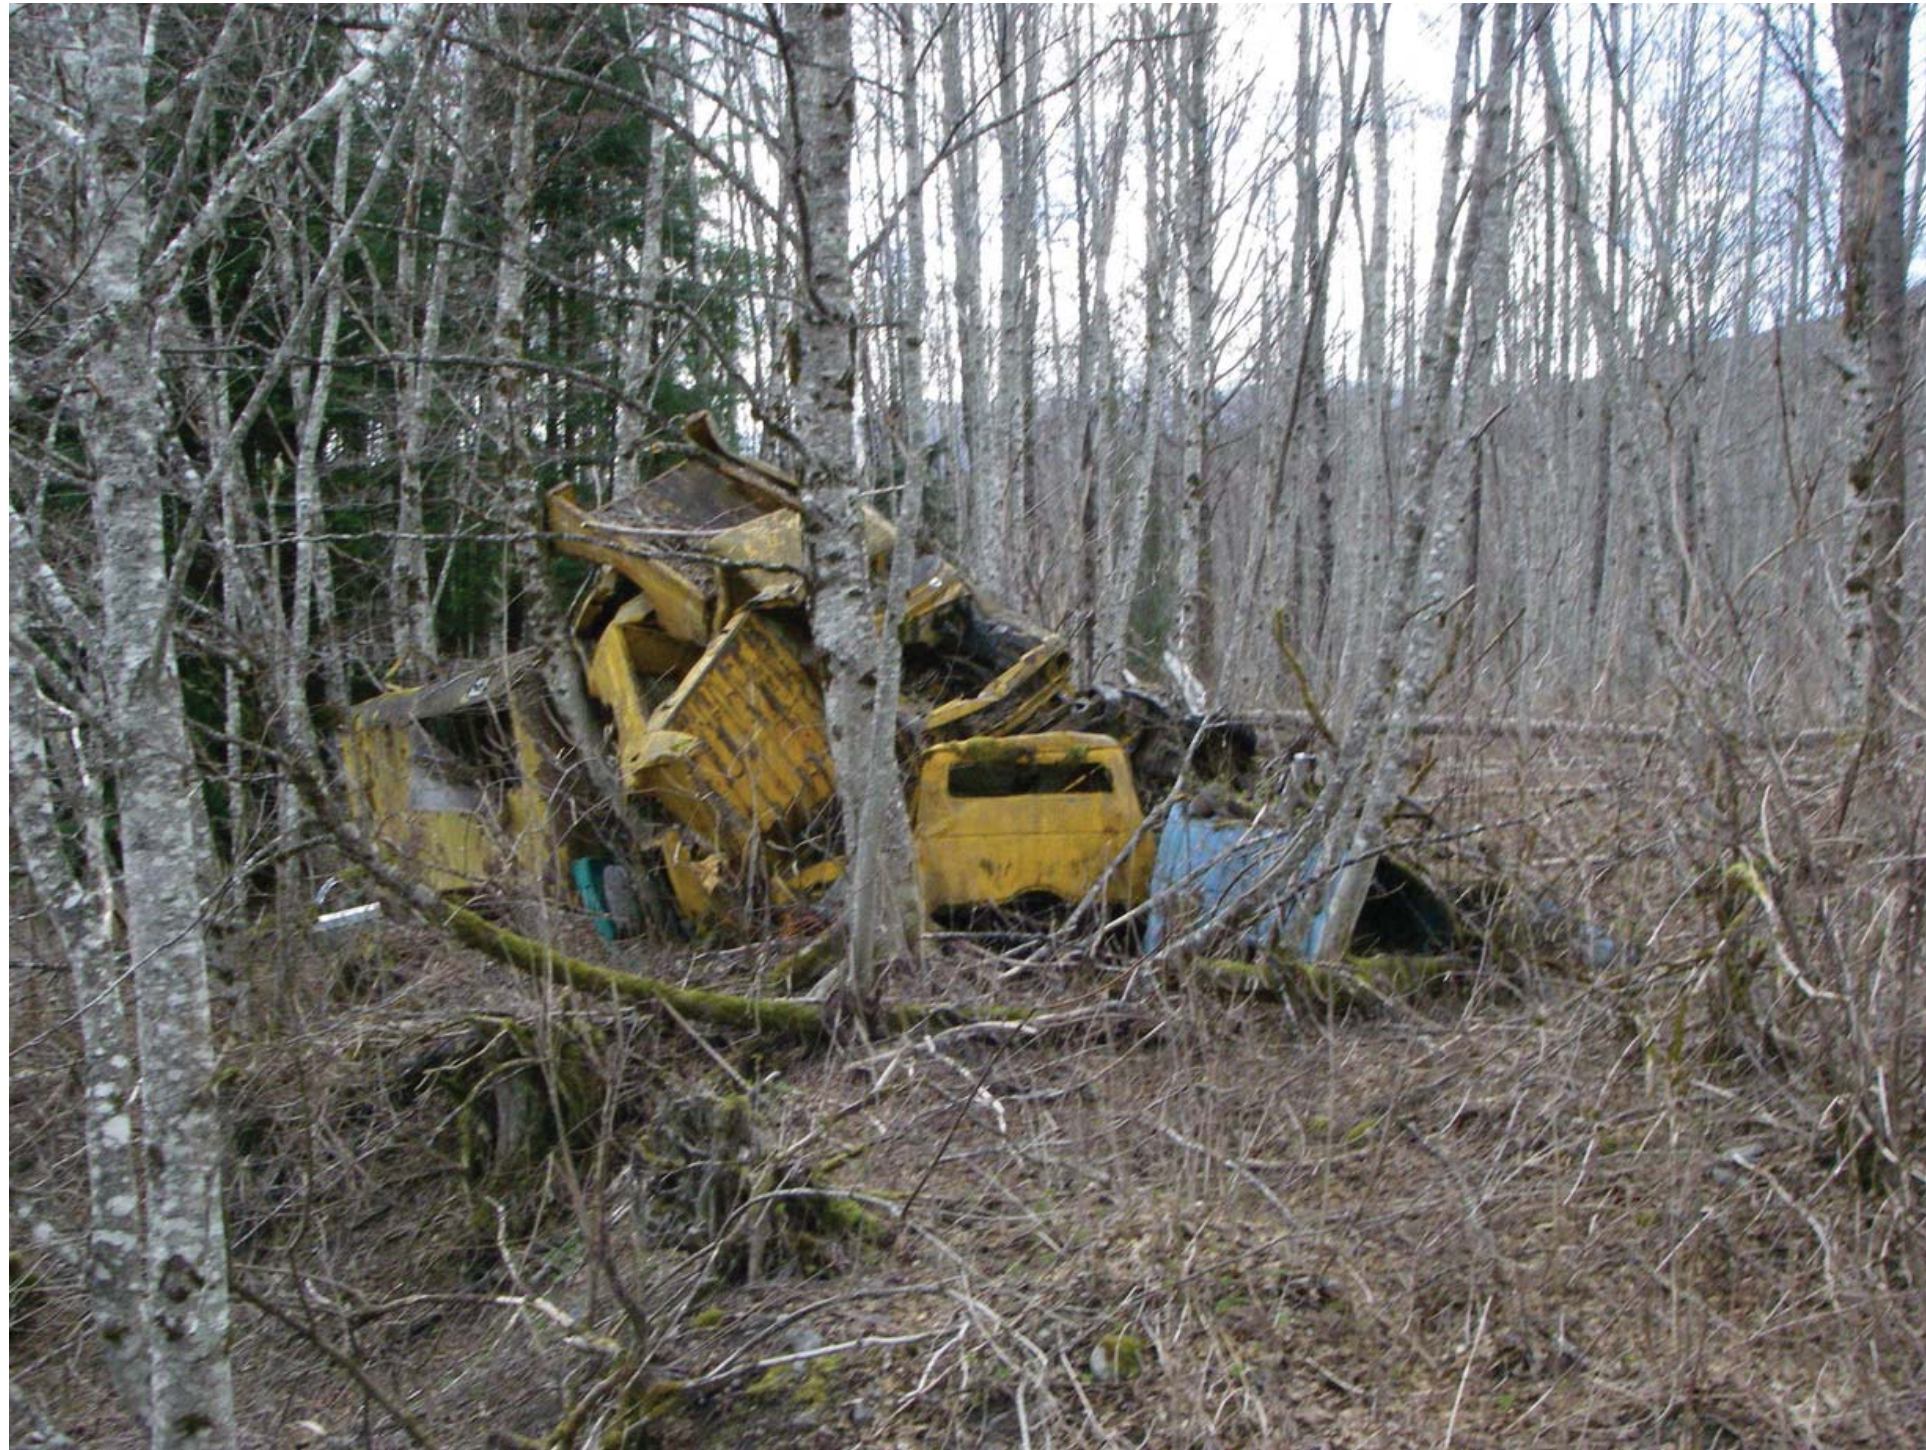
MM 09 5449

Waste steel in the brush. Don indicates there is a buried industrial waste dump at this site. A channel avulsion occurred at this site in 1978.

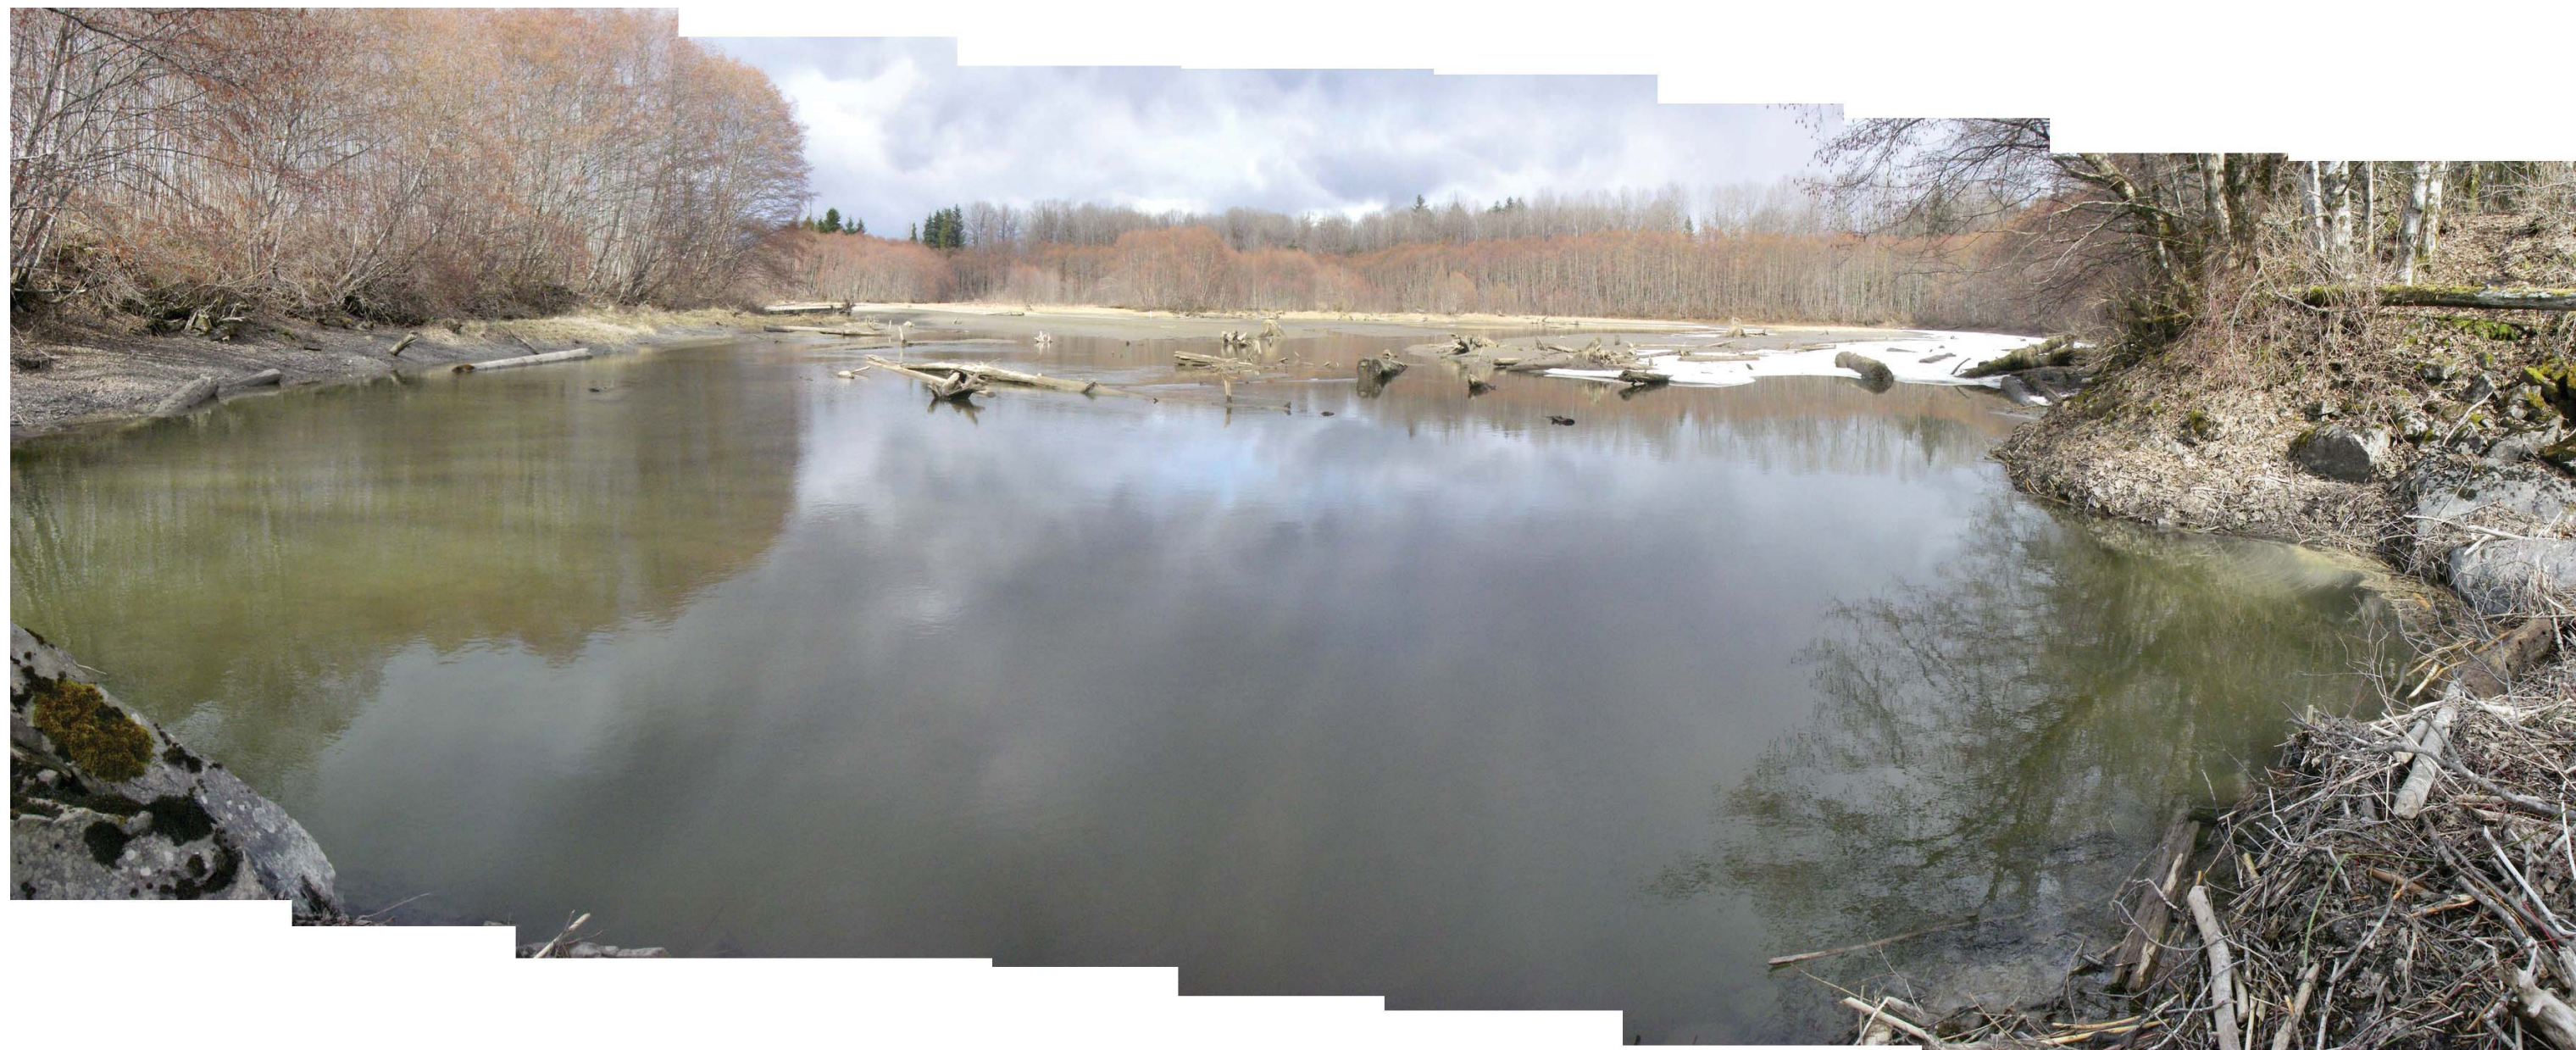
MM 09 5450 to 5458

GPS Mark 148

Now standing on the outlet of the pond.

Panorama looking upstream over the pond, showing sediment and woody debris deposition. Don mentioned that this area is filling in quite rapidly. Much of the upstream pond surface is now equivalent to the outlet elevation.

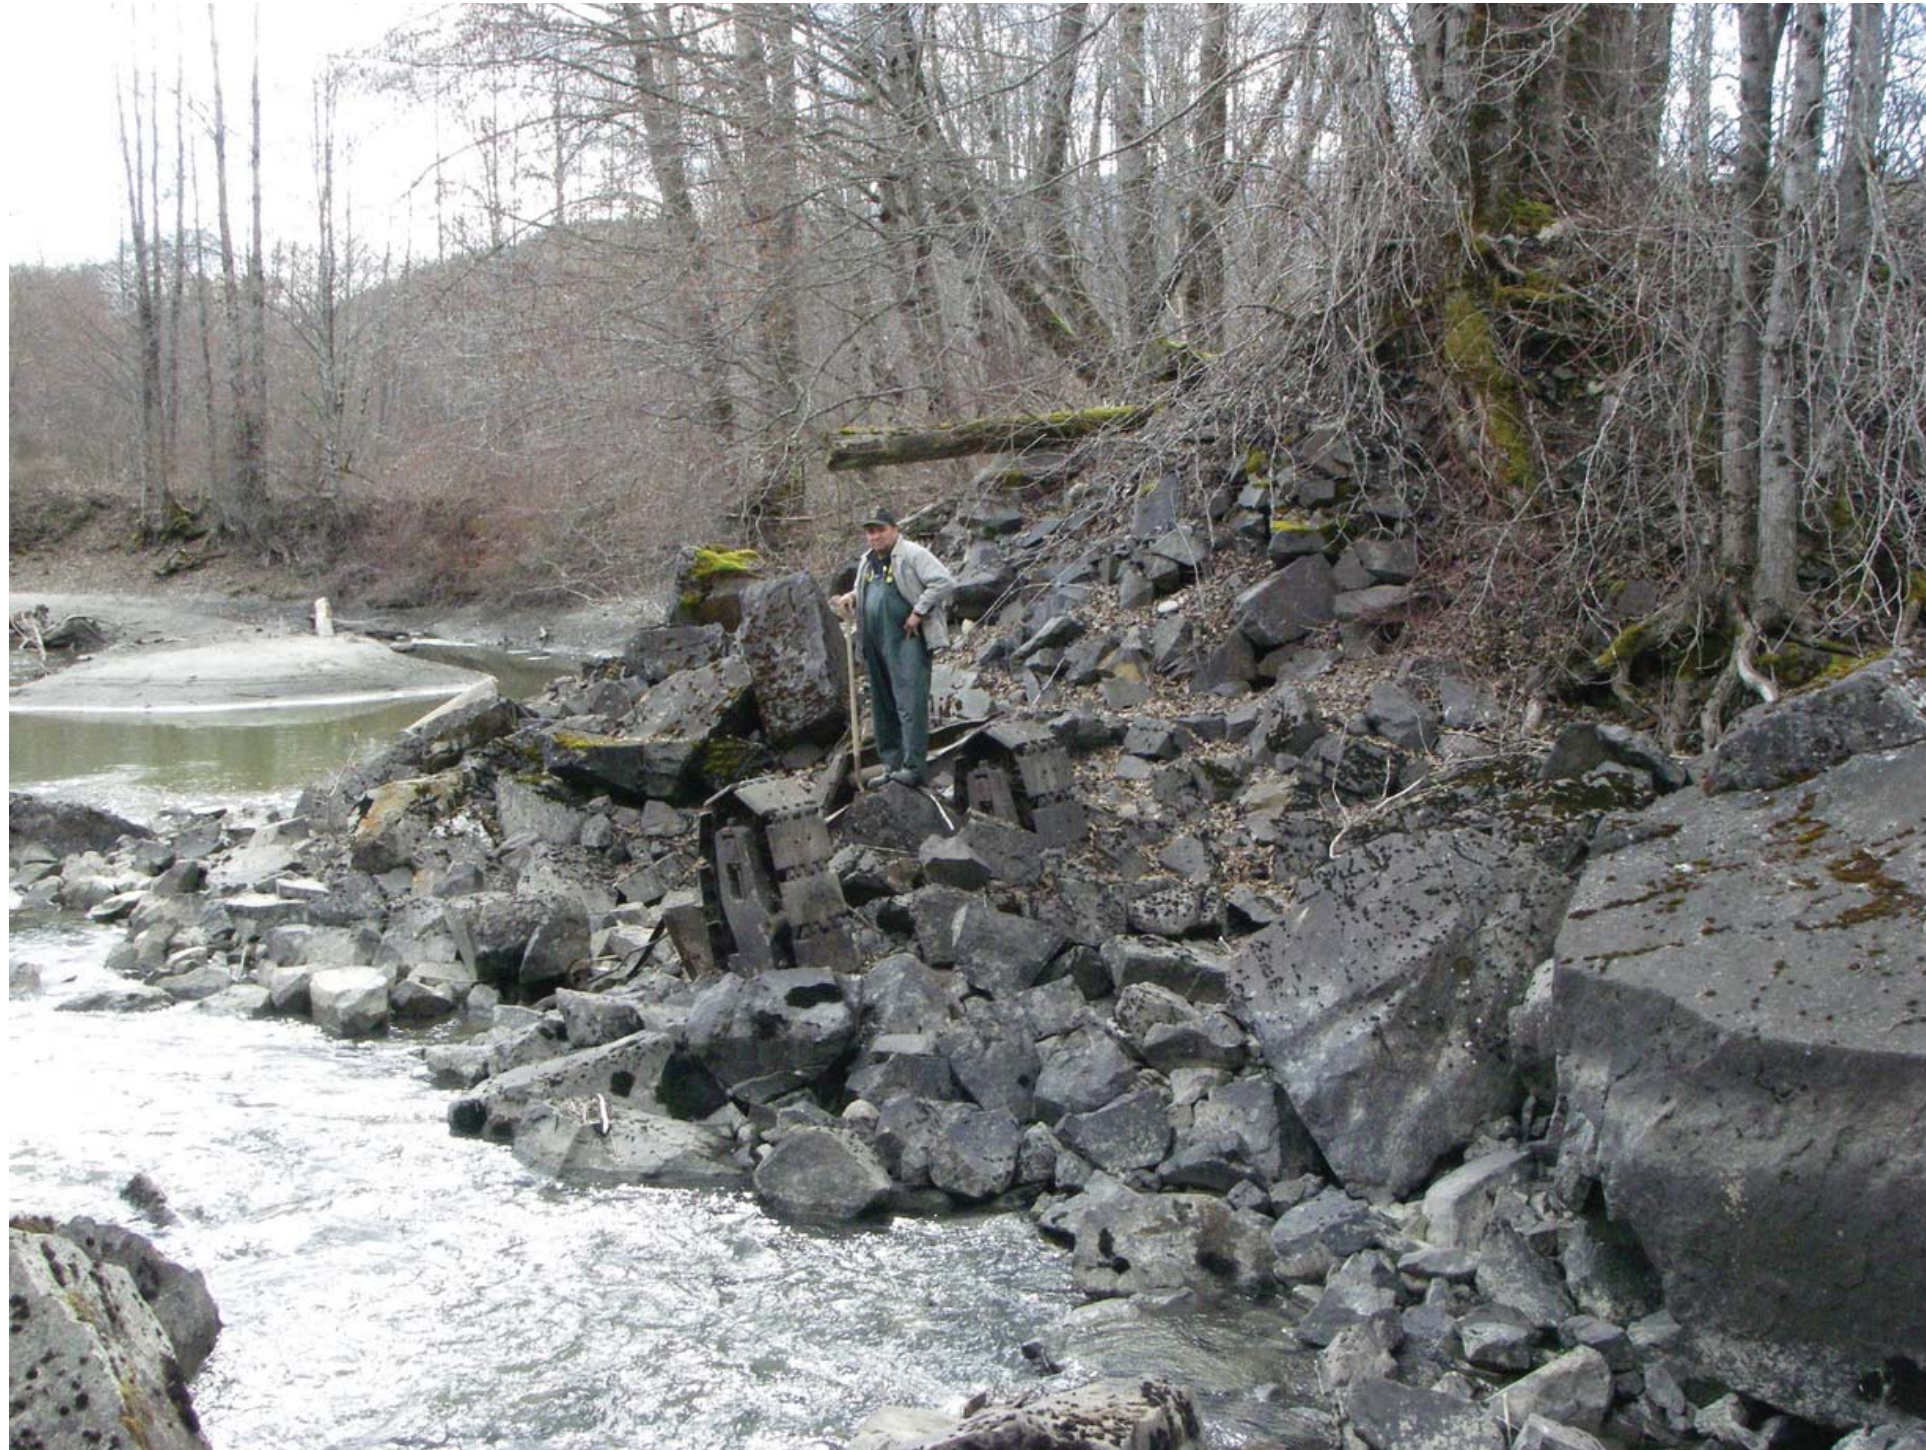
MM 09 5466

Picture of Don and a tracked vehicle that has been buried in the outlet spillway.

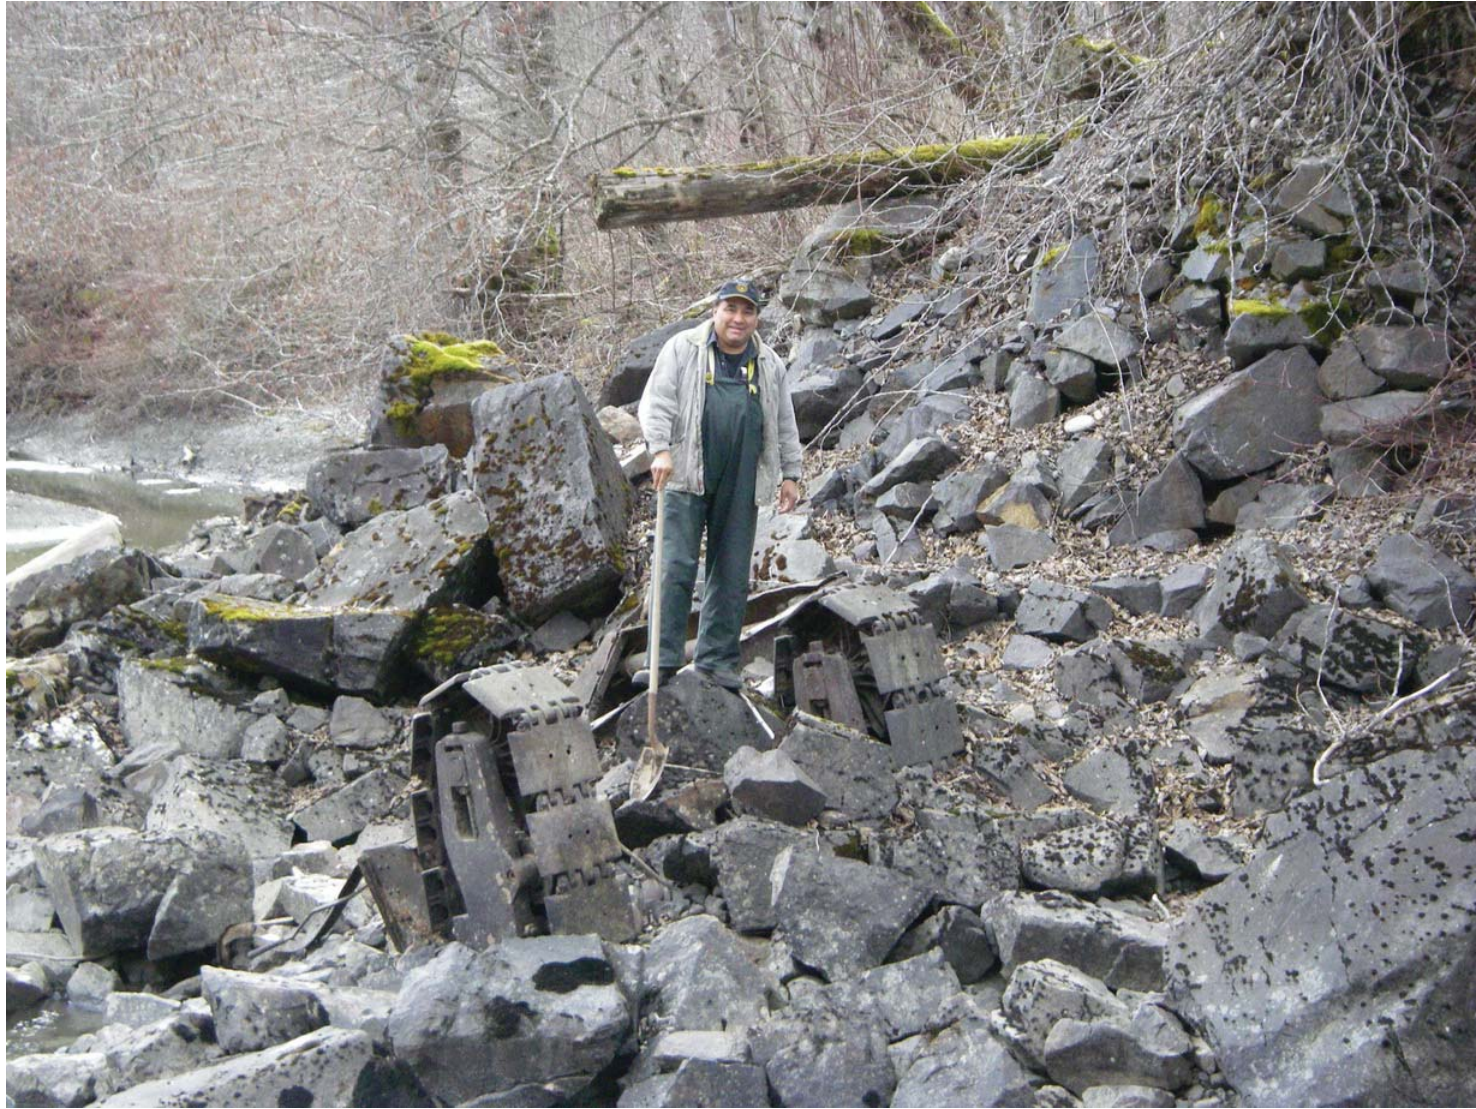
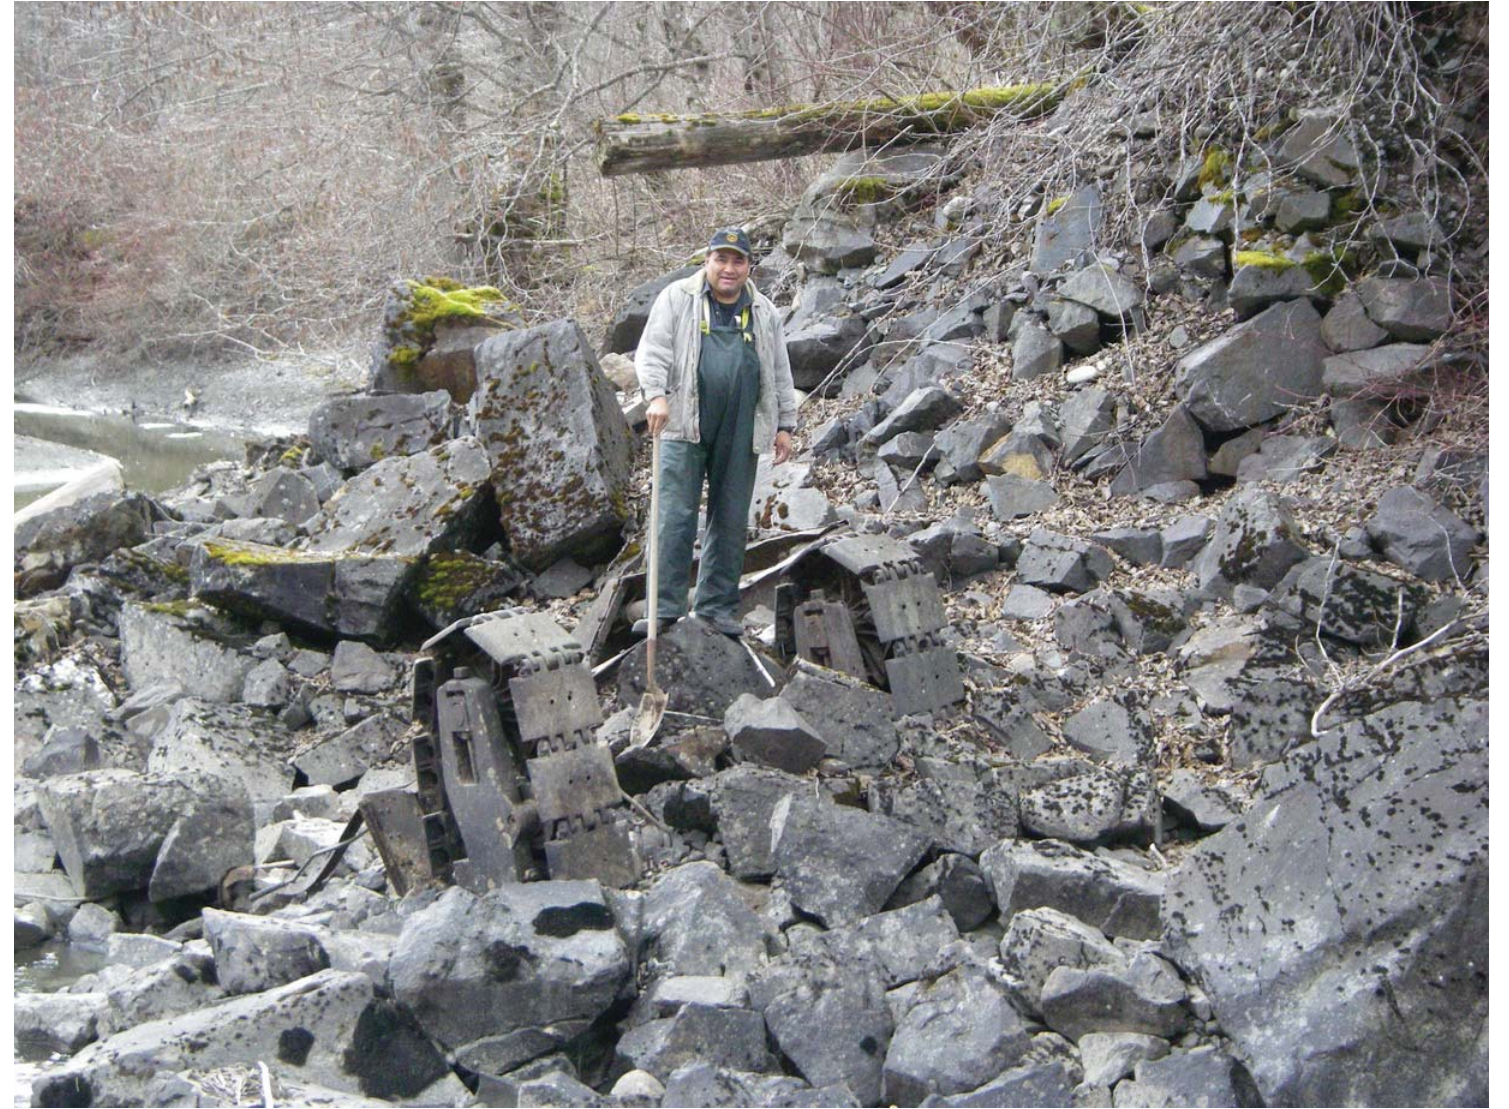
MM 09 5467 & 5468

Two more pictures of Don with the buried tracked vehicle.

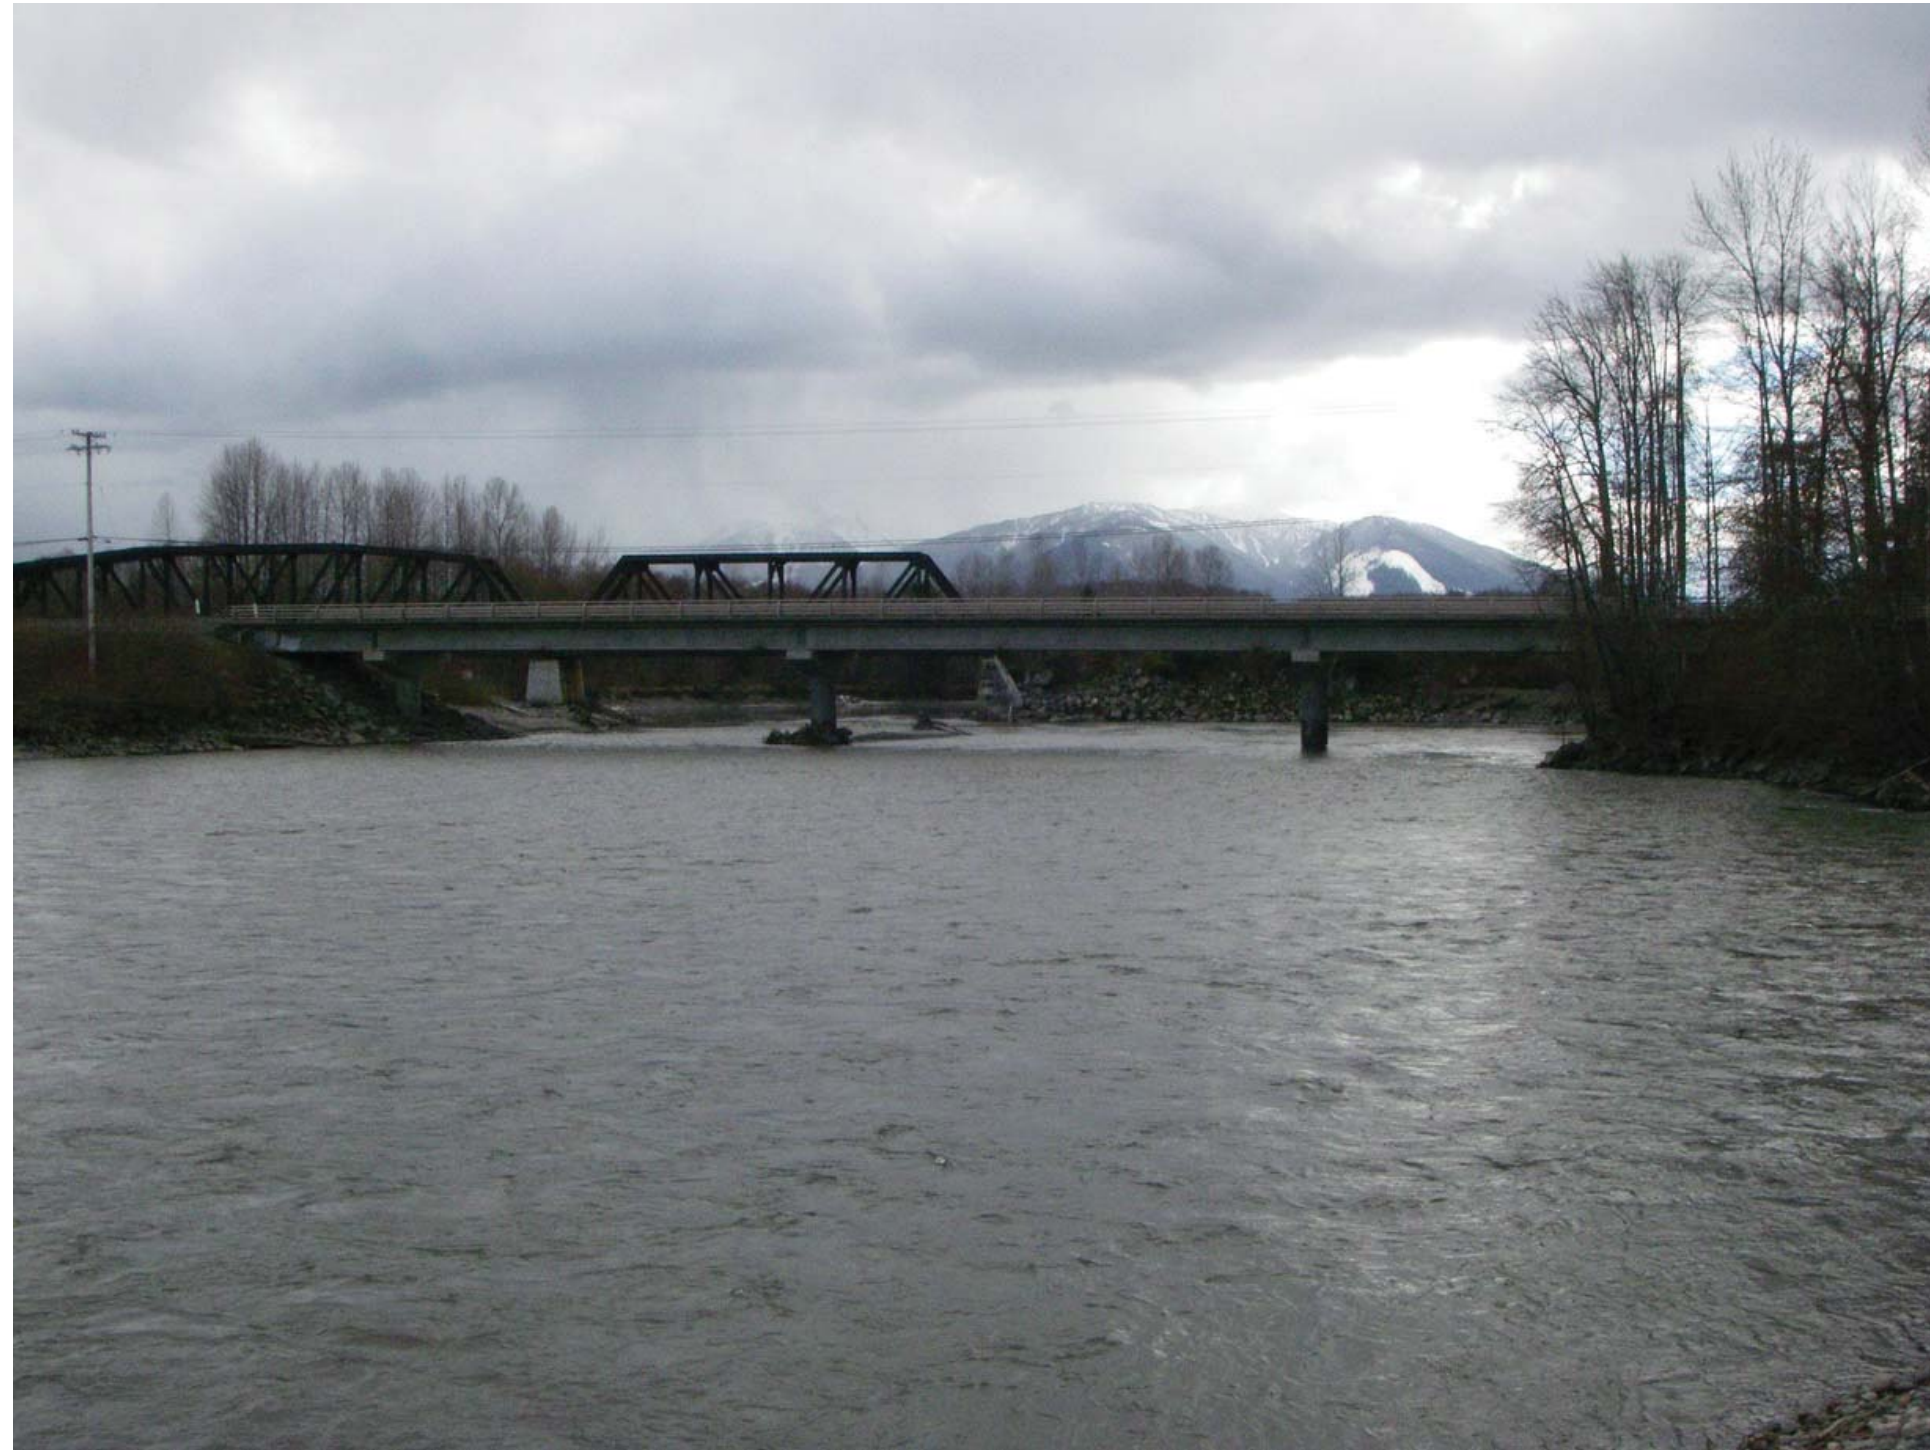
MM 09 5470

Single photo looking downstream to the Highway Bridge with the Railway Bridge in the background. Note that only one span of the railway bridge is now functional and the river used to be substantially wider than the two spans.

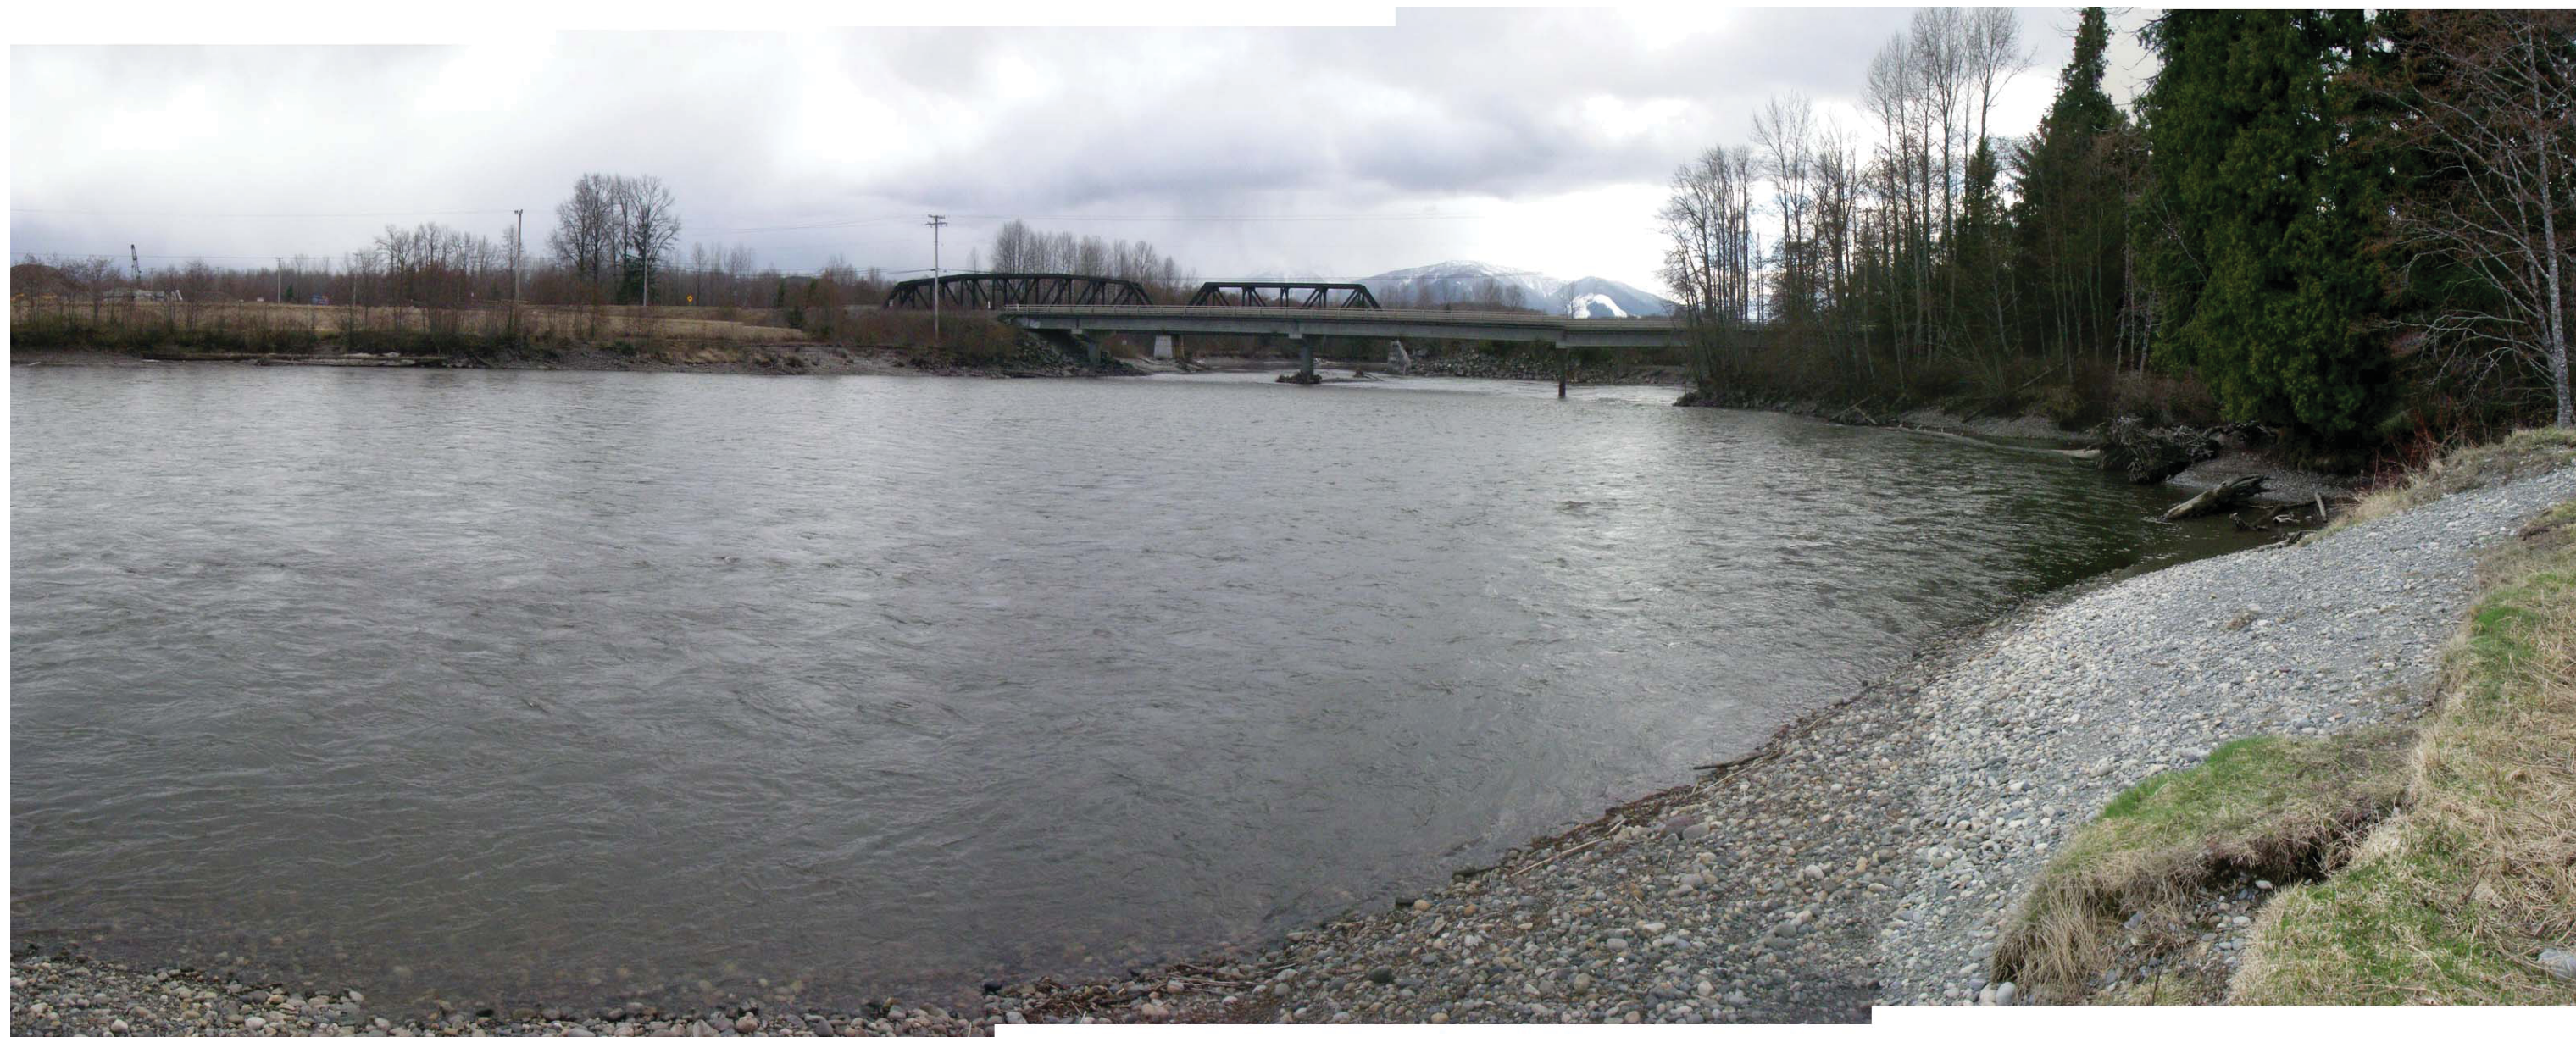
MM 09 5471 to 5477

Panorama looking downstream to the Highway Bridge with the Railway Bridge in the background.
Note that only one span of the railway bridge is nowfunctional and the river used to be substantially wider than the two spans.
