KITSUMKALUM RIVER CHANNEL STABILITY ASSESSMENT

AERIAL AND GROUND INSPECTION APRIL 22 to 23, 2009 COMPILATION OF DIGITAL AND VIDEO IMAGERY

May 6, 2009

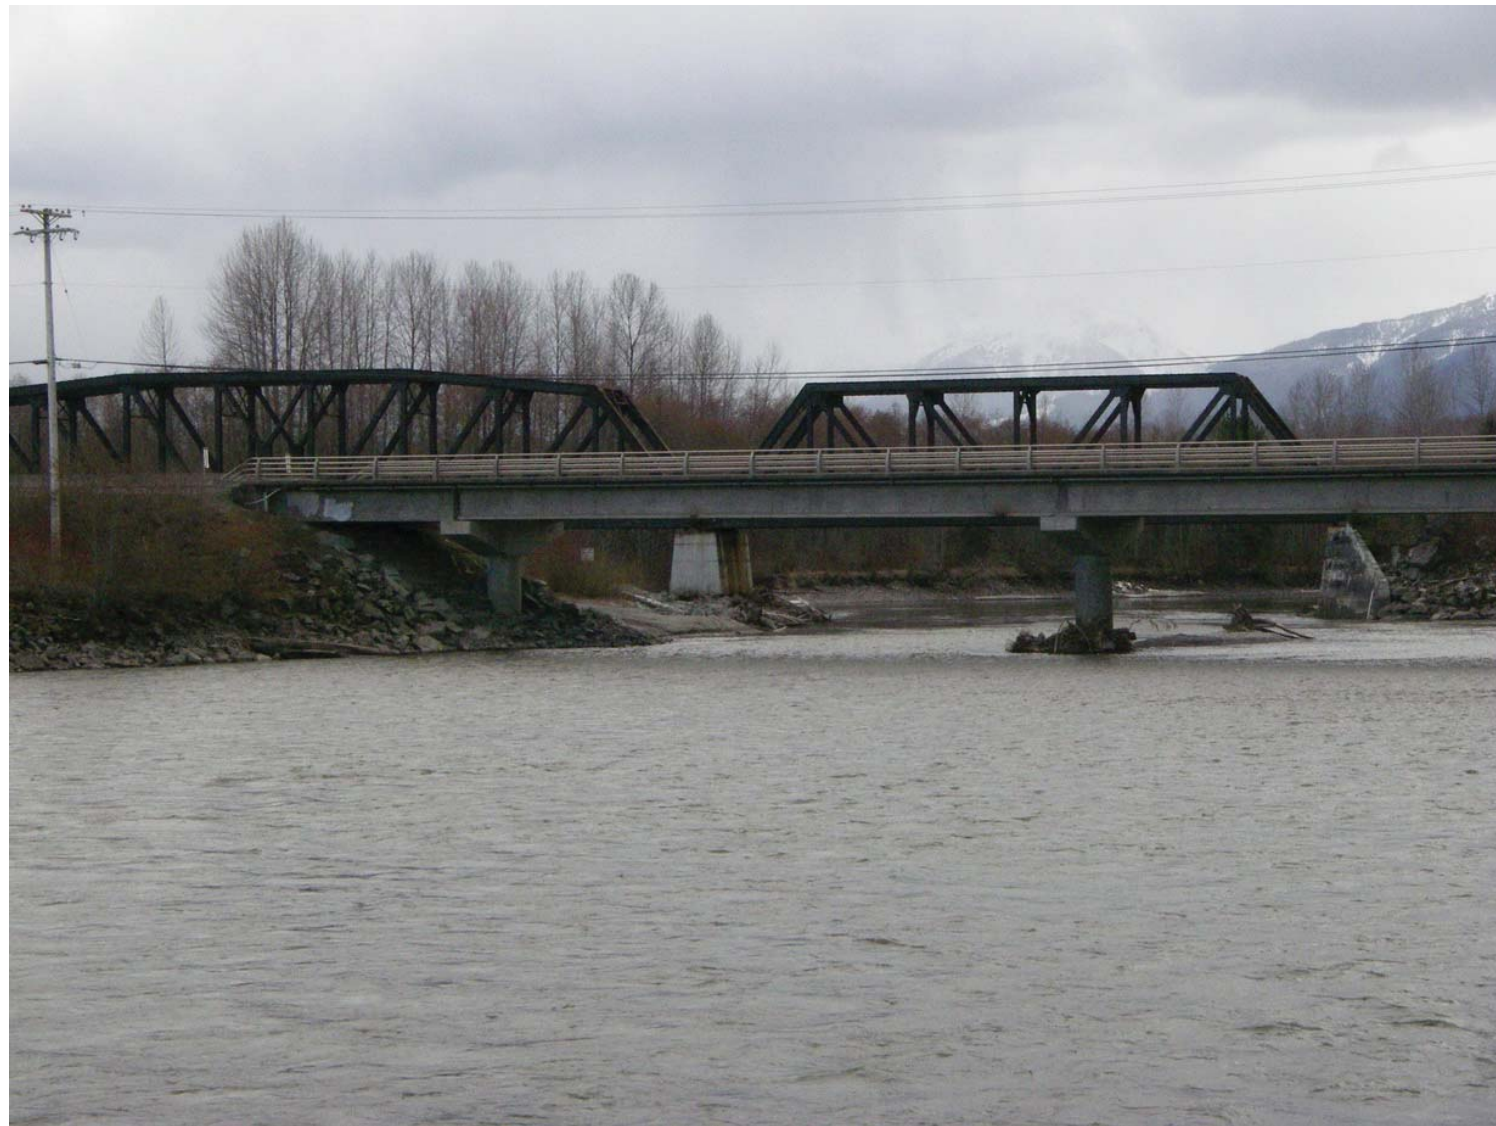
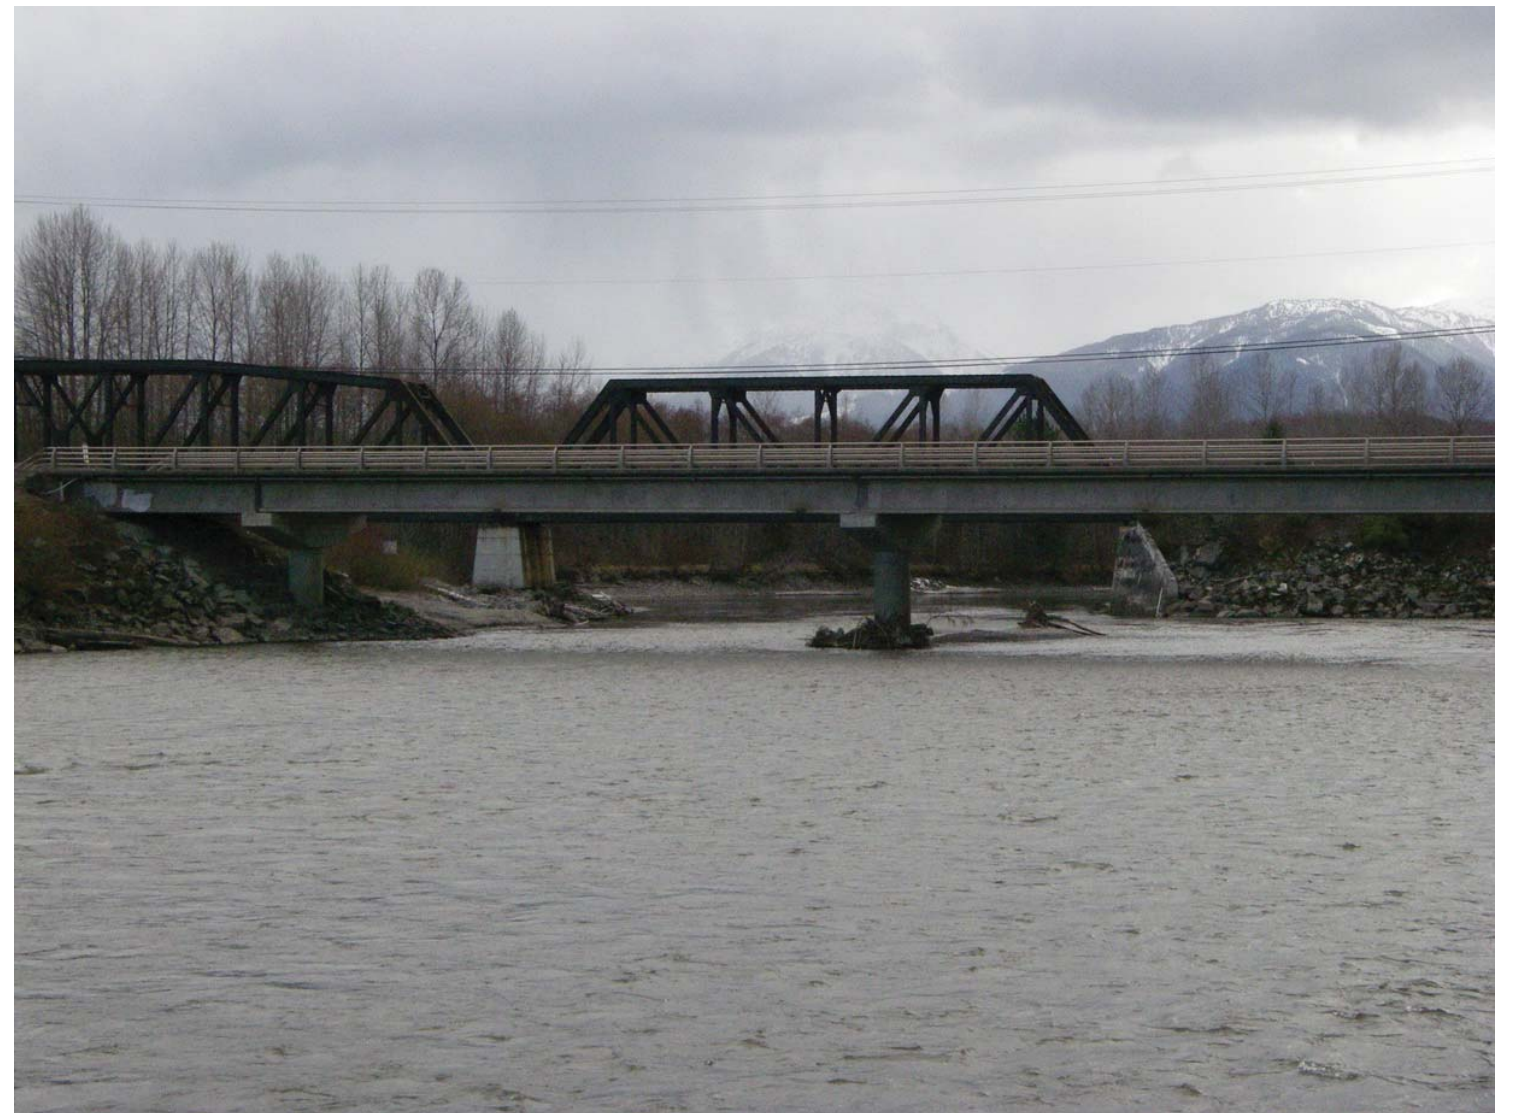
MM 09 5478 & 5479

Single photos looking downstream showing the railway span which is located behind the highway bridge.
Don said that at the height of the June 2007 flood the water level was just up to the top of the cylindrical piles.

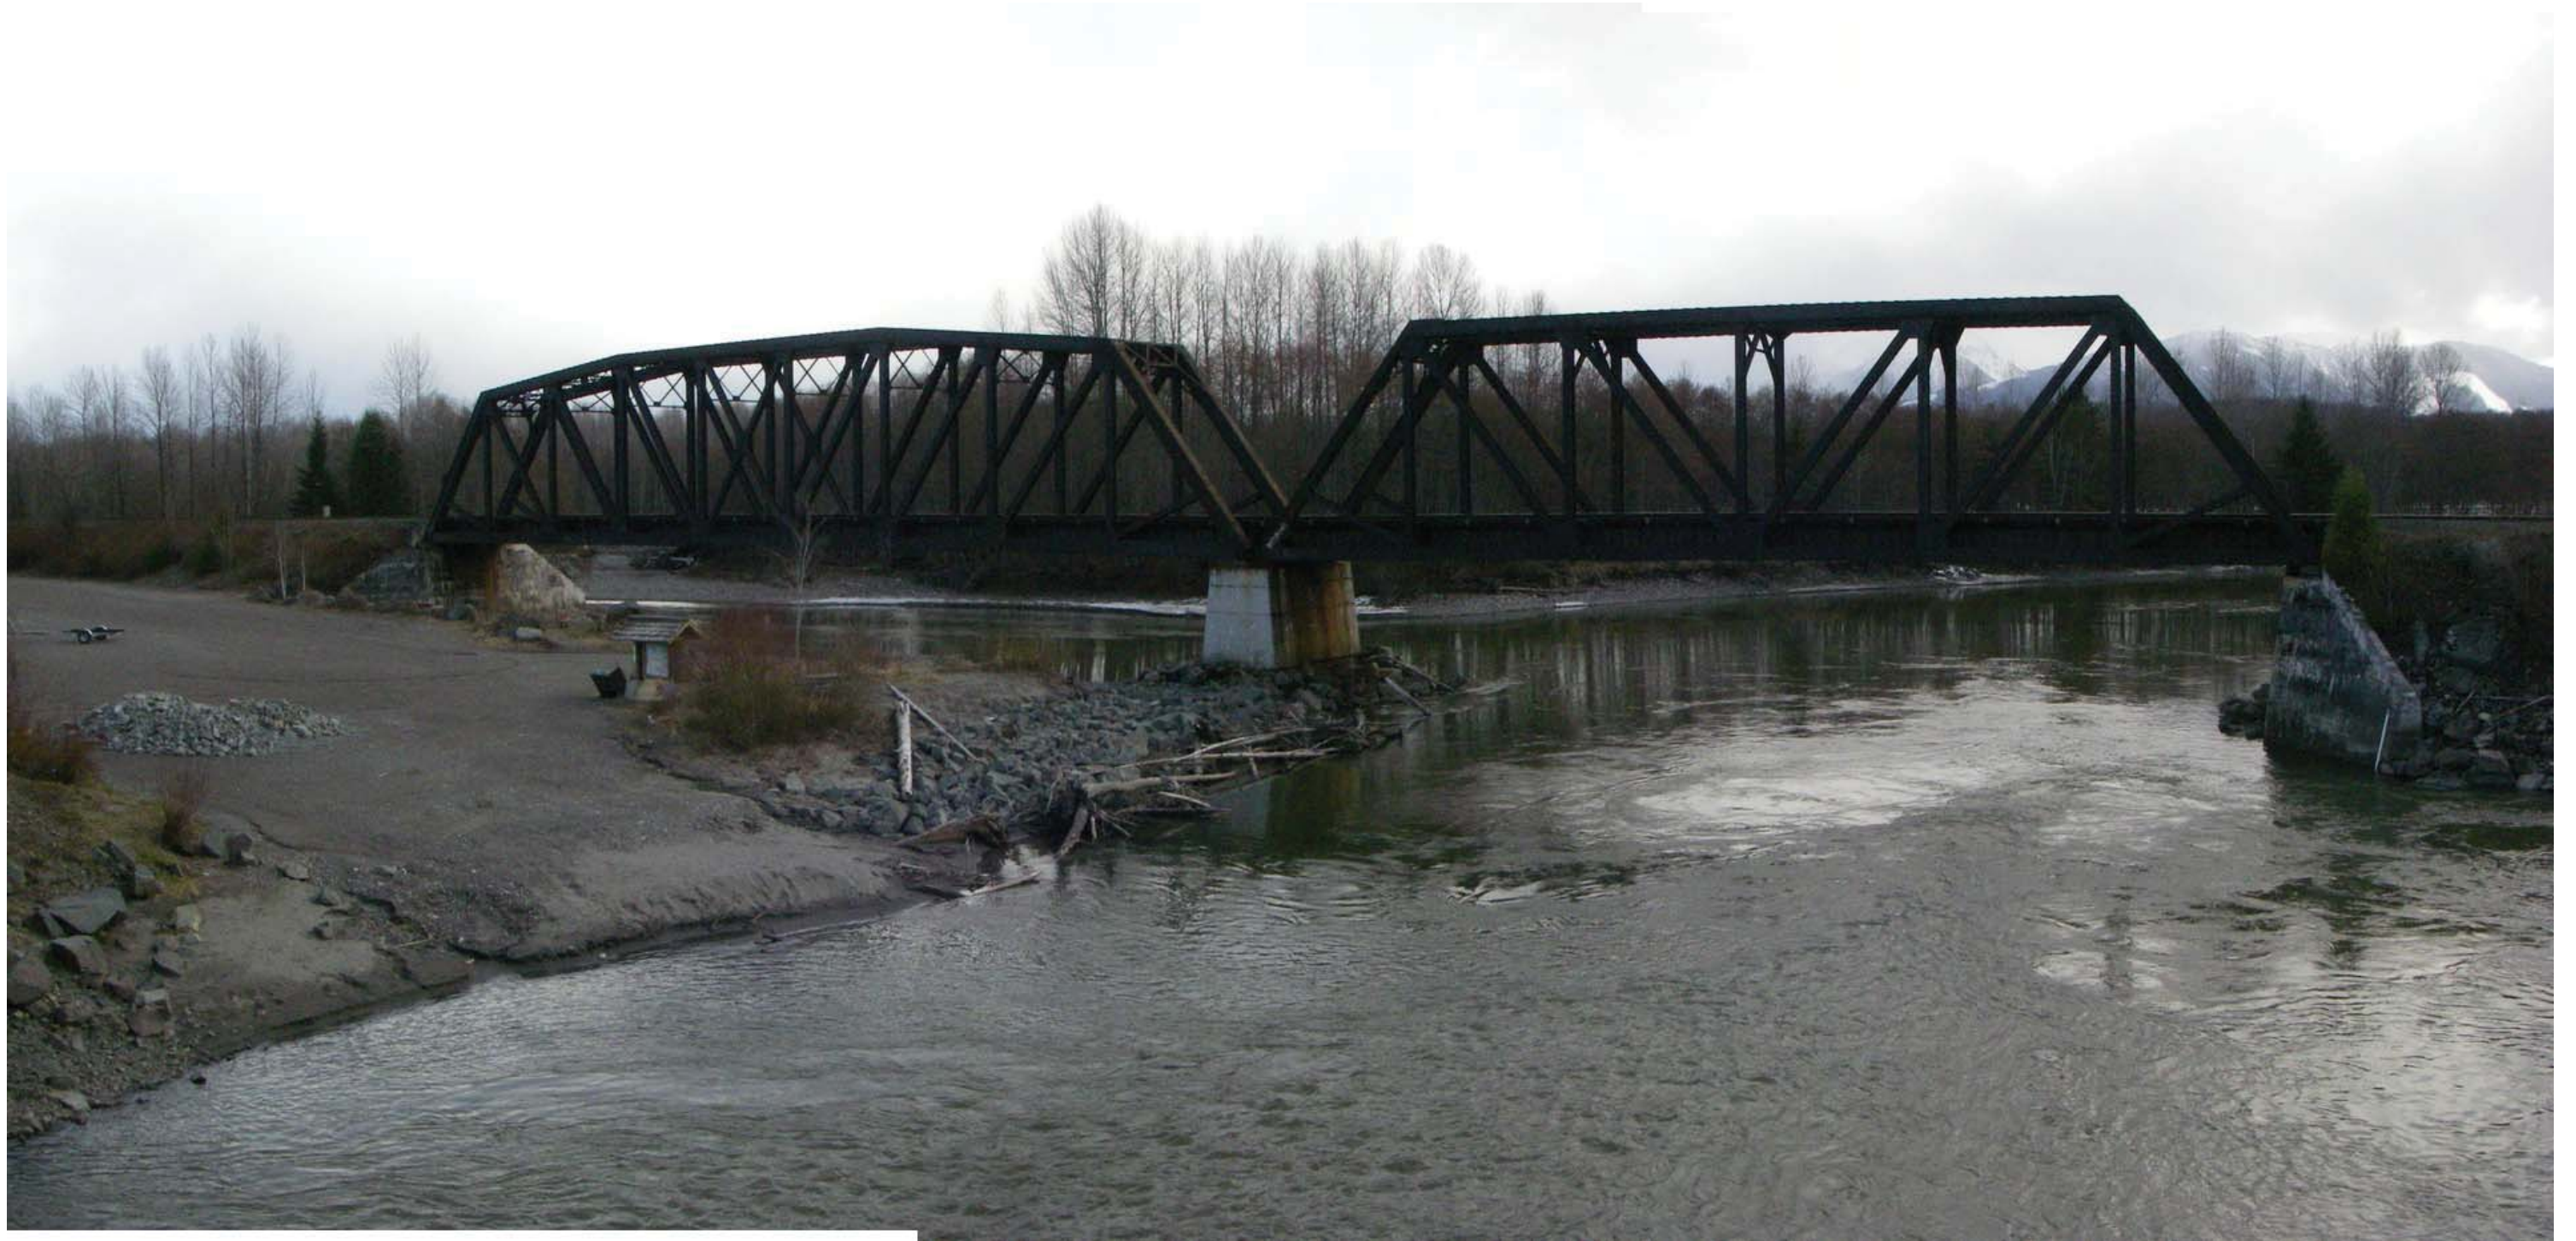
MM 09 5509 & 5510

Panorama looking downstream to the railway bridge from the highway bridge. These show the lack of a channel underneath the left bank opening.

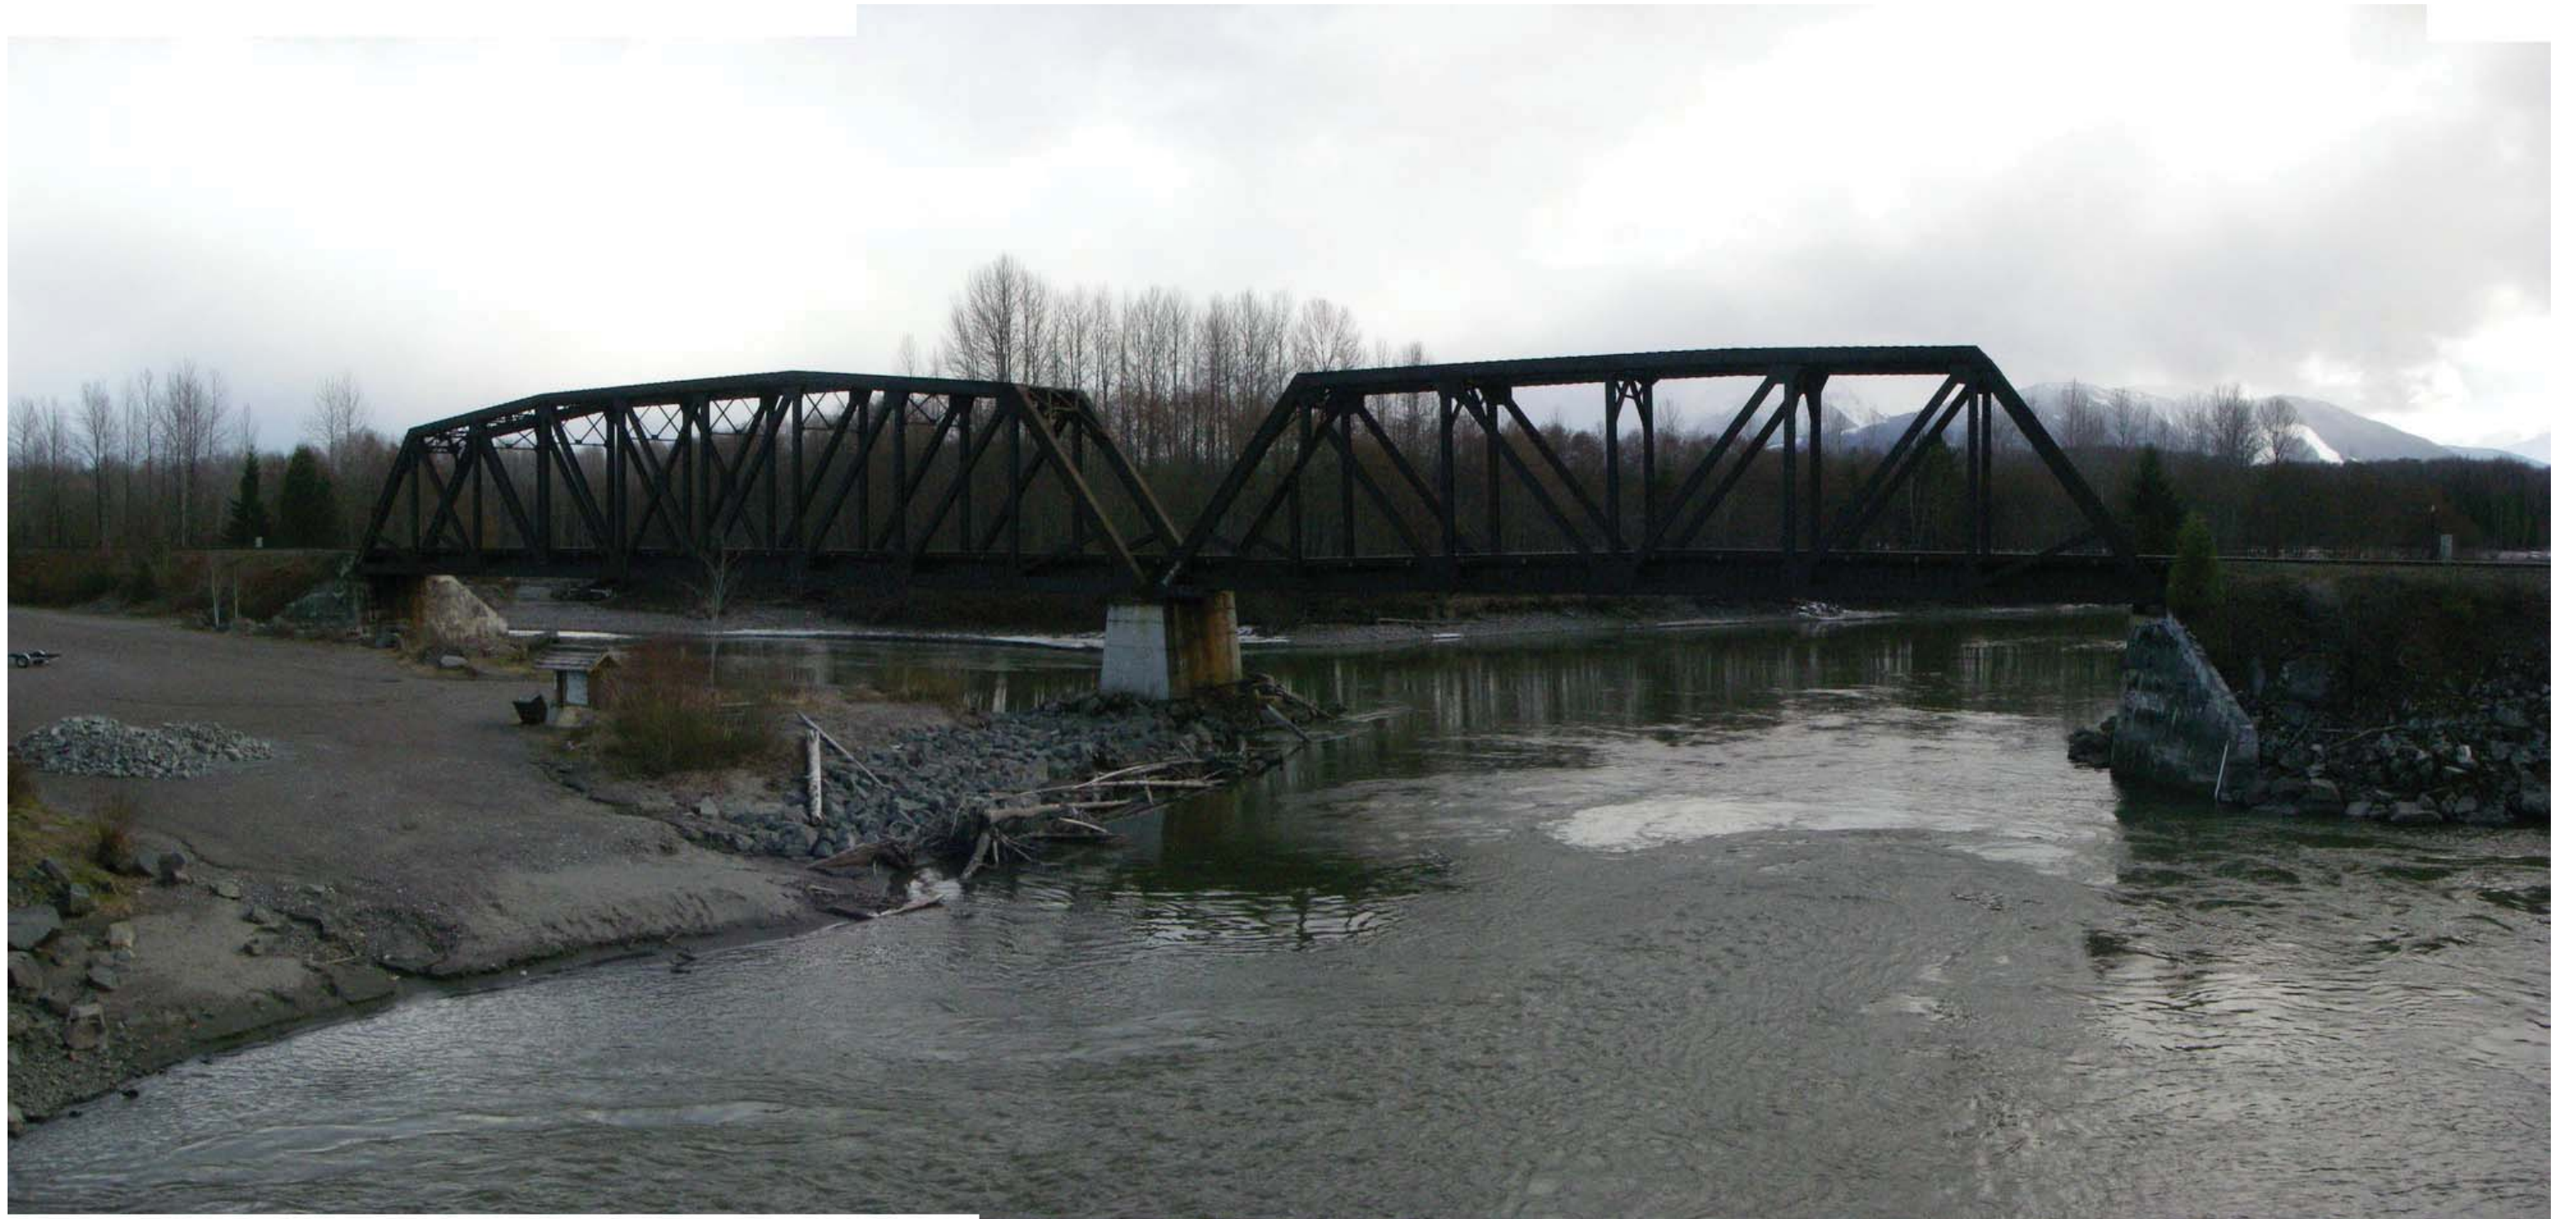
MM 09 5511 to 5513

Second panorama looking downstream to the railway bridge from the highway bridge showing the lack of a channel underneath the left bank opening.
