August 10, 2022

Project Number: 2022-019

# RE: Geotechnical Investigation and Slope Stability Analysis (Revised) 5412, 5414 and 5416 McConnell Cres in Terrace, BC

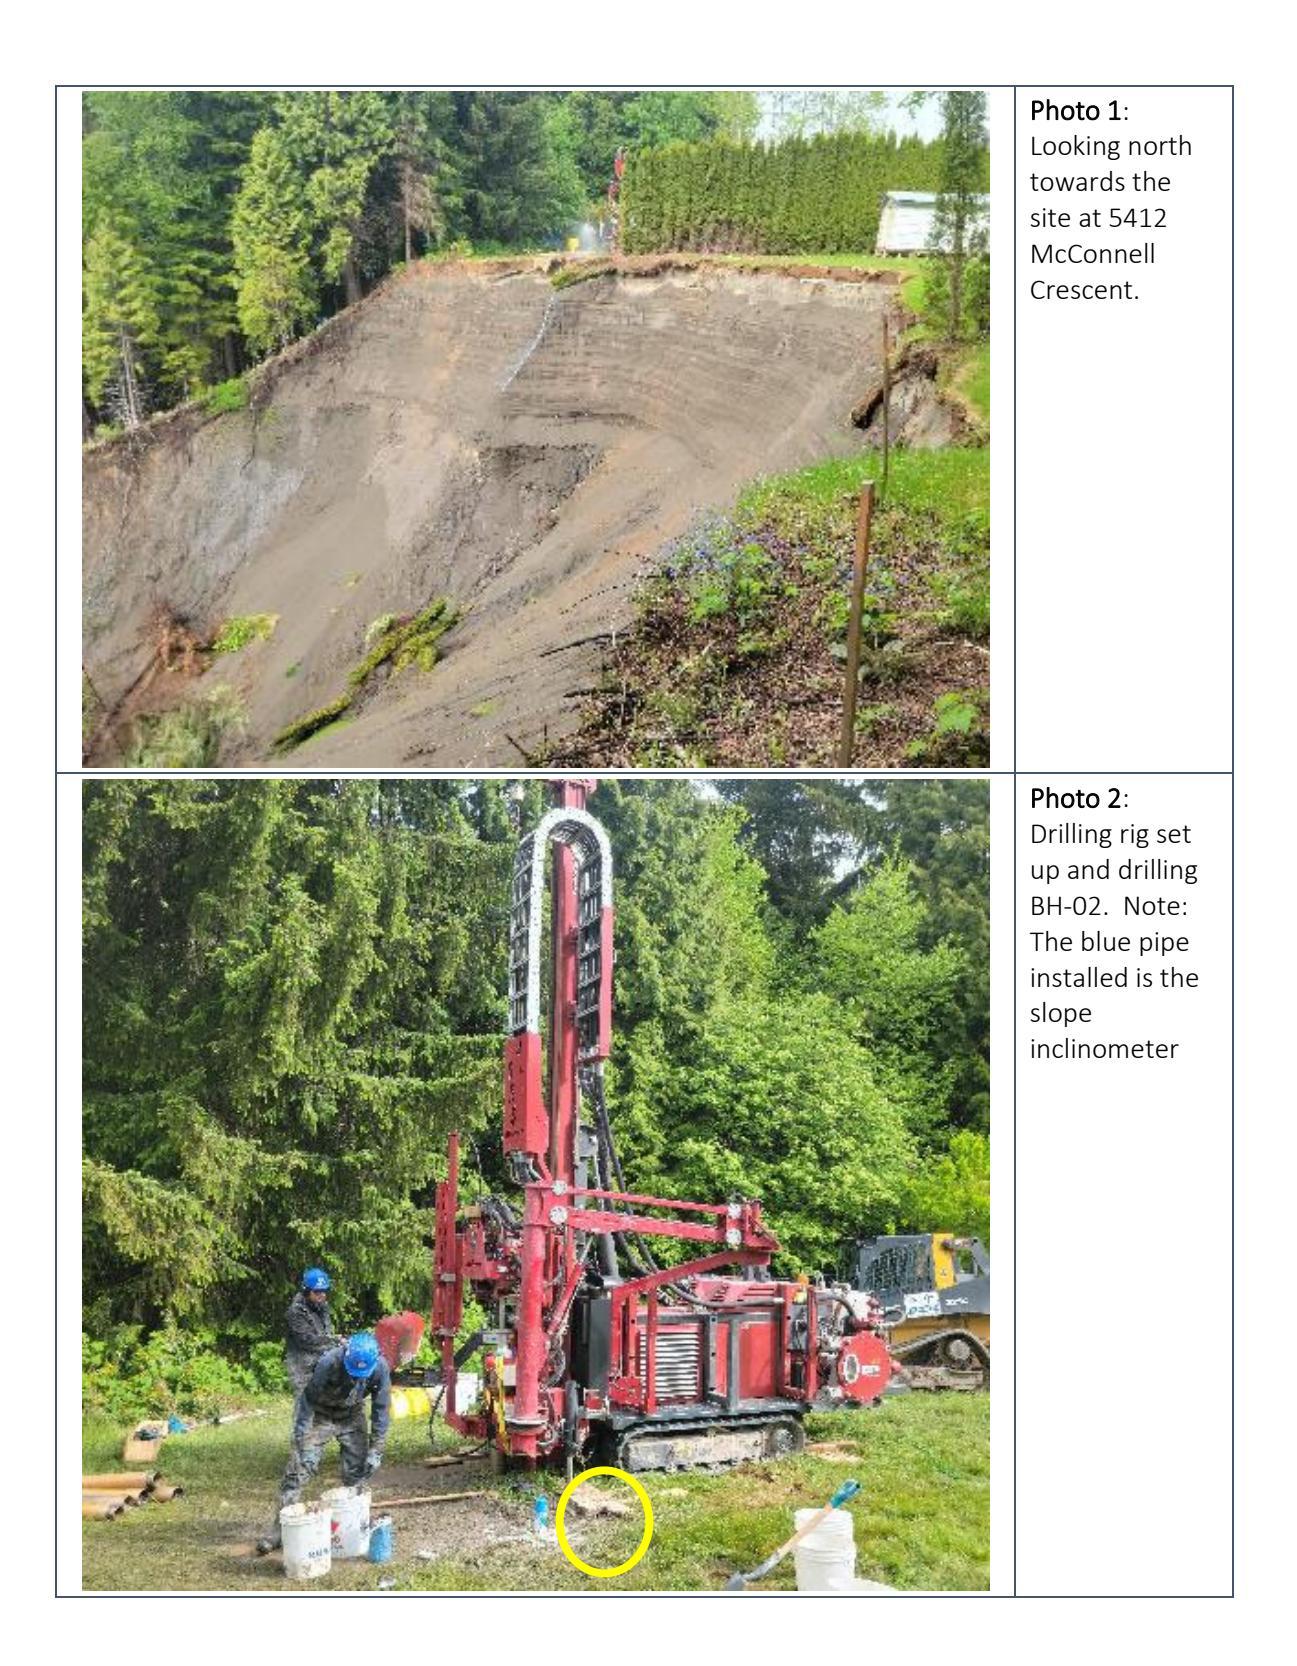
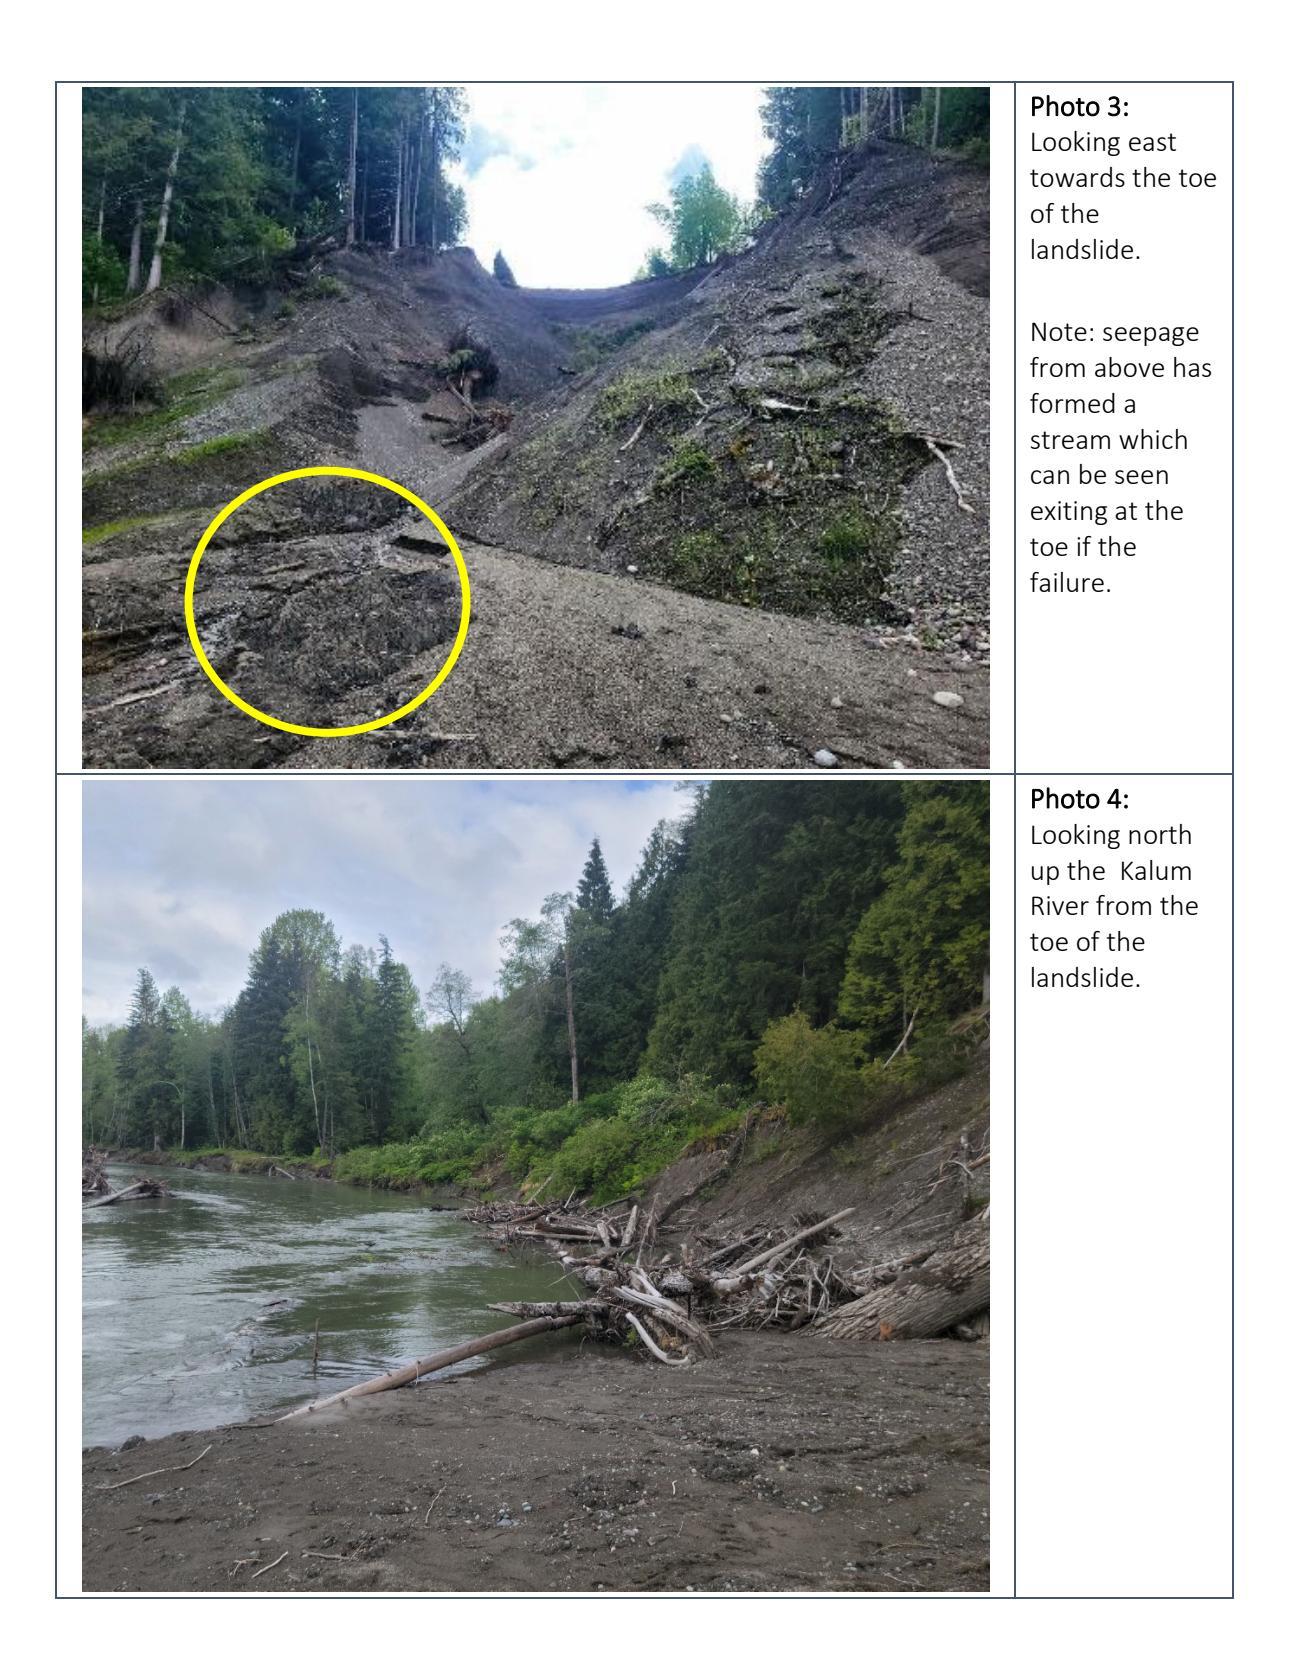
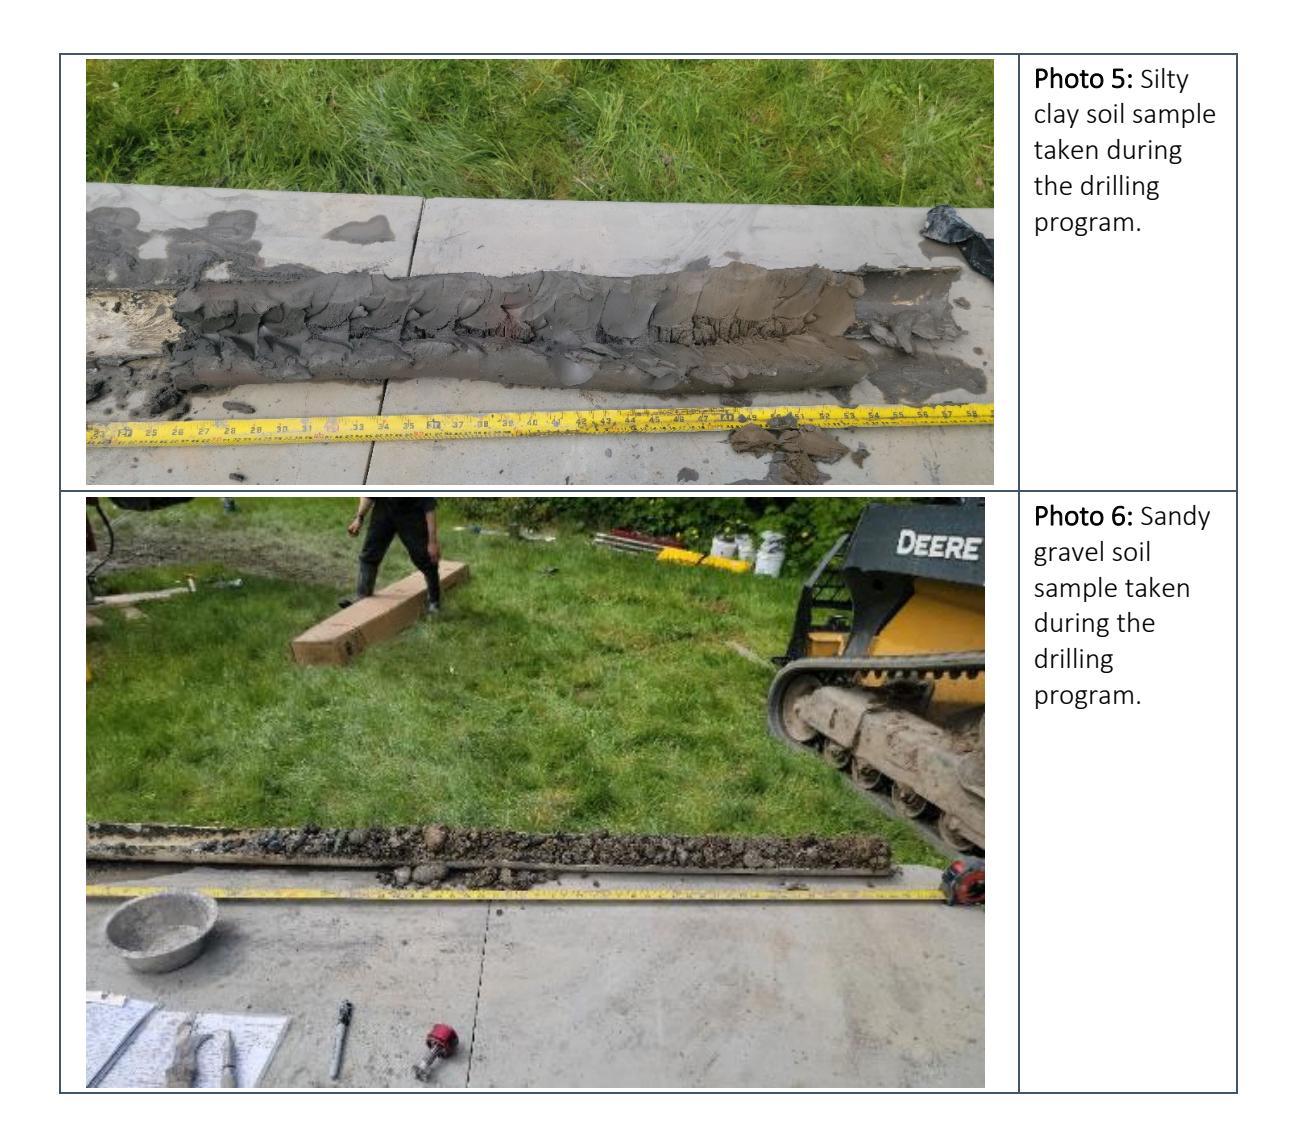
APPENDIX B: SITE INSPECTION PHOTOS

- Progressive ravelling is occurring within the upper sand layer as it is over steepened and exposed to drying and wetting cycles.
- Progressive ravelling of the silty clay zone is occurring as surface soils experience drying and wetting cycles.
- Deposited silty clay observed in the lower fan.
- Concentration of seepage through the slope within the silty clay layer. This is suspected to be washing away the lower fan materials.
- Concentrated seepage is resulting in a channel forming within the failure.
- There is a relatively small volume of deposited materials within the lower fan. These materials likely get transported from surface water movement and the Kalum River.
