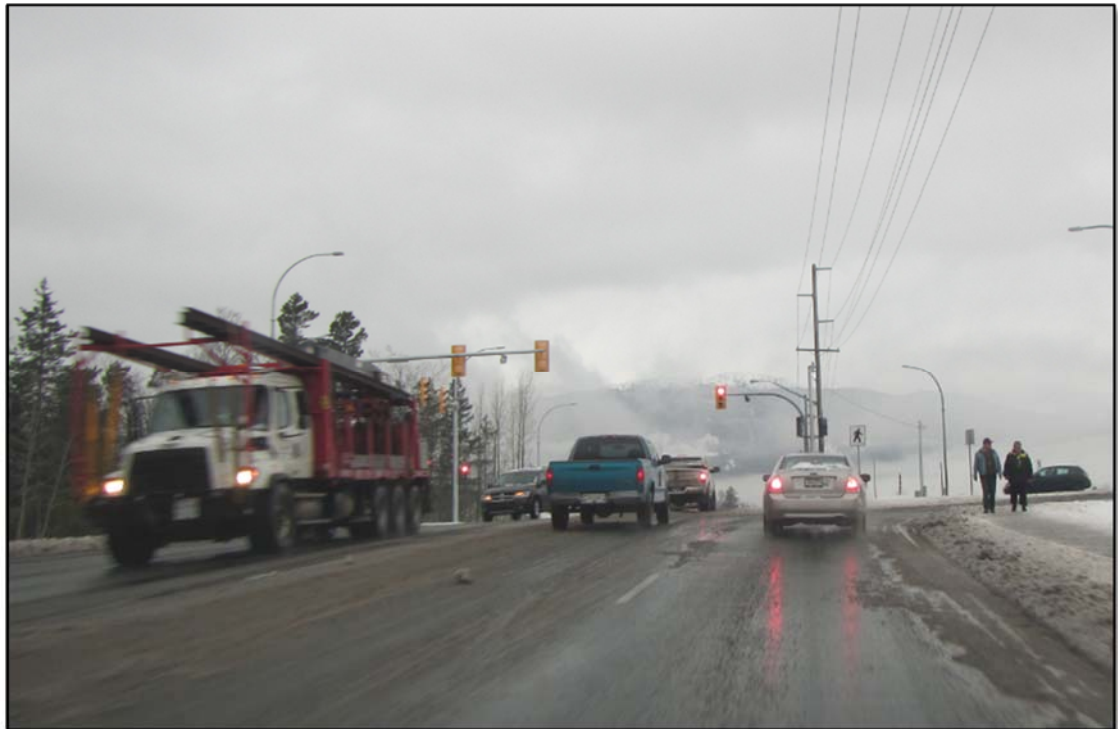
*Figure 43: Highway 16 (Keith Avenue) at Sande Street*

The provincial highways are, by MoTI policy, open for use by all legal trucks and dangerous goods carriers (Figure 43). In this respect, Hwy 16, Hwy 37, and Kalum Lake Road (Hwy 113) are currently designated truck routes through Terrace. These routes inherently serve through traffic by virtue of continuing to regional destinations outside the city limits.

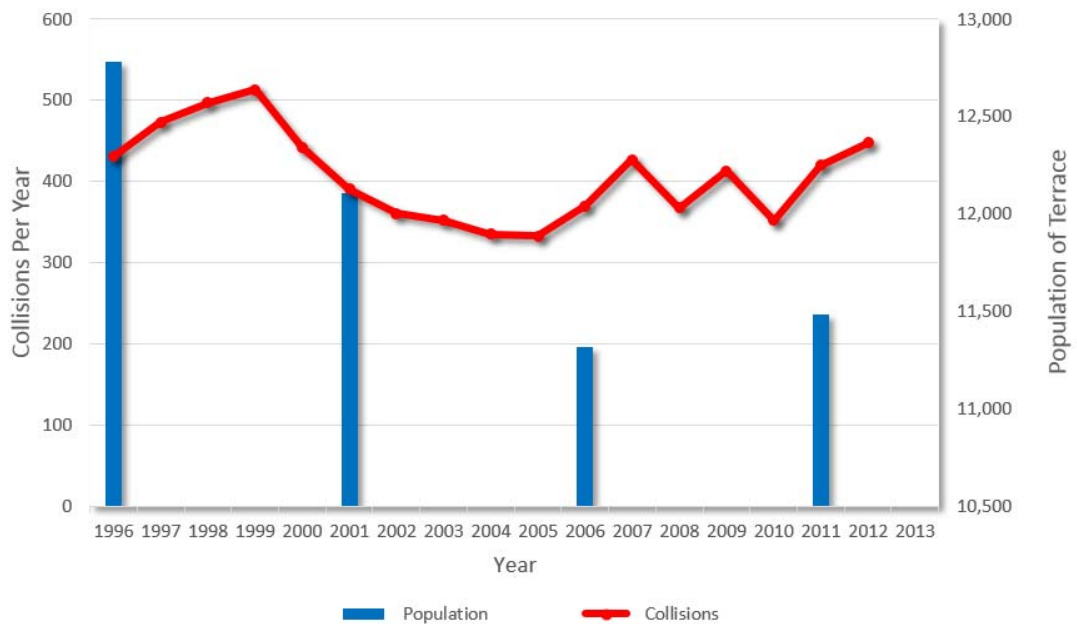
**Figure 45: Annual Collision Frequency and City Population**  
(source: ICBC Collision Data and Census Canada)

The annual number of non-parking related collisions on public roadways since 1996 has generally fluctuated between 300 and 500 per year (Figure 45). Using population data from Census Canada as an indicator of the traffic activity in Terrace, the annual collision frequency appeared to rise and fall with the population until the mid-2000s. After this period, a decrease in population did not appear to have an effect on the collision frequency, which increased to approximately 400 collisions per year.

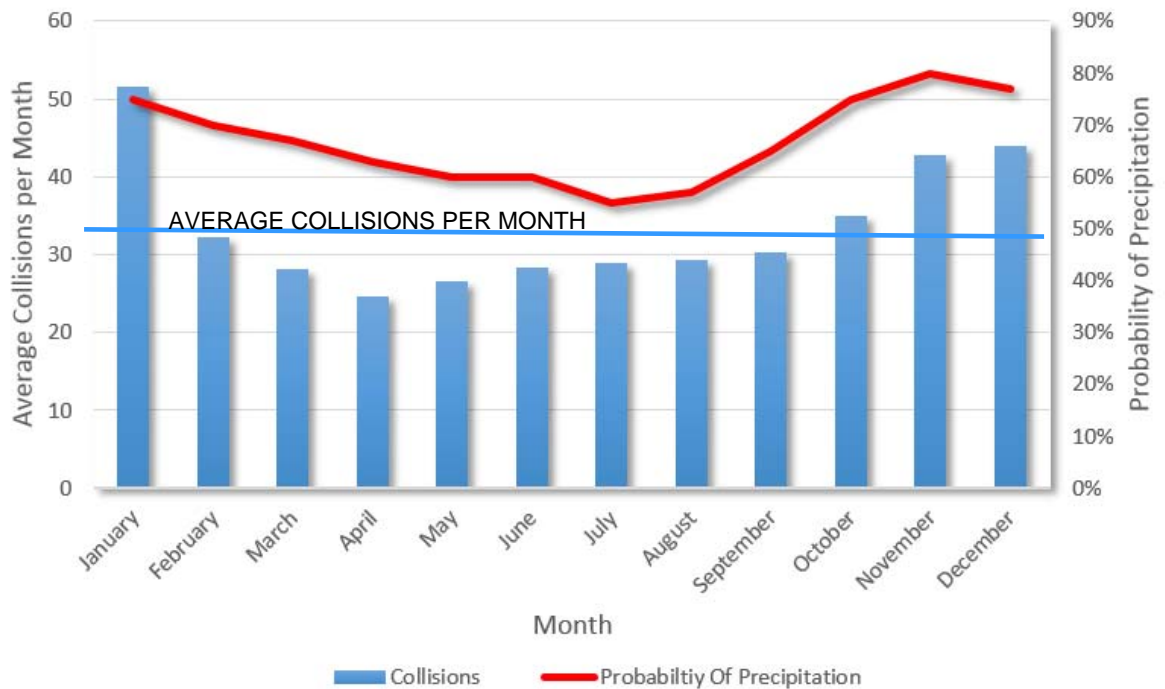
**Figure 46: Monthly Collision Frequency and Probability of Precipitation**  
(source: weatherspark.com)

On a seasonal basis, the collision frequency during the winter months is typically 30% to 50% higher than the annual monthly average (Figure 46). This is largely a reflection of the effect of winter road conditions in a northern climate. The probability of precipitation is higher in winter, and the average daily temperature in Terrace is below freezing between November and February. This trend underscores the importance of winter road maintenance operations in traffic safety.

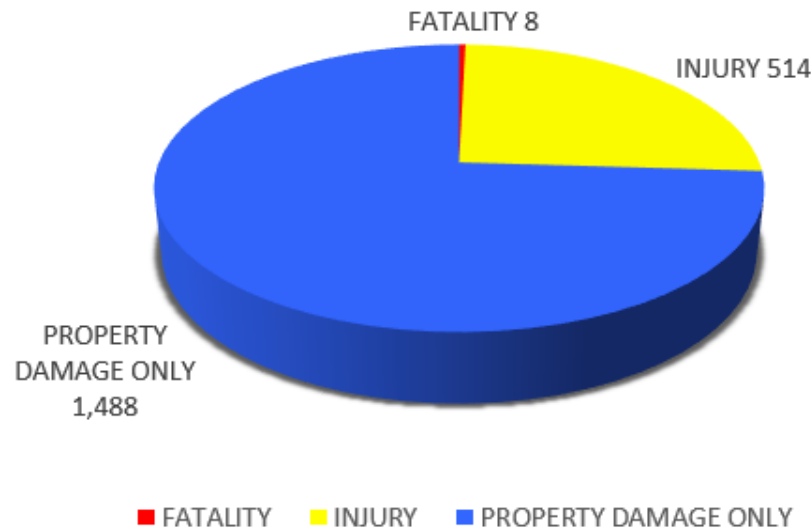
**Figure 49: Collision Severity**

Approximately 75% of all non-parking related collisions in Terrace during the analysis period were classified as Property Damage Only, in which only vehicle or other property damage was involved (Figure 49). The majority of the remainder involved an injury of some kind.

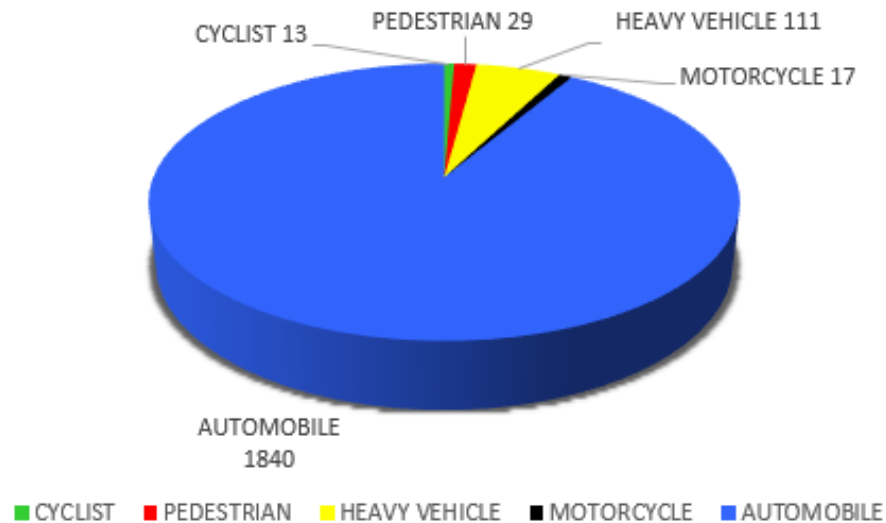
**Figure 50: Collisions by Mode**

Over 90% of the collisions were between automobiles, as would be expected from the relative proportions of vehicles on the road (Figure 50). The number of collisions involving cyclists, pedestrians, and motorcycles was relatively low. For motorcycles and cyclists, this is likely a function of exposure, as fewer people typically use these modes in northern climates.

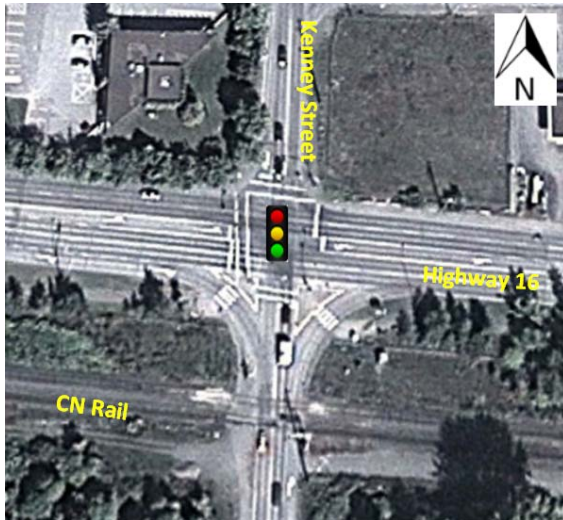
**Figure 52: Highway 16 at Kenney Street**

The signalized intersection of Highway 16 and Kenney Street (Figure 52) is the first of two at-grade railway crossings west of the Sande Street overpass. The south leg connects to the Keith Avenue industrial area; the north leg connects to Lanfear Drive, which is the busiest of the three routes to the Upper Bench area. Consequently, the intersection has a significant traffic demand, with an estimated average daily entering volume of 12,000 vpd.

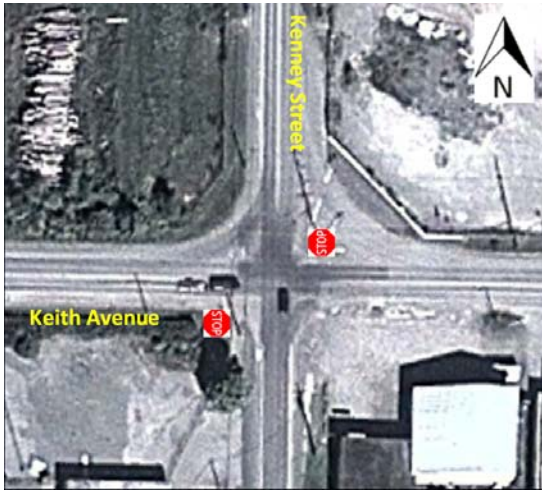
**Figure 54: Keith Avenue at Kenney Street**

The intersection of Keith Avenue at Kenney Street (Figure 54) has stop control on the eastbound and westbound approaches on Keith Avenue. The intersection is part of a major truck route through Terrace's industrial area, and connects directly to Highway 16 to the east and to the north. The estimated entering traffic volume is 8,200 vpd.

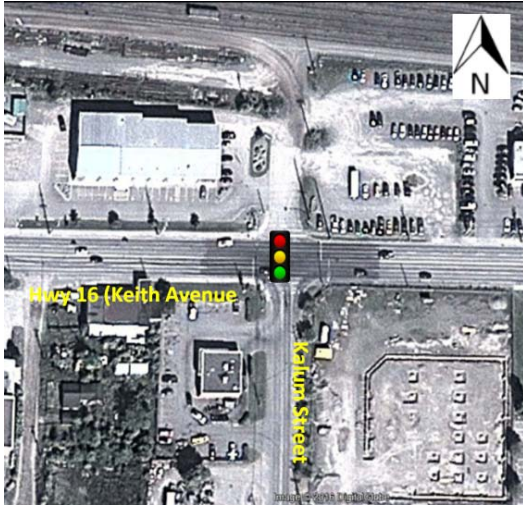
**Figure 56: Hwy 16 (Keith Ave) at Kalum Street**

The signalized intersection of Highway 16 (Keith Avenue) at Kalum Street (Figure 56) connects highway traffic to the residential area to the south. One of the two local Tim Horton’s restaurants is situated on the southwest corner, which contributes to a significant volume of turning traffic at the intersection.

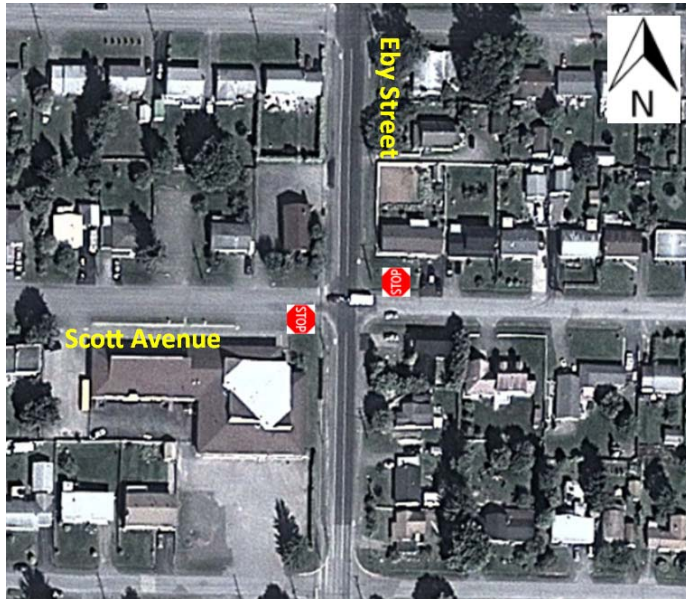
The eastbound and westbound approaches on Scott Avenue have stop conditions. Eby Street is free-flowing through the intersection. The daily traffic volume entering the intersection is estimated at 3,500 vpd. The posted speed on all approaches is 50 km/h. This is the only city intersection that had a fatal collision during the study period.

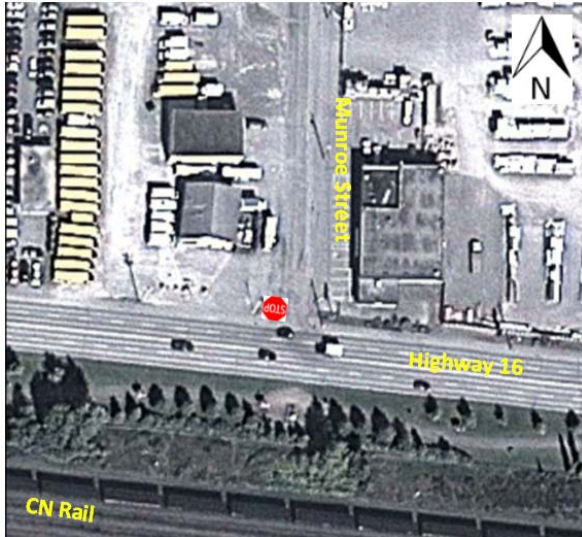
Figure 64: Hwy 16 at Munroe Street

The T-intersection of Highway 16 and Munroe Street connects a main city collector to the provincial highway (Figure 64). The highway has four lanes of free flow traffic through the intersection; Munro Street is two-lanes, with a stop condition at the highway. There are no turning lanes on any of the approaches.

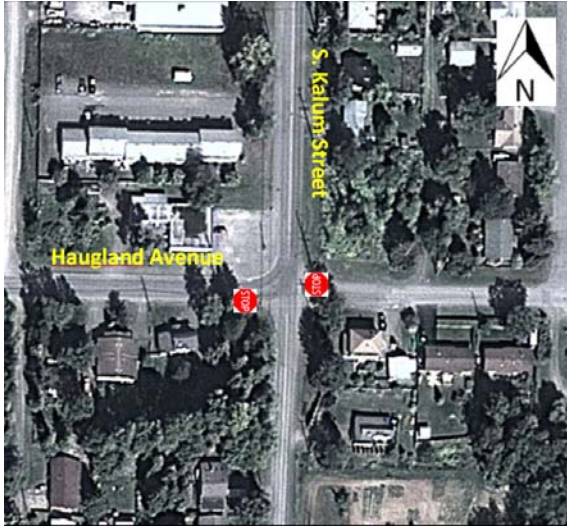
The intersection of Haugland Avenue and Kalum Street is located on the south side of Terrace. Both roads are two lane collectors with no designated turning lanes. South Kalum Street has right-of-way. The eastbound and westbound approaches on Haugland Avenue have stop conditions (Figure 70).

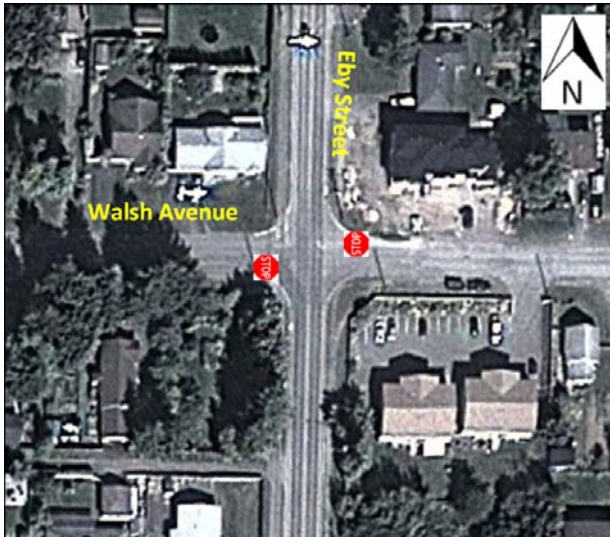
The intersection of Eby Street and Walsh Avenue is centrally located in Terrace. Eby Street is a collector which connects to Highway 16 and the Downtown. Walsh Street is classified as a local road, but is also the main access route to Skeena Middle School to the west. There are stop conditions on the Walsh Avenue approaches, with free flow traffic movement on Eby Street (Figure 76).

Although not related to any observed collision trends, the abundant foliage in the southwest corner of the intersection may be obstructing sight lines looking from Walsh Avenue to the south. These trees should be pruned as necessary to ensure safe sight lines are maintained at the intersection.

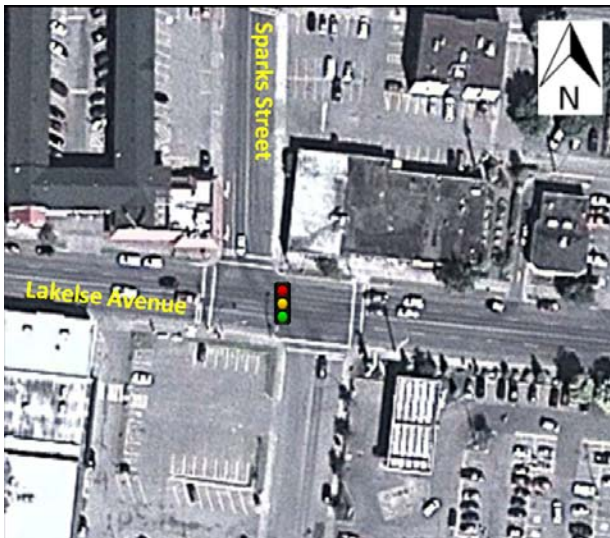
**Figure 80: Lakelse Ave at Sparks Street**

The signalized intersection of Lakelse Avenue and Sparks Street is located in the middle of Downtown Terrace (Figure 80). Both roads are classified as collectors. Lakelse is four lanes through the intersection, and Sparks Street is two lanes, with right turn lanes on each approach.

7. Lakelse Avenue at Sparks Street: the heavier traffic demand expected in the Downtown will exacerbate the delays already incurred by the split signal timing necessitated by the offset T intersection. Heavier volumes on the skewed north-south movement will also invite safety concerns.

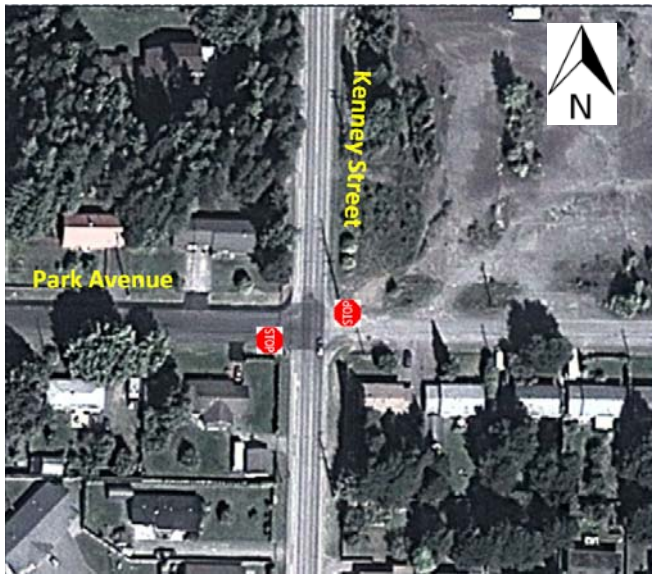
The intersection of Park Avenue and Kenney Street is located west of the Downtown (Figure 82). Both roads are classified as collector roads, although Kenney Street is the busier road. Kenney Street has bicycle lanes, curb/gutter, and a sidewalk. Traffic on Kenney Street is free-flowing through the intersection. Park Avenue is narrow east of Kenney Street, and has open shoulders. Traffic on Park Avenue has a stop condition at Kenney Street. There are no turning lanes at the intersection.

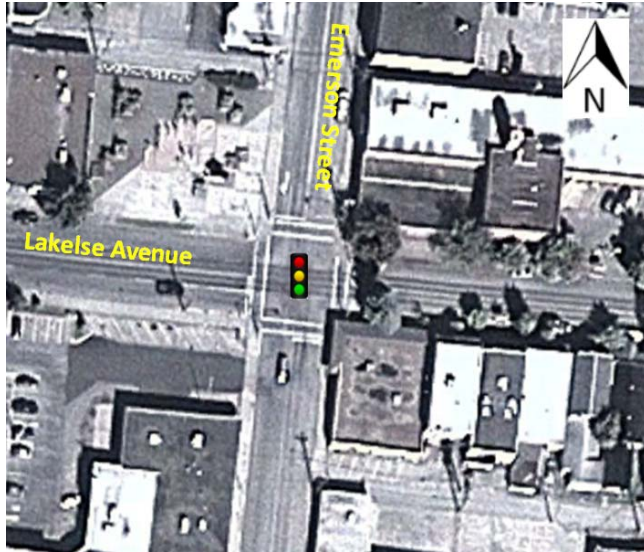
**Figure 88: Lakelse Avenue at Emerson Street**

The intersection of Lakelse Avenue and Emerson Street in Downtown Terrace is controlled by a two phase traffic signal (Figure 88). The west leg of Lakelse Avenue is four lanes, with the right lane on the eastbound approach restricted to right turns. The east leg of Lakelse Avenue is two lanes only. Both approaches on Emerson Street have one through-left lane, and a right turn lane.

The proposed lane diet on Lakelse Avenue would also improve the safety of this intersection by (a) providing a traffic calming effect, (b) reducing the demand for lane changes, and (c) affording more space for cyclists.

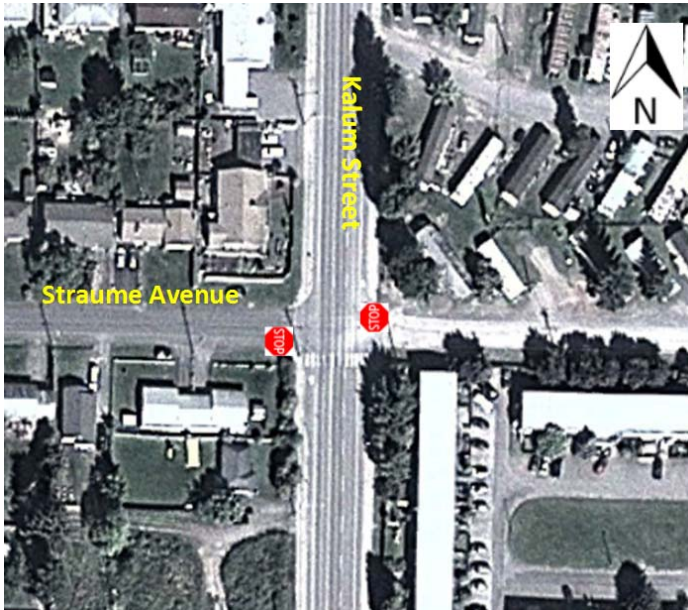
**Figure 90: Straume Avenue at Kalum Street**

The intersection of Straume Avenue and Kalum Street has stop conditions on the eastbound and westbound (Straume Ave) approaches (Figure 90). Straume Avenue is a narrow two lane local road. Kalum Street is a collector that connects the Downtown to the east side of the Upper Bench, and has recently had a lane diet from four lanes to two lanes with a Two Way Left Turn Lane. There are no other turning lanes at the intersection.

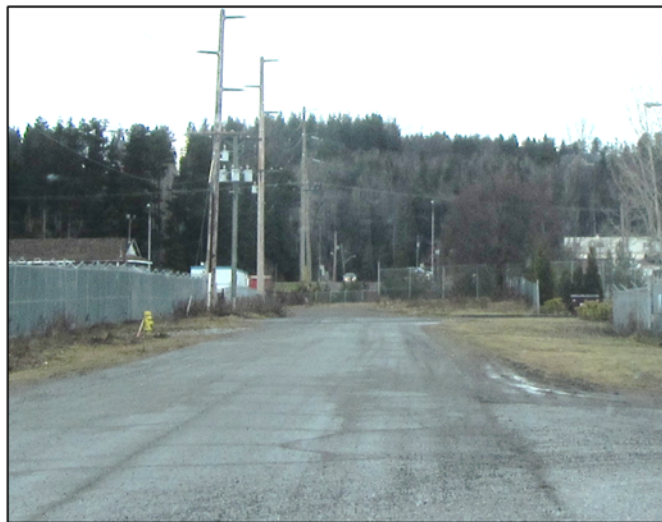
**Figure 96: Kalum Lake Intersection as Viewed from Braun Street**

The Kalum Lake Road intersection (Figure 96) is an ideal location for a rail overpass from a number of perspectives:

1. The location is 800 metres from the signalized intersections at Kenney Street (to the east) and Frank Street (to the west), which achieves an appropriate spacing for traffic signals along an arterial highway corridor.
2. A crossing at Kalum Lake Road would provide a convenient alternative for westbound traffic turning south when Kenney Street is closed for train crossings.
3. As the overpass will necessarily become the future truck route, there is an advantage to connecting it directly to Kalum Lake Road, a provincial highway.
4. The topography for a rail crossing is advantageous at Kalum Lake Road.

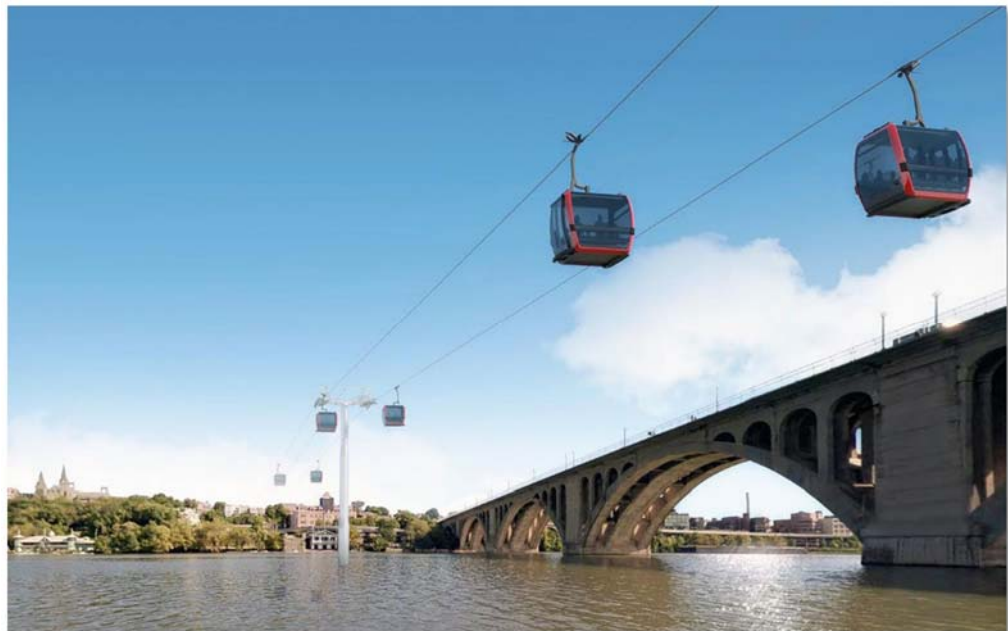
**Figure 98: Pedestrian Gondolas, Washington, DC**  
(source: wtop.com)

A more cost effective alternative at Kalum Street would be a gondola system, which could be designed to automatically shuttle pedestrians and cyclists from ground level to ground level, and crossing the tracks at a clearance of 11 metres (see example, Figure 98). The typical speed for such an installation would be 3 m/s, making a crossing approximately 2 minutes in duration. These facilities are commonly used for active transportation connections outside North America. The cost is estimated at \$3-4 Million for construction, with an estimated annual operating cost of \$50k.

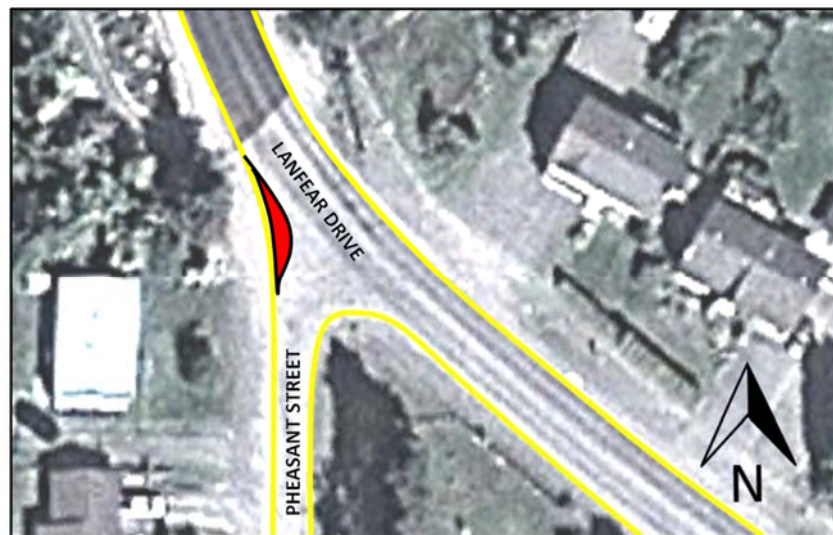
Figure 103: Potential Bulb on Pheasant Street at Lanfear Drive

As an alternative, the traffic turning from Lanfear Drive onto Pheasant Street could be slowed by the installation of an intersection bulb (Figure 103). This improvement would reduce traffic speeds at the intersection without eliminating the turning movement, and would also improve the safety of the intersection for pedestrians. The intersection bulb would have to be designed to accommodate the turning vehicles without overlapping the path of northbound traffic, such that the potential for southbound rear end conflicts on Lanfear Drive is minimized. Also, this solution would not necessarily prevent speeding traffic short-cutting through Pheasant Street after negotiating the turn at the intersection.

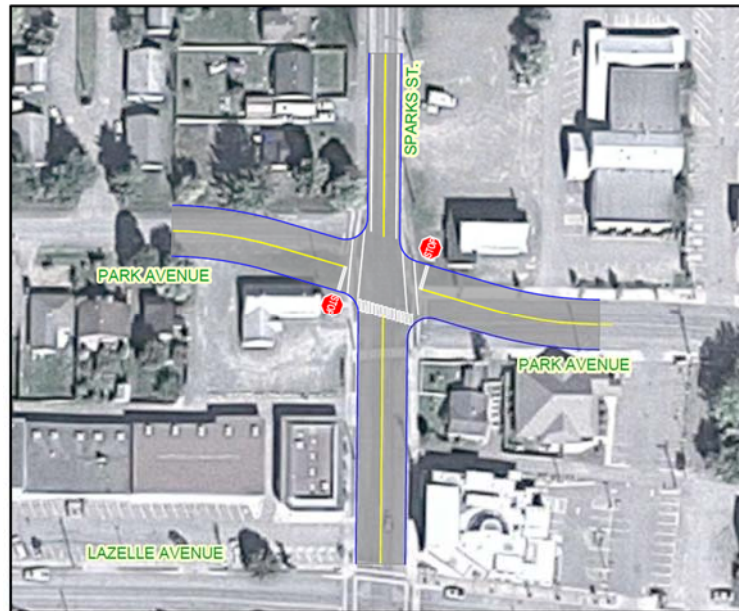
**Figure 104: Proposed Realignment of Park Avenue at Sparks Street**

Park Avenue is functionally classified as a collector, and (with extensions implemented to the west) will become a key route to and from the Downtown. At the Sparks Street intersection, an offset T configuration creates awkward turning movements, and may have safety concerns under heavier traffic flows. In particular, the nature of the offset “T” configuration is such that opposing left turns on Sparks Street would overlap. The intersection should be realigned to create one four leg intersection (Figure 104).

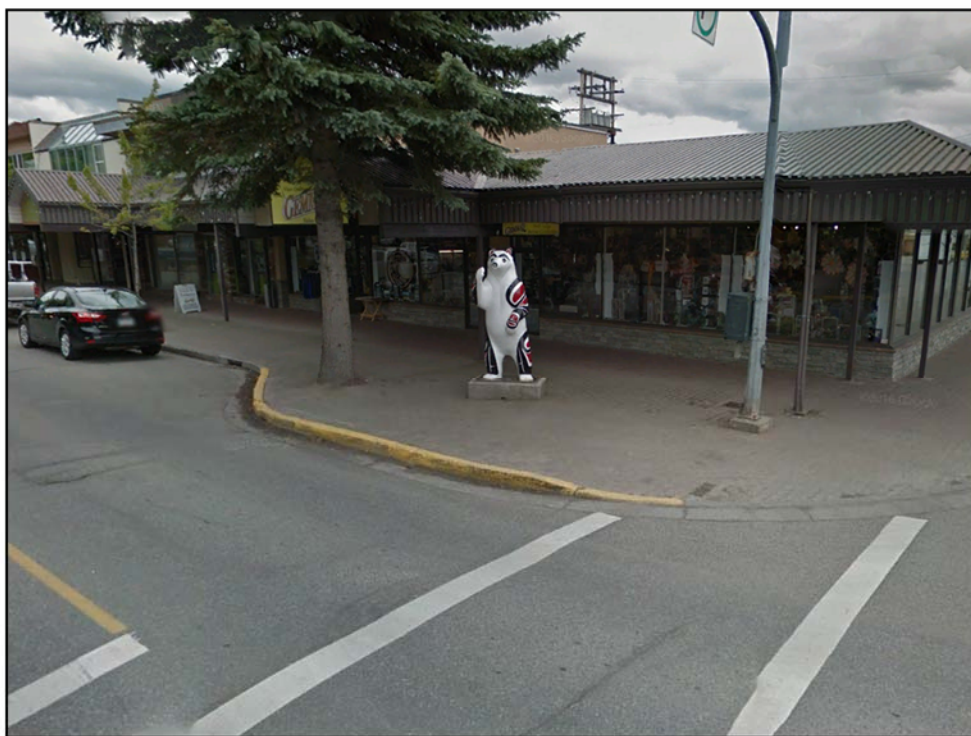
**Figure 109: Sidewalk Bulb on Lakelse Avenue at Emerson Street**

2. Horizontal deflections: among the more effective and aesthetic traffic calming measures are horizontal deflections, such as curb extensions (“sidewalk bulbs”), chicanes, and simple narrower roads. The reduction in the road width can be used to create more space for vulnerable road users and street-scaping, and may also reduce the amount of snow clearing required. Sidewalk bulbs have been used effectively throughout Downtown Terrace (Figure 109), and should be implemented wherever possible. To facilitate snow clearing around the bulbs, the bulbs should be developed with no more than a 30 degree angle from the original curb lines.
