CHANNEL STABILITY ASSESSMENT: SKEENA AND KITSUMKALUM RIVERS IN THE VICINITY OF TERRACE

Prepared for:

CITY OF TERRACE
5003 Graham Avenue
Terrace, BC, V8G 1B3

M. MILES AND ASSOCIATES LTD.
645 Island Road
Victoria, BC, V8S 2T7

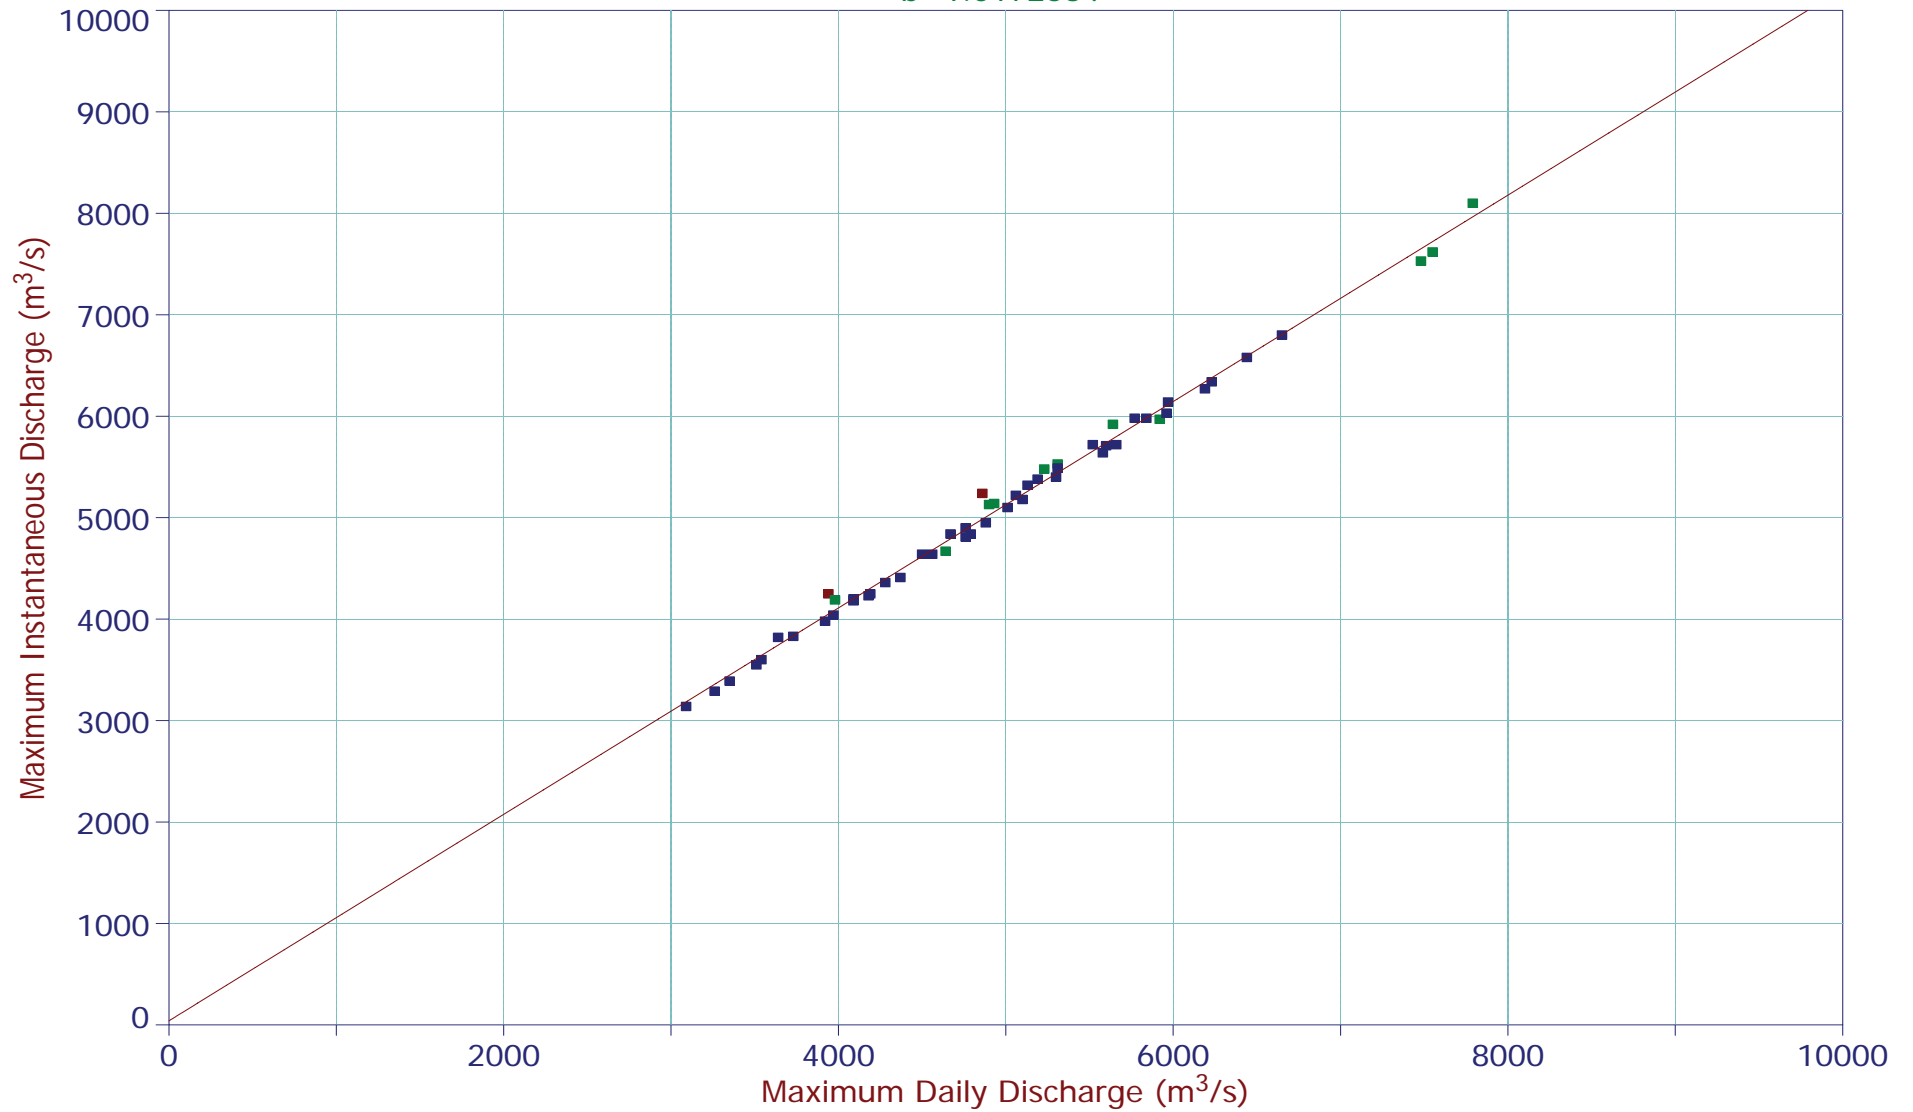
Figure 4.3.1.2: Relationship between annual maximum daily and instantaneous discharges observed on Skeena River at Usk.

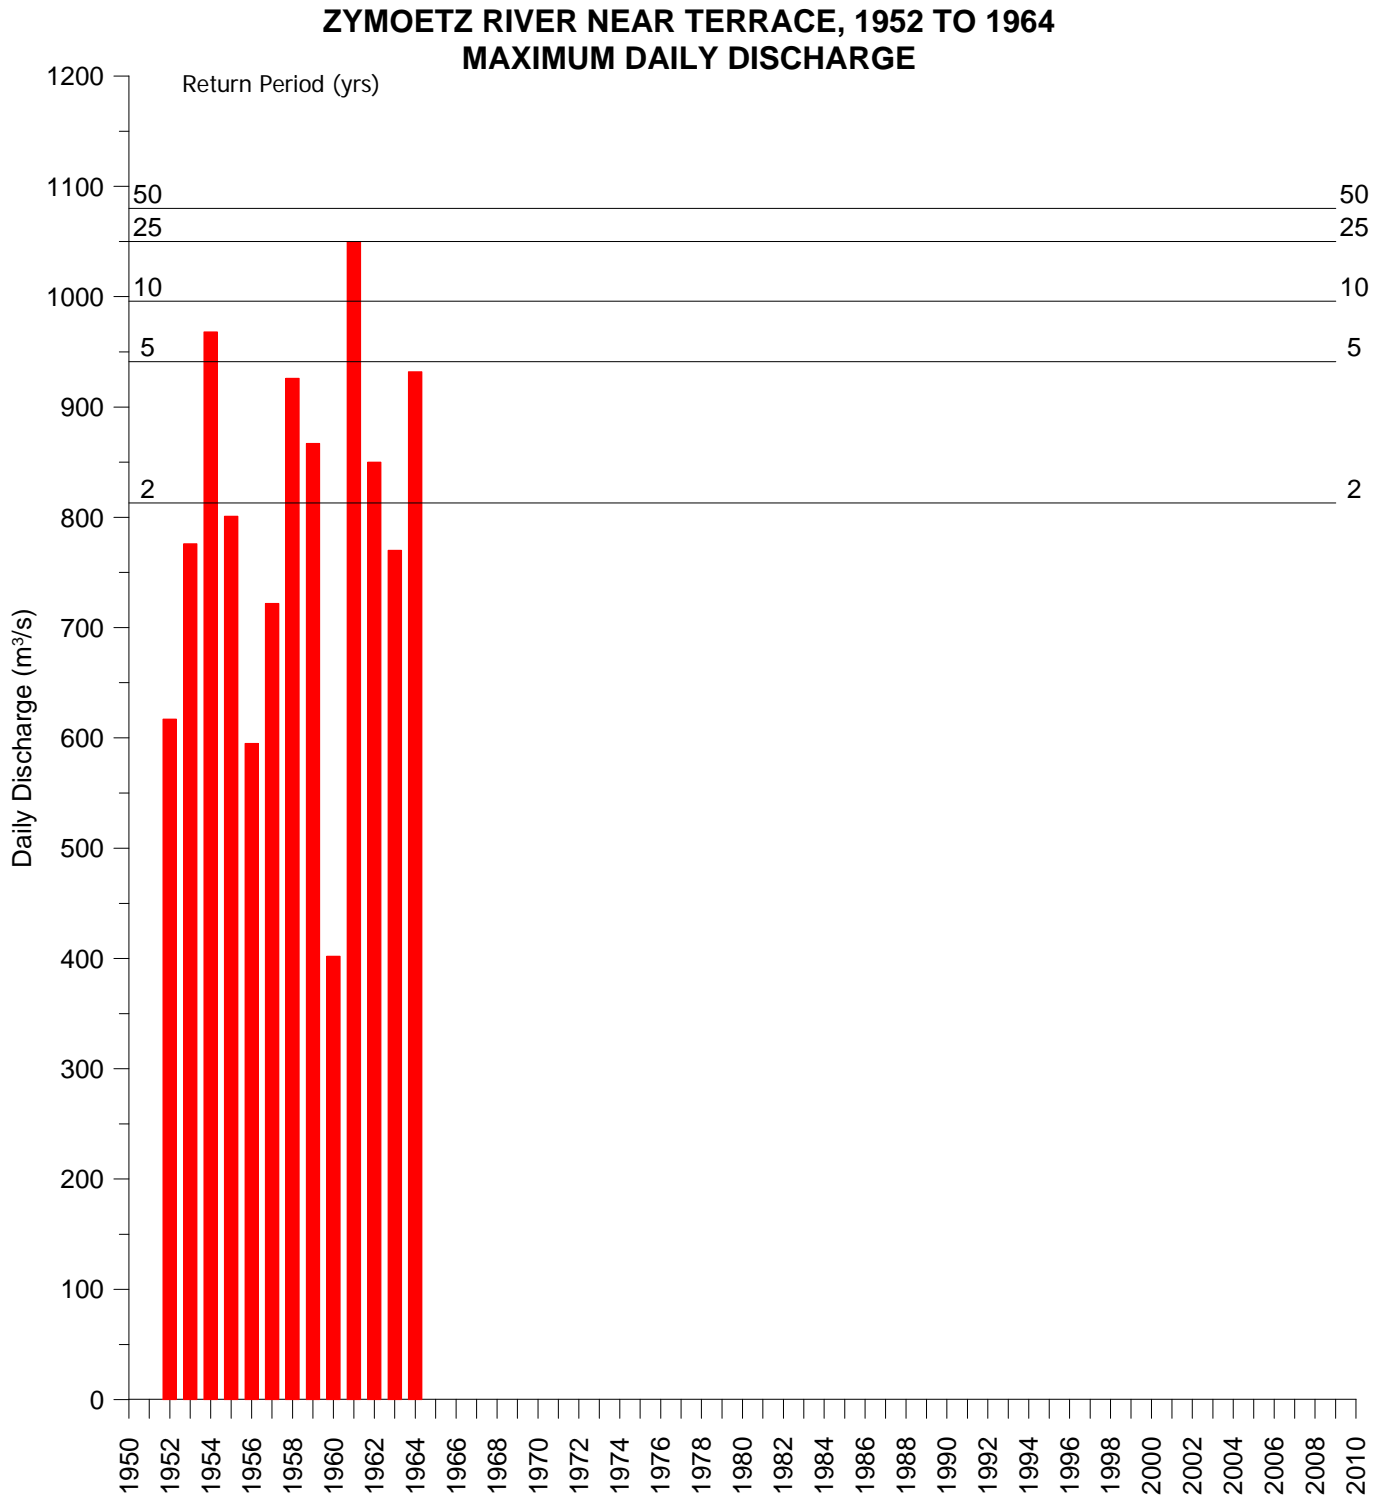
Figure 4.3.2.1: Historical variation in annual maximum daily discharge, Zymoetz River near Terrace, 1952 to 1964.

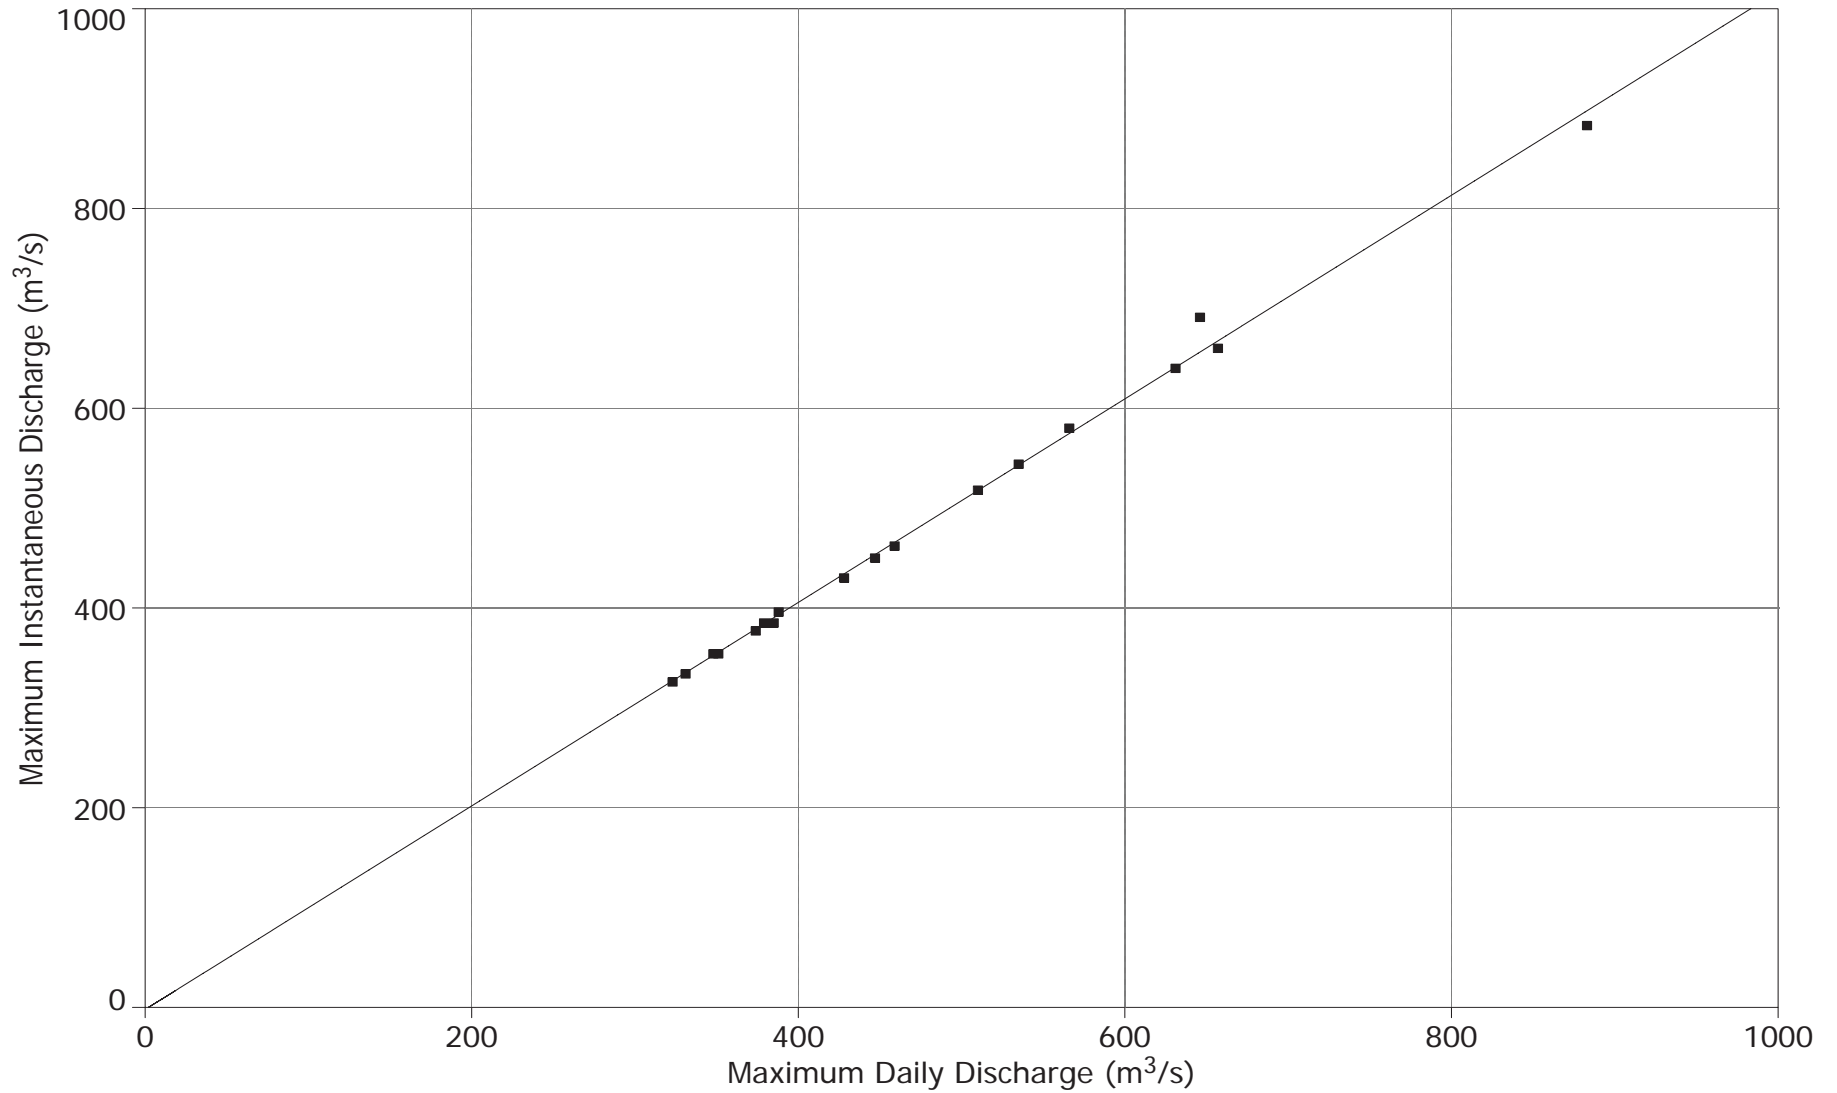
Figure 4.3.3.2: Relationship between annual maximum daily and instantaneous discharges observed on Kitsumkalum River near Terrace.

We have tried to improve the reliability of the flood frequency analyses by using the annual maximum daily discharge data to estimate missing annual maximum instantaneous discharge values. The relationship between these two values is shown on *Figure 4.3.3.2*. The r² value is 0.99. The extended series of annual maximum instantaneous discharges is shown on *Figure 4.3.3.3* and the results of a revised flood frequency analysis are summarized on *Table 4.3.3.3*. On this basis the estimated 2 and 200-year flood flows are 454 m³/s (0.298 m³/s/km²) and 1,130 m³/s (0.518 m³/s/km²). Unfortunately there are no overlapping data records from regional streams of comparable size (e.g. Kitimat River, Little Wedeene River) which would allow flood magnitudes in the 1929 to 1952 periods to be compared with those that are presently occurring. Given this limitation, and the short period of record available from Kitsumkalum River, additional regional analyses are required to develop a reliable design flood estimate for this watershed.

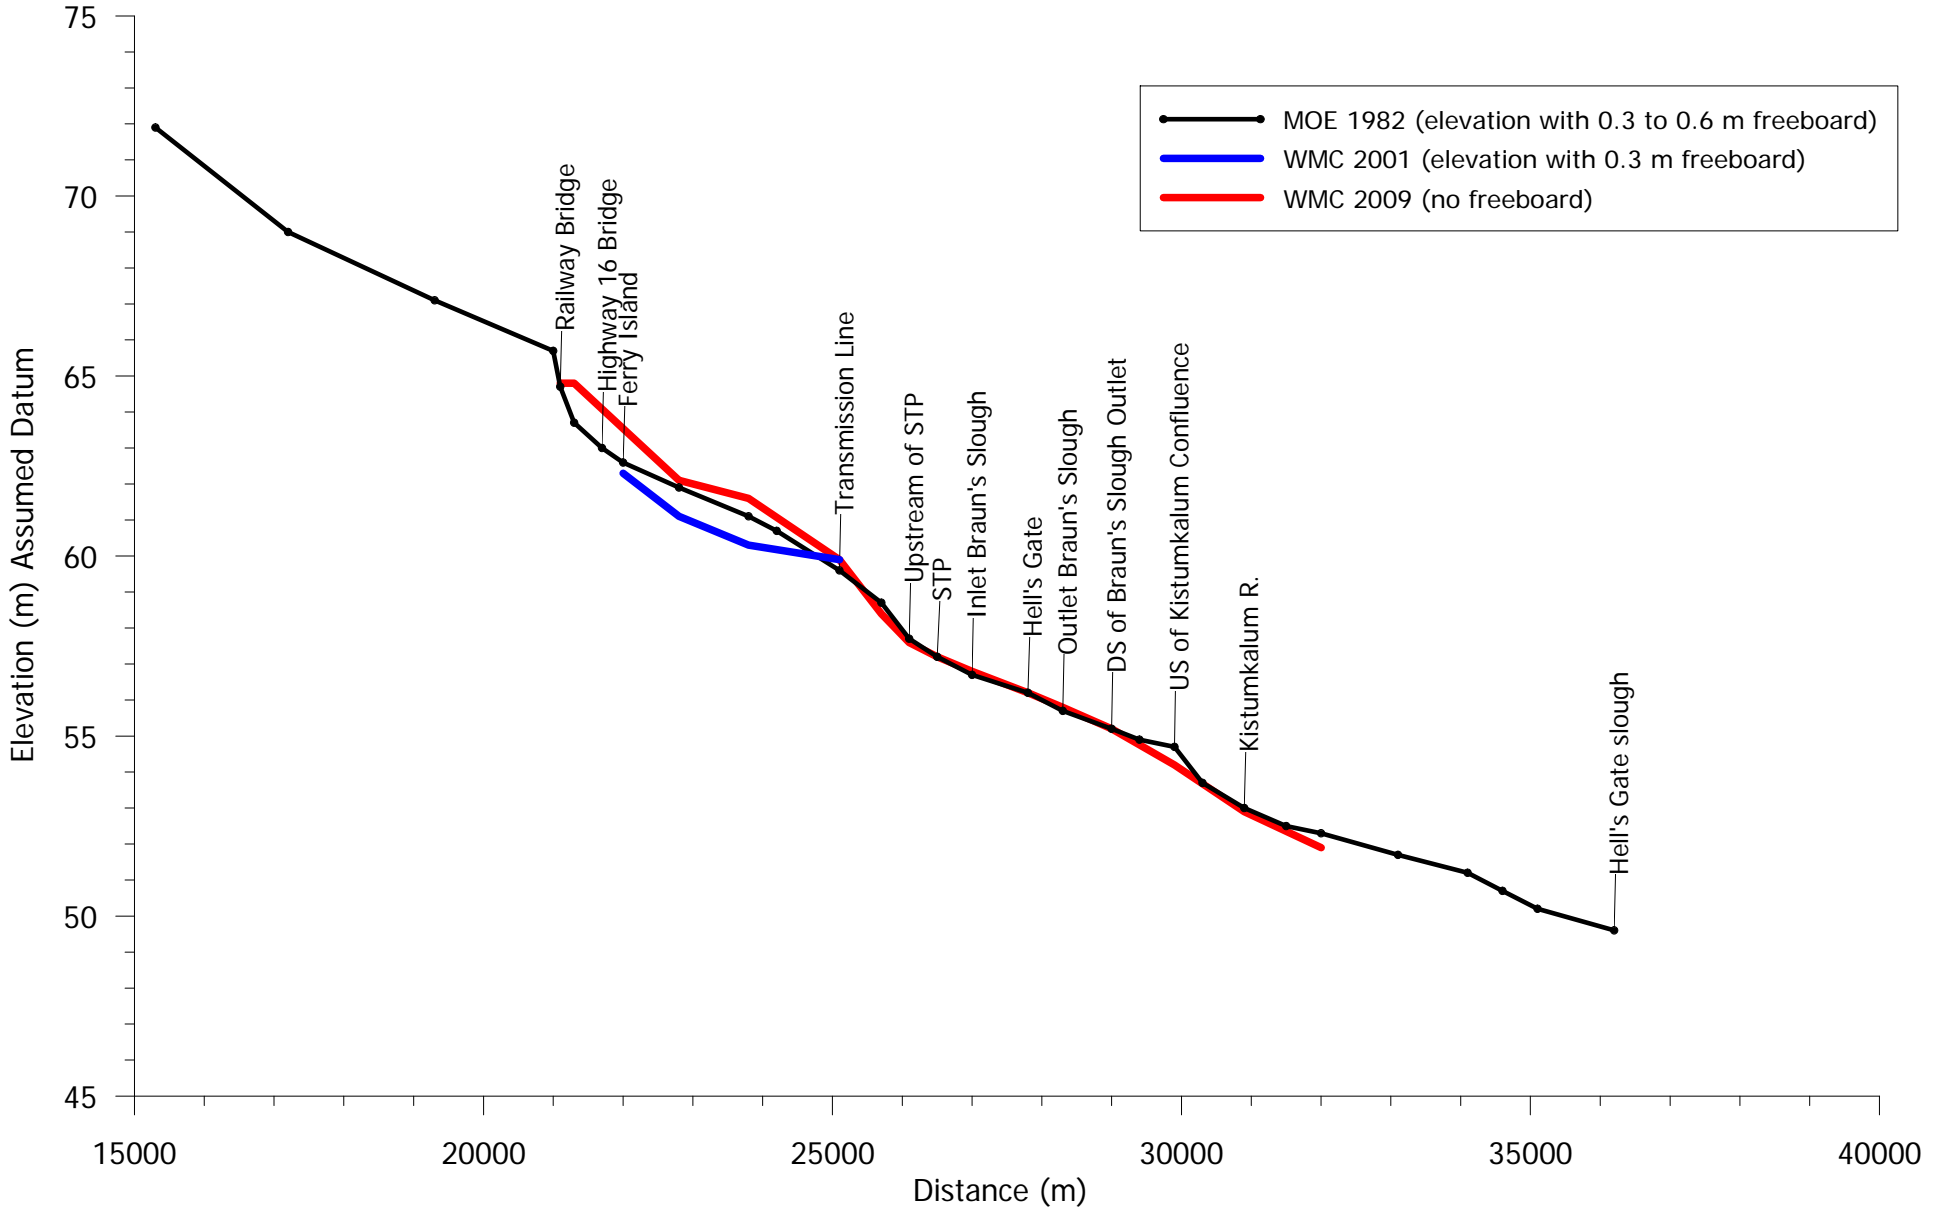
Figure 5.3.1.1: Comparison of predicted 200 year return period flood elevations on Skeena River.

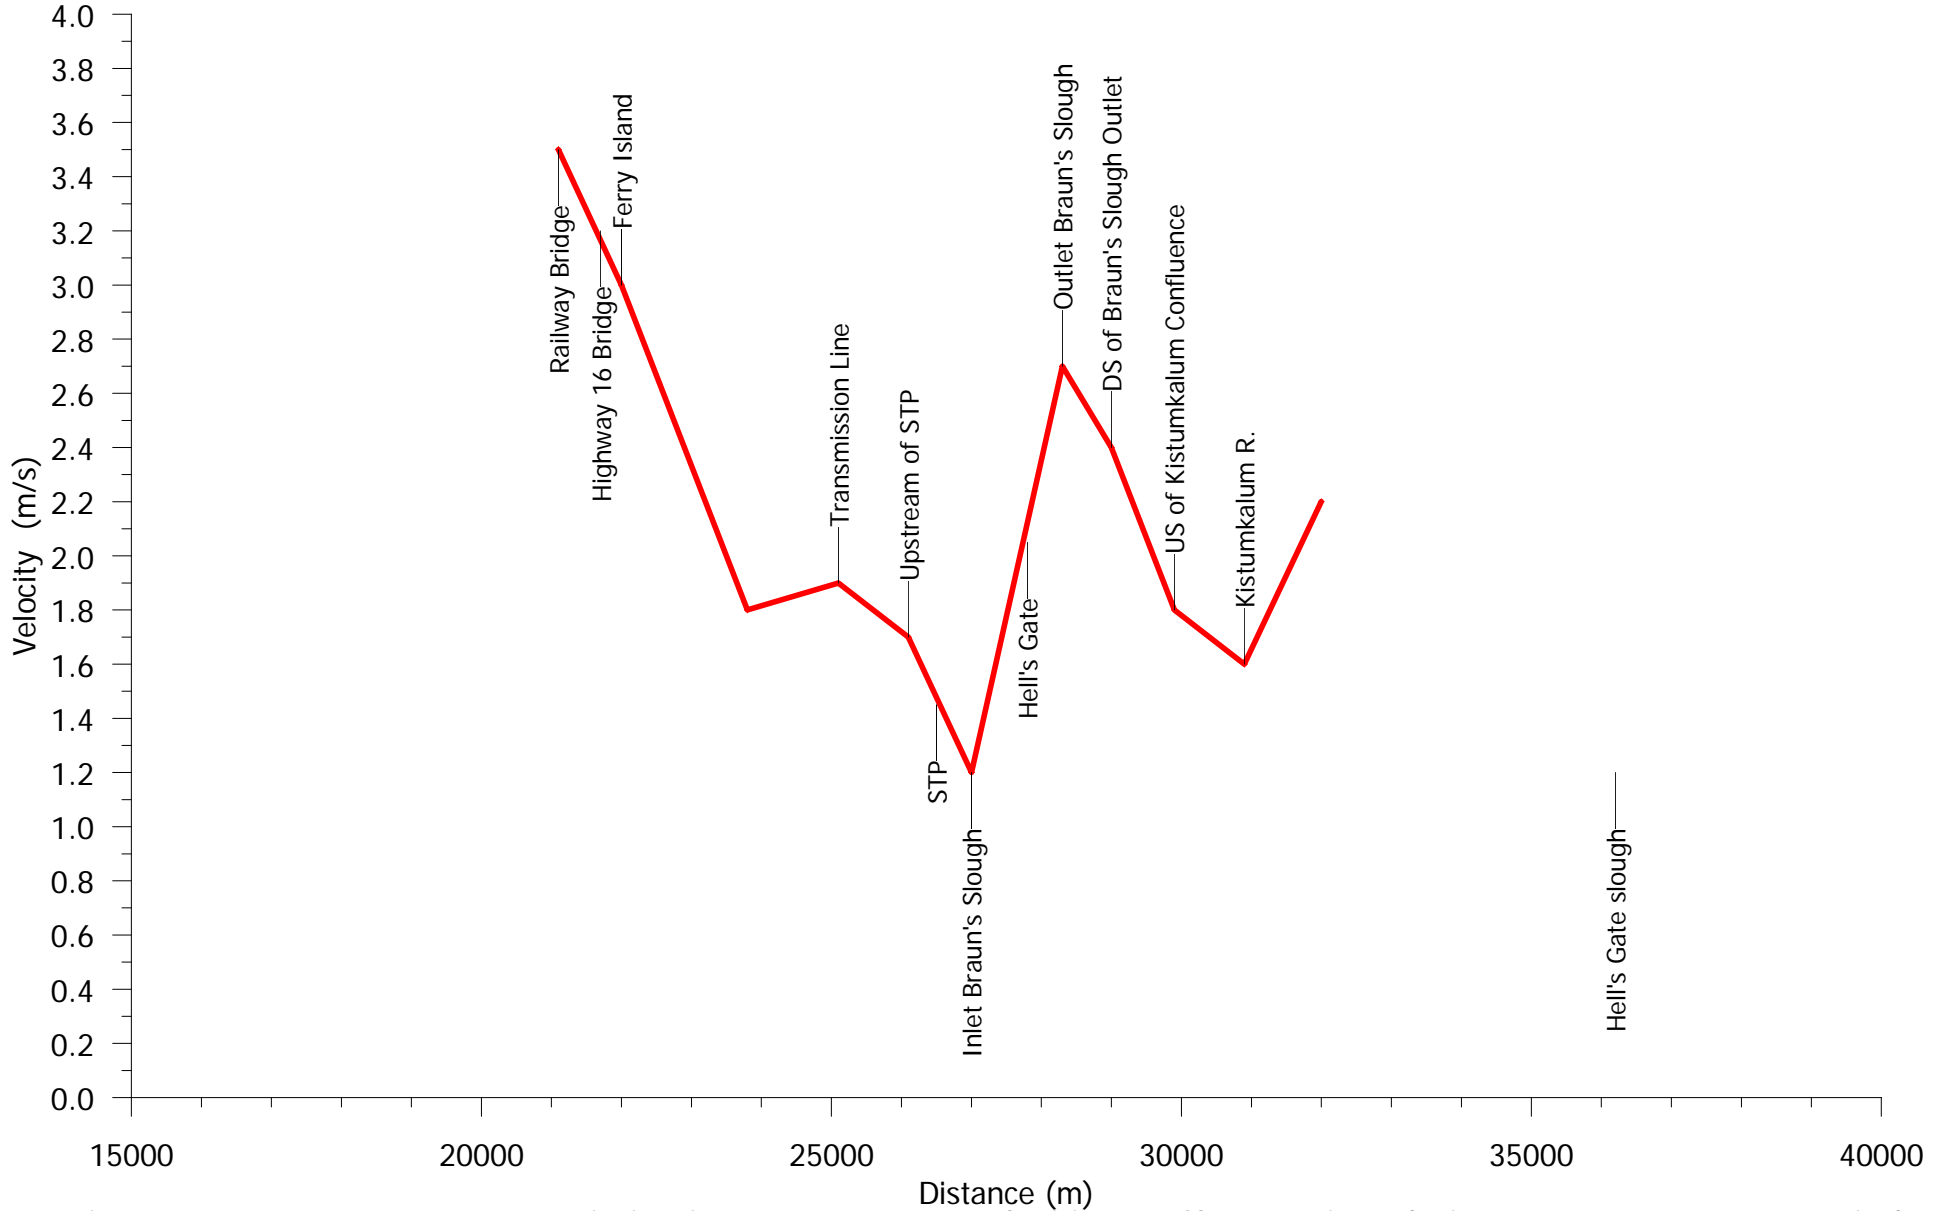
Figure 5.3.1.2: Downstream variation in average water velocities on Skeena River during a 200-year return period flood (WMC, 2009).

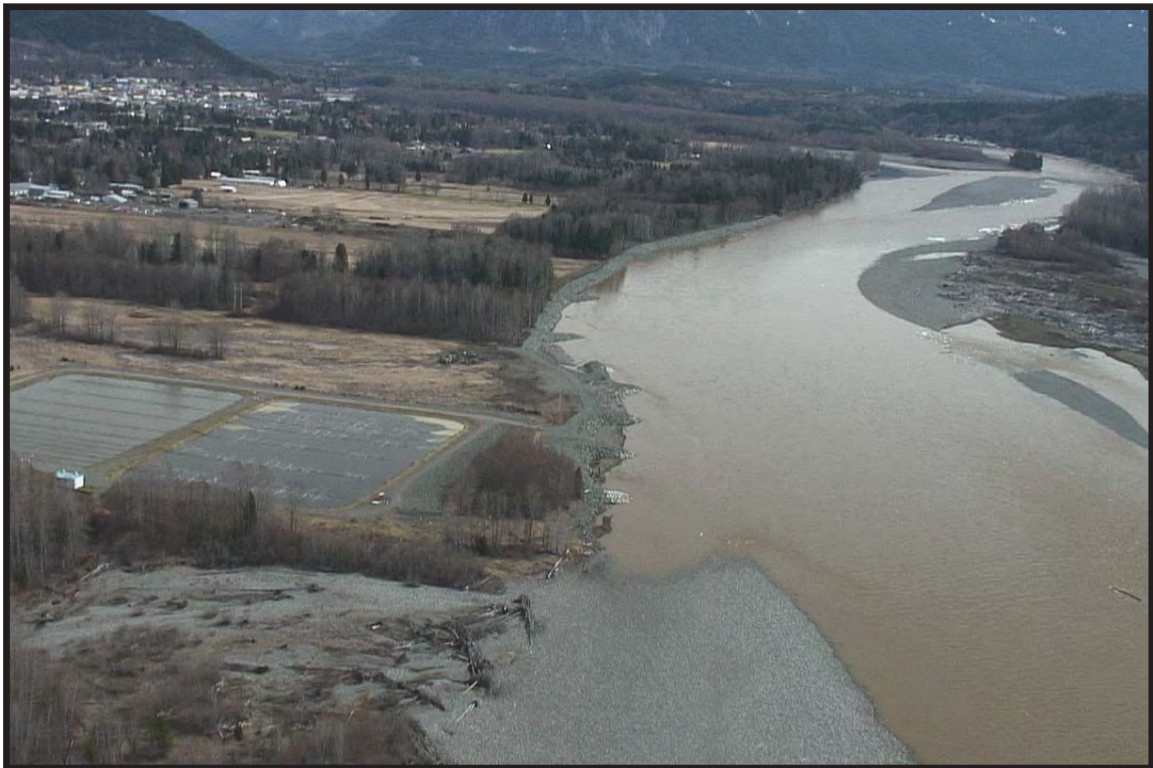
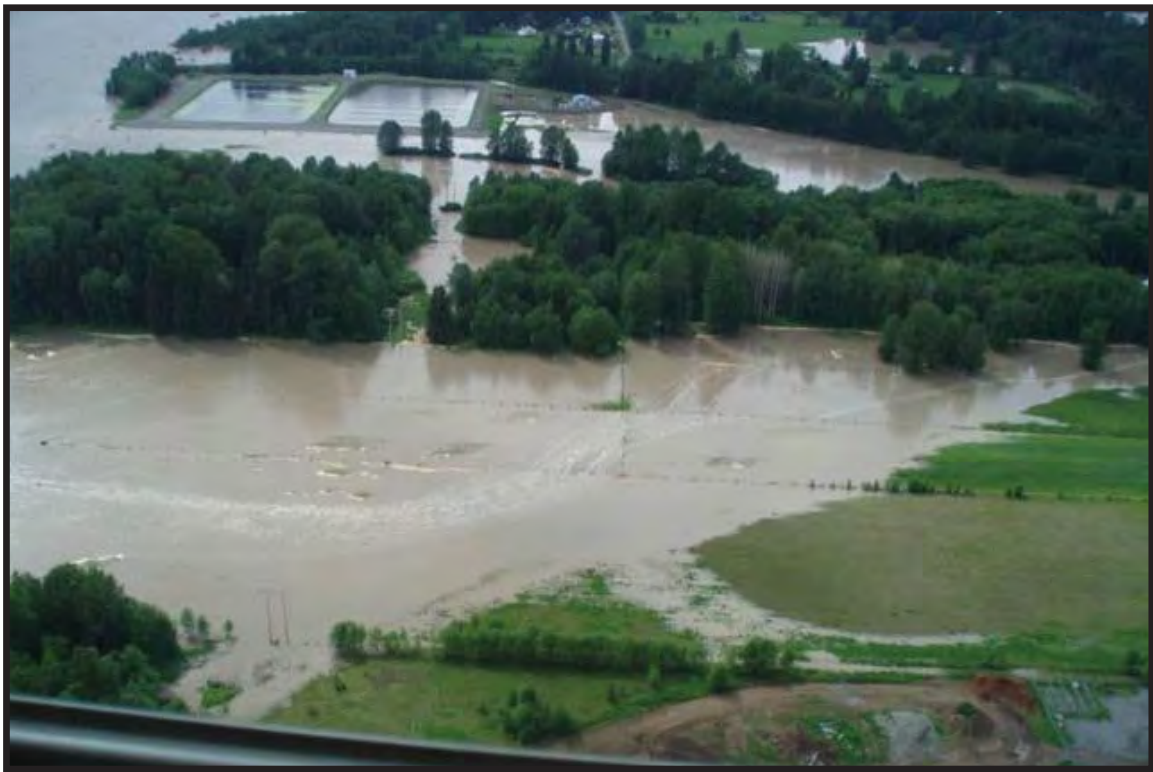
a) conditions prior to bank protection

b) conditions following bank protection

Plate 6.2.4.1: Looking upstream on Skeena River illustrating how the mainstem flow is directed into the north bank upstream of the City of Terrace STP.

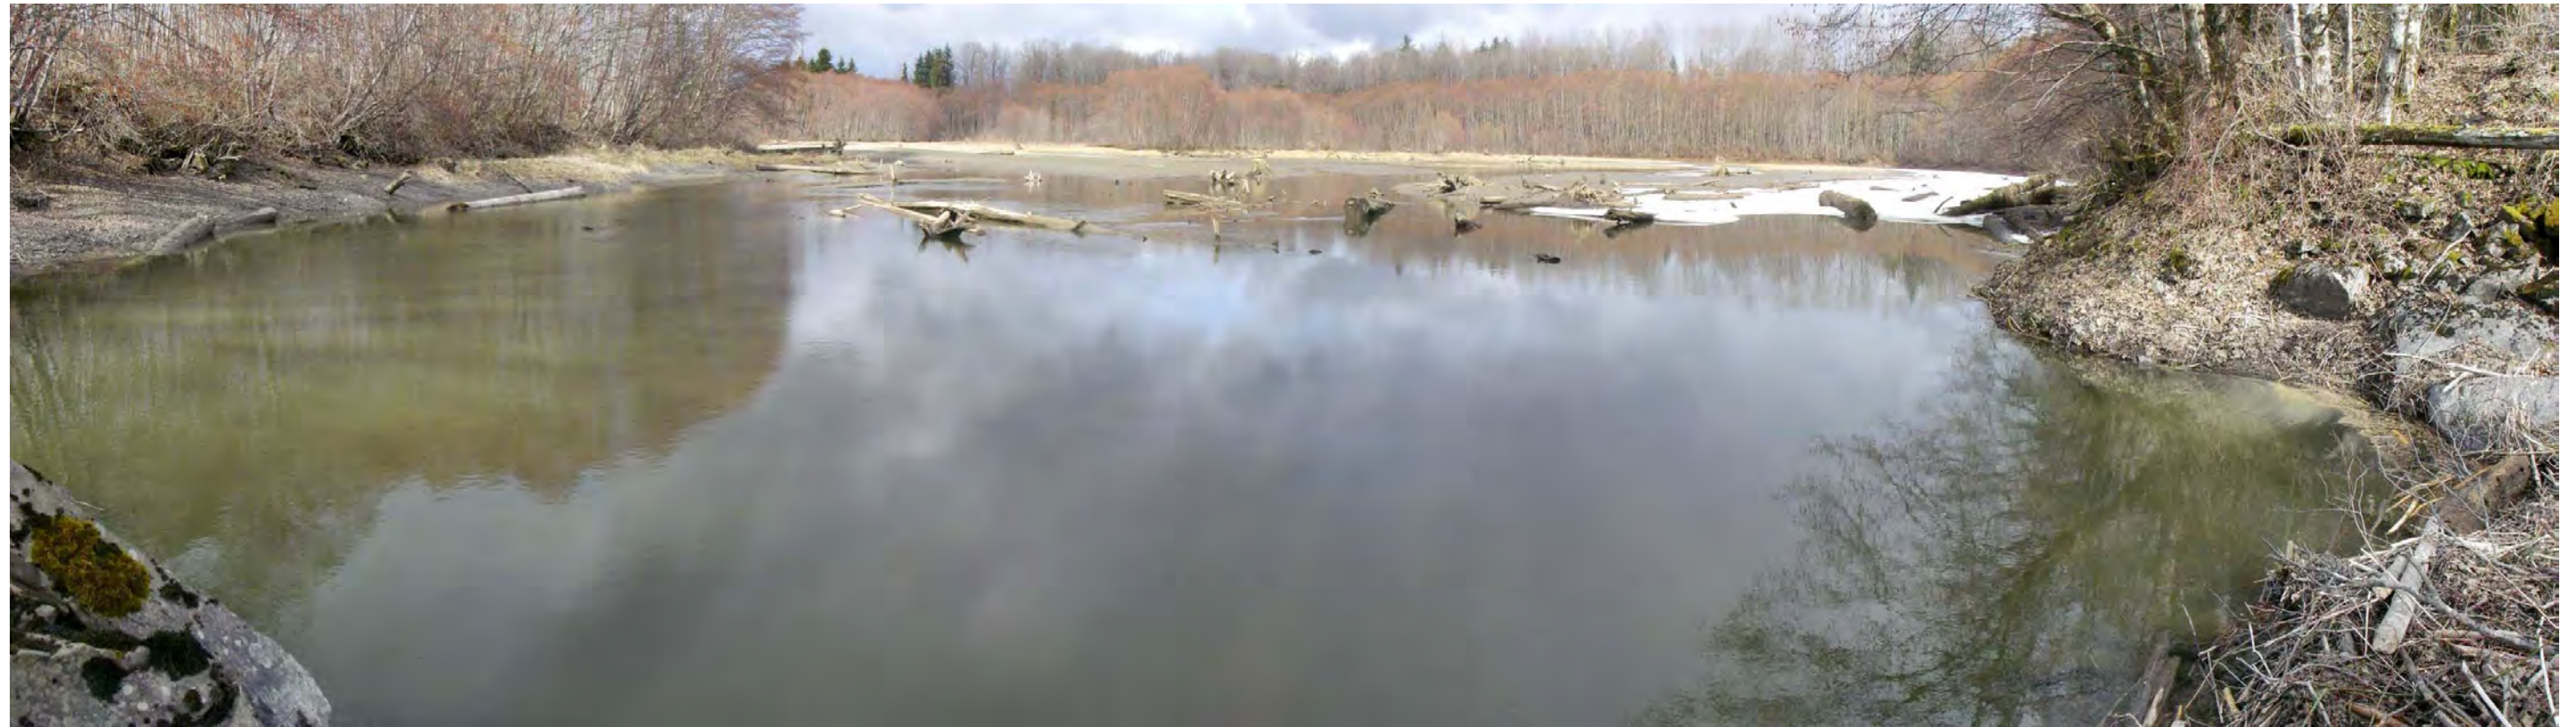
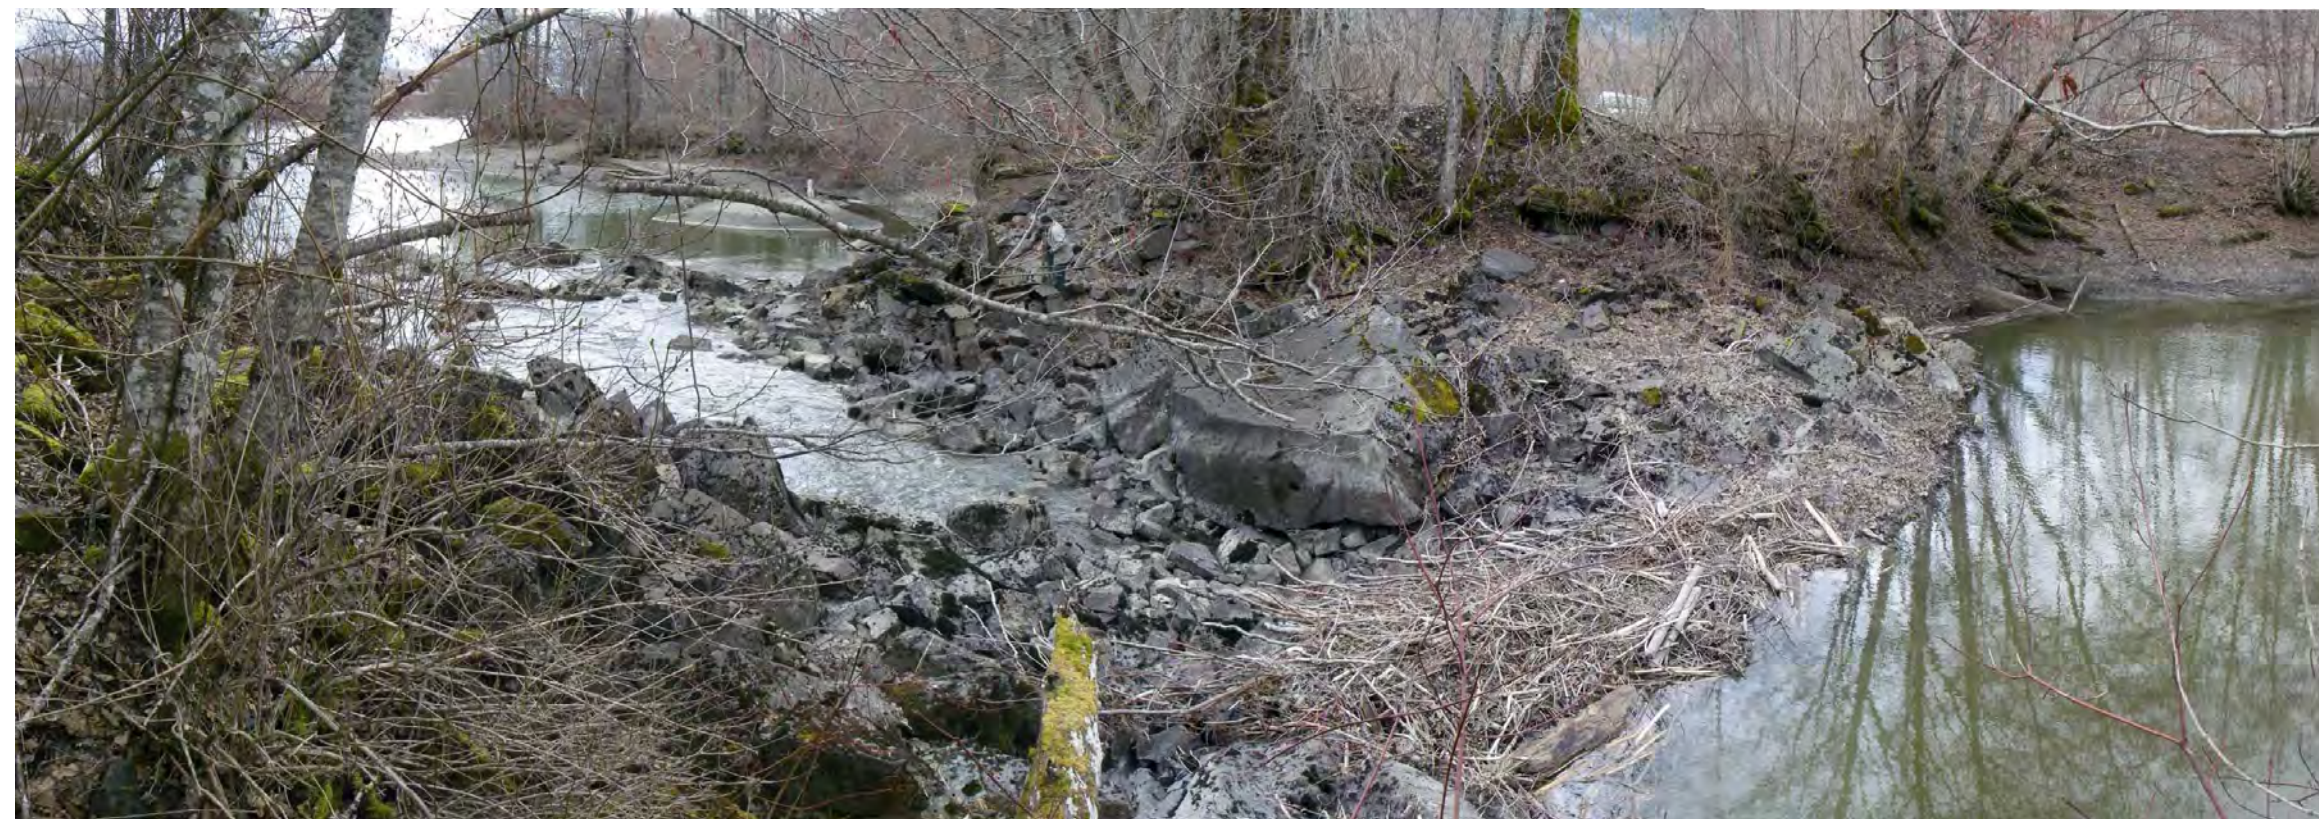
Plate 6.3.3.3: Oblique aerial photographs of abandoned log storage structures on lower Kitsumkalum River.

Plate 6.3.3.4: Ground photos of the log storage area on lower Kitsumkalum River.

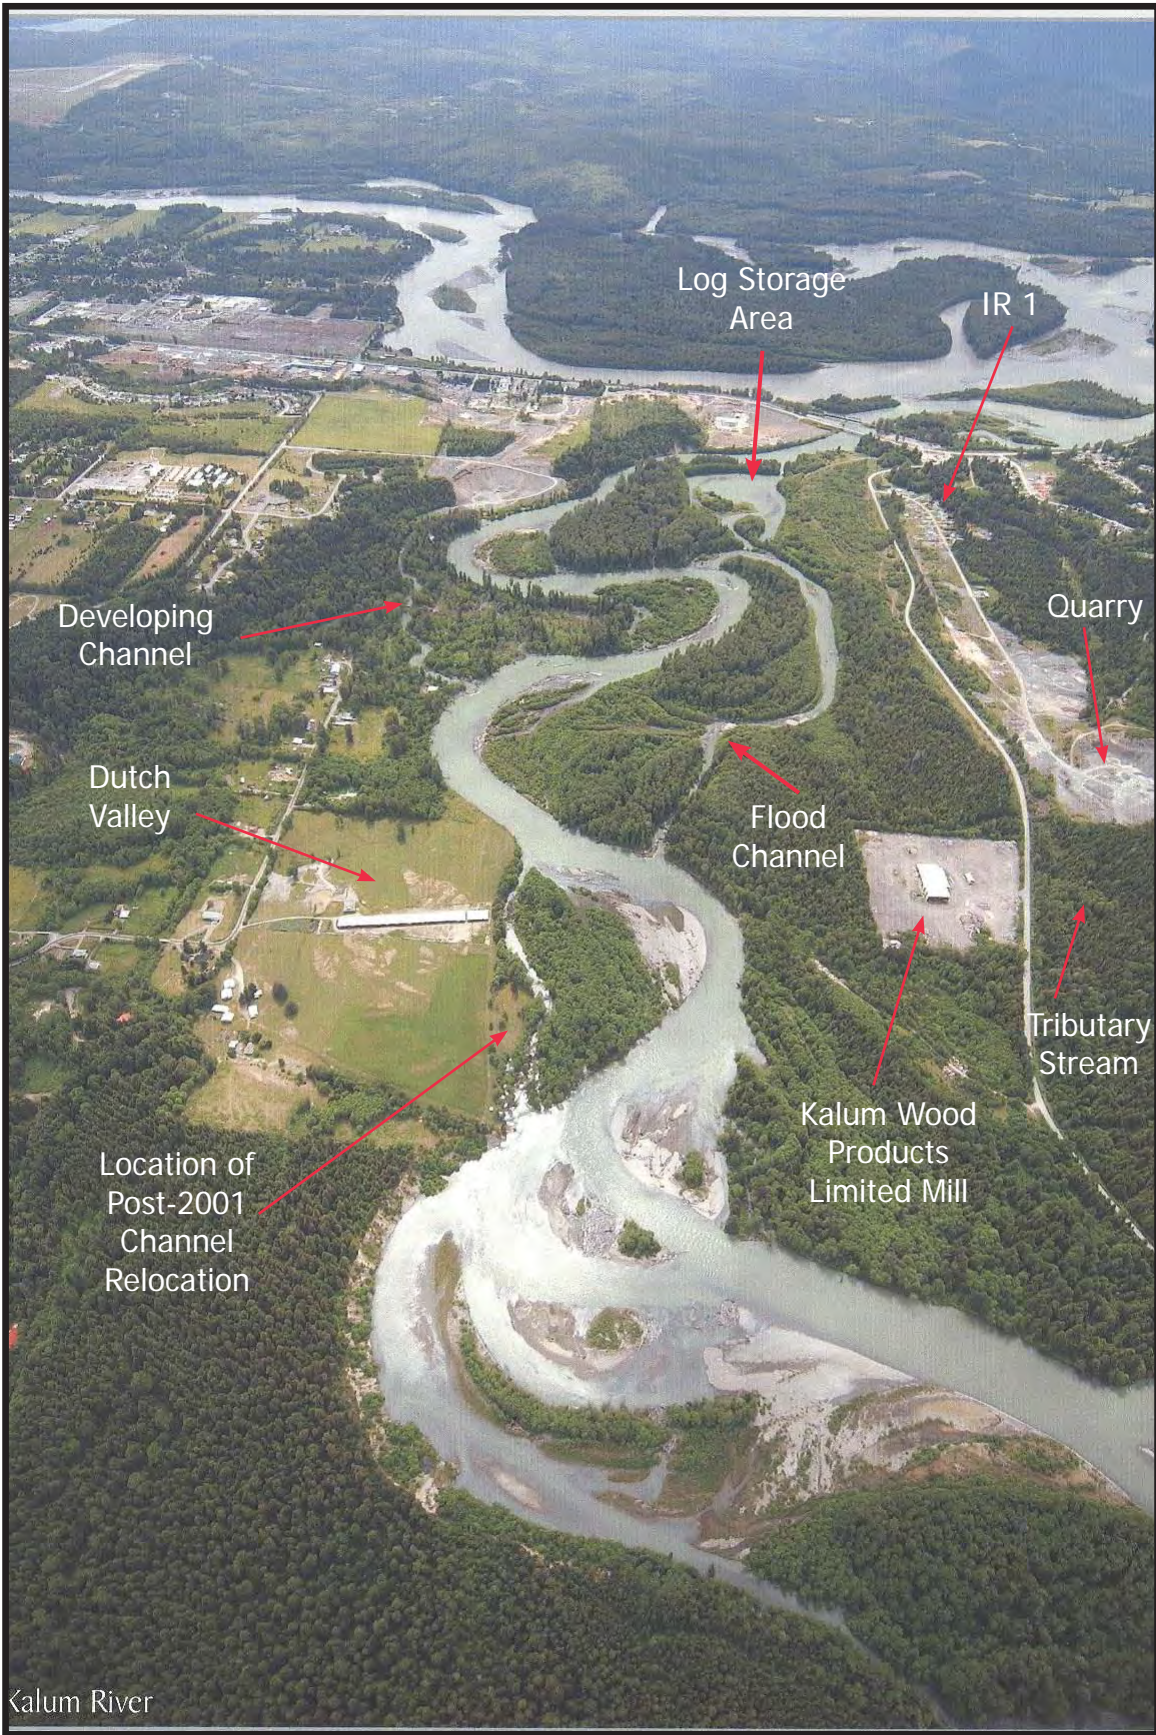
Plate 6.3.3.5: Pre-2007 oblique aerial photograph of the lower Kalum River. [Photo provided by Cambria Gordon Ltd.]

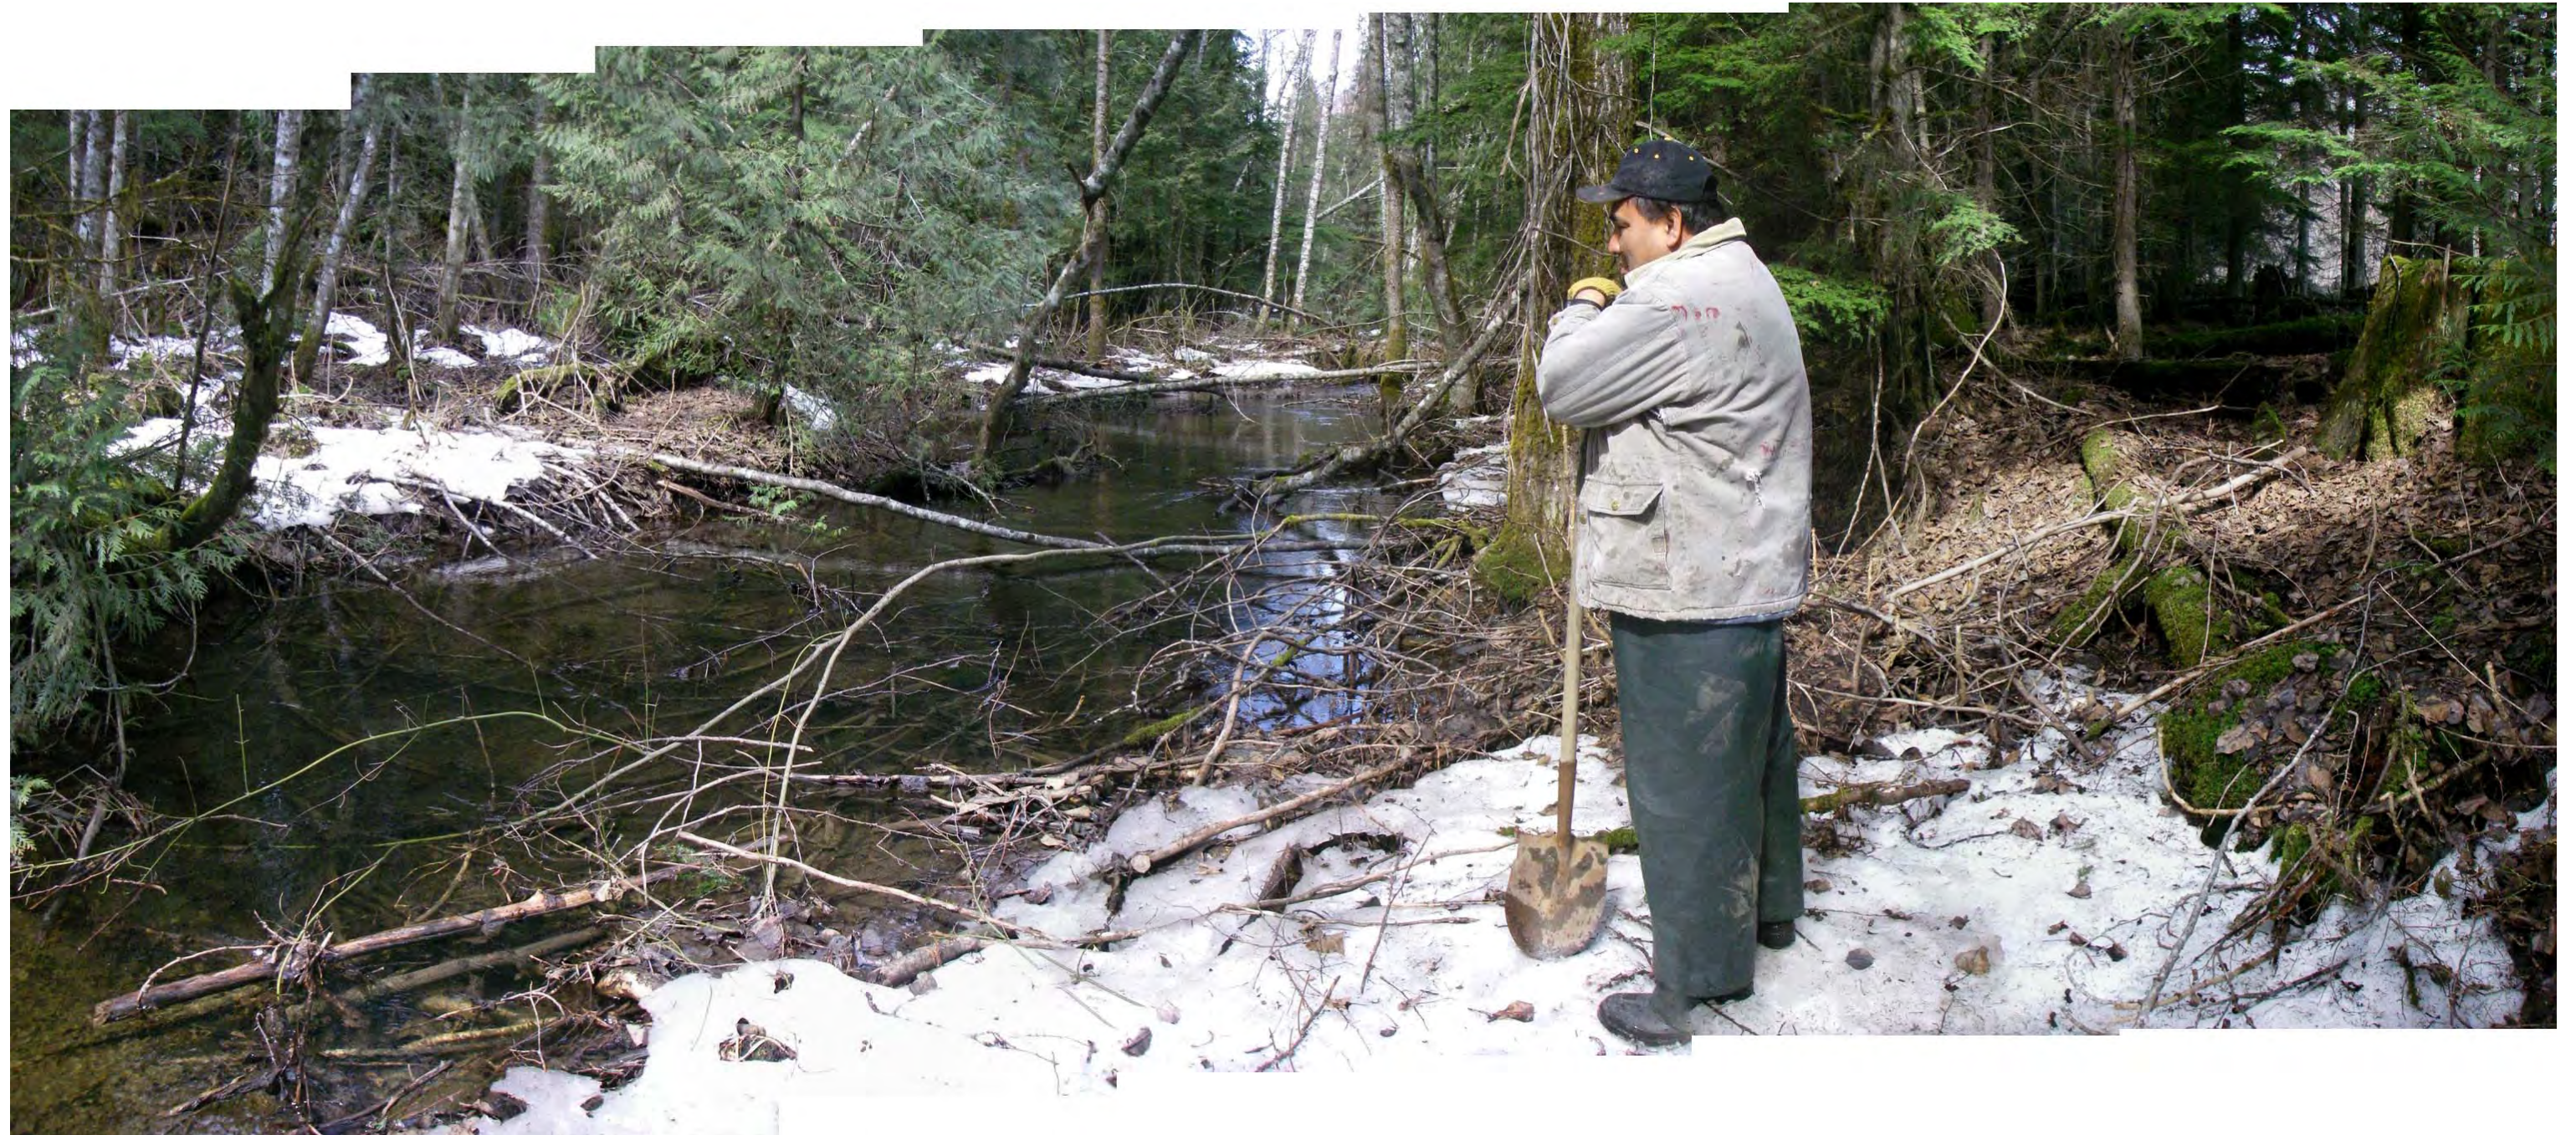
Plate 6.3.3.6: Oblique aerial photographs of a cut-off channel which is developing across the meander bend located downstream of Dutch Valley.
