KITSUMKALUM RIVER CHANNEL STABILITY ASSESSMENT

AERIAL AND GROUND INSPECTION APRIL 22 to 23, 2009 COMPILATION OF DIGITAL AND VIDEO IMAGERY

May 6, 2009

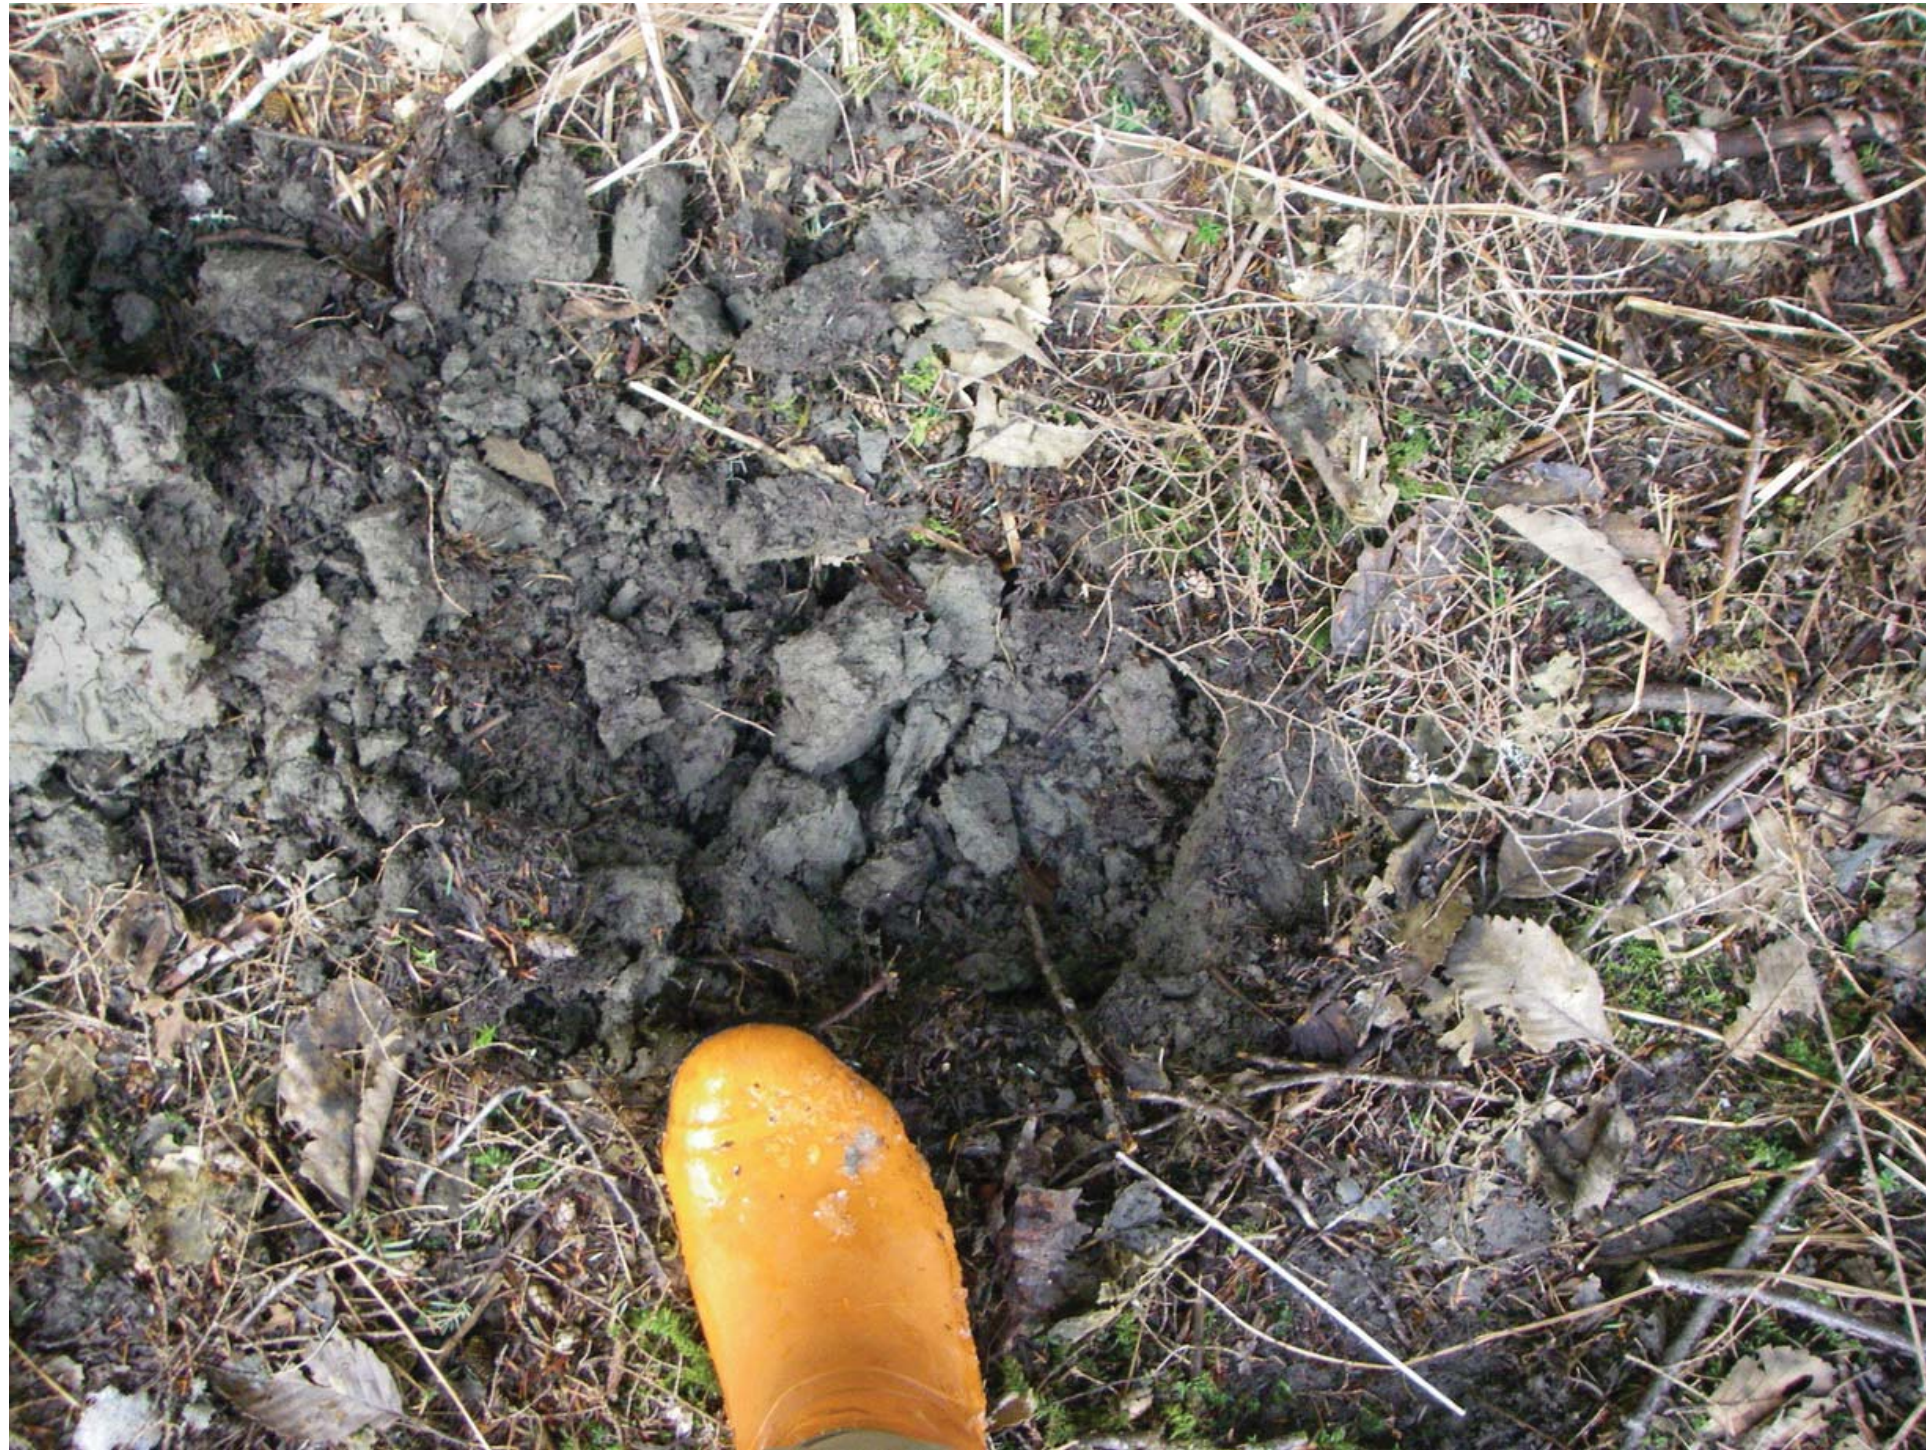
MM 09 5393

Mikes right boot showing soil detail.

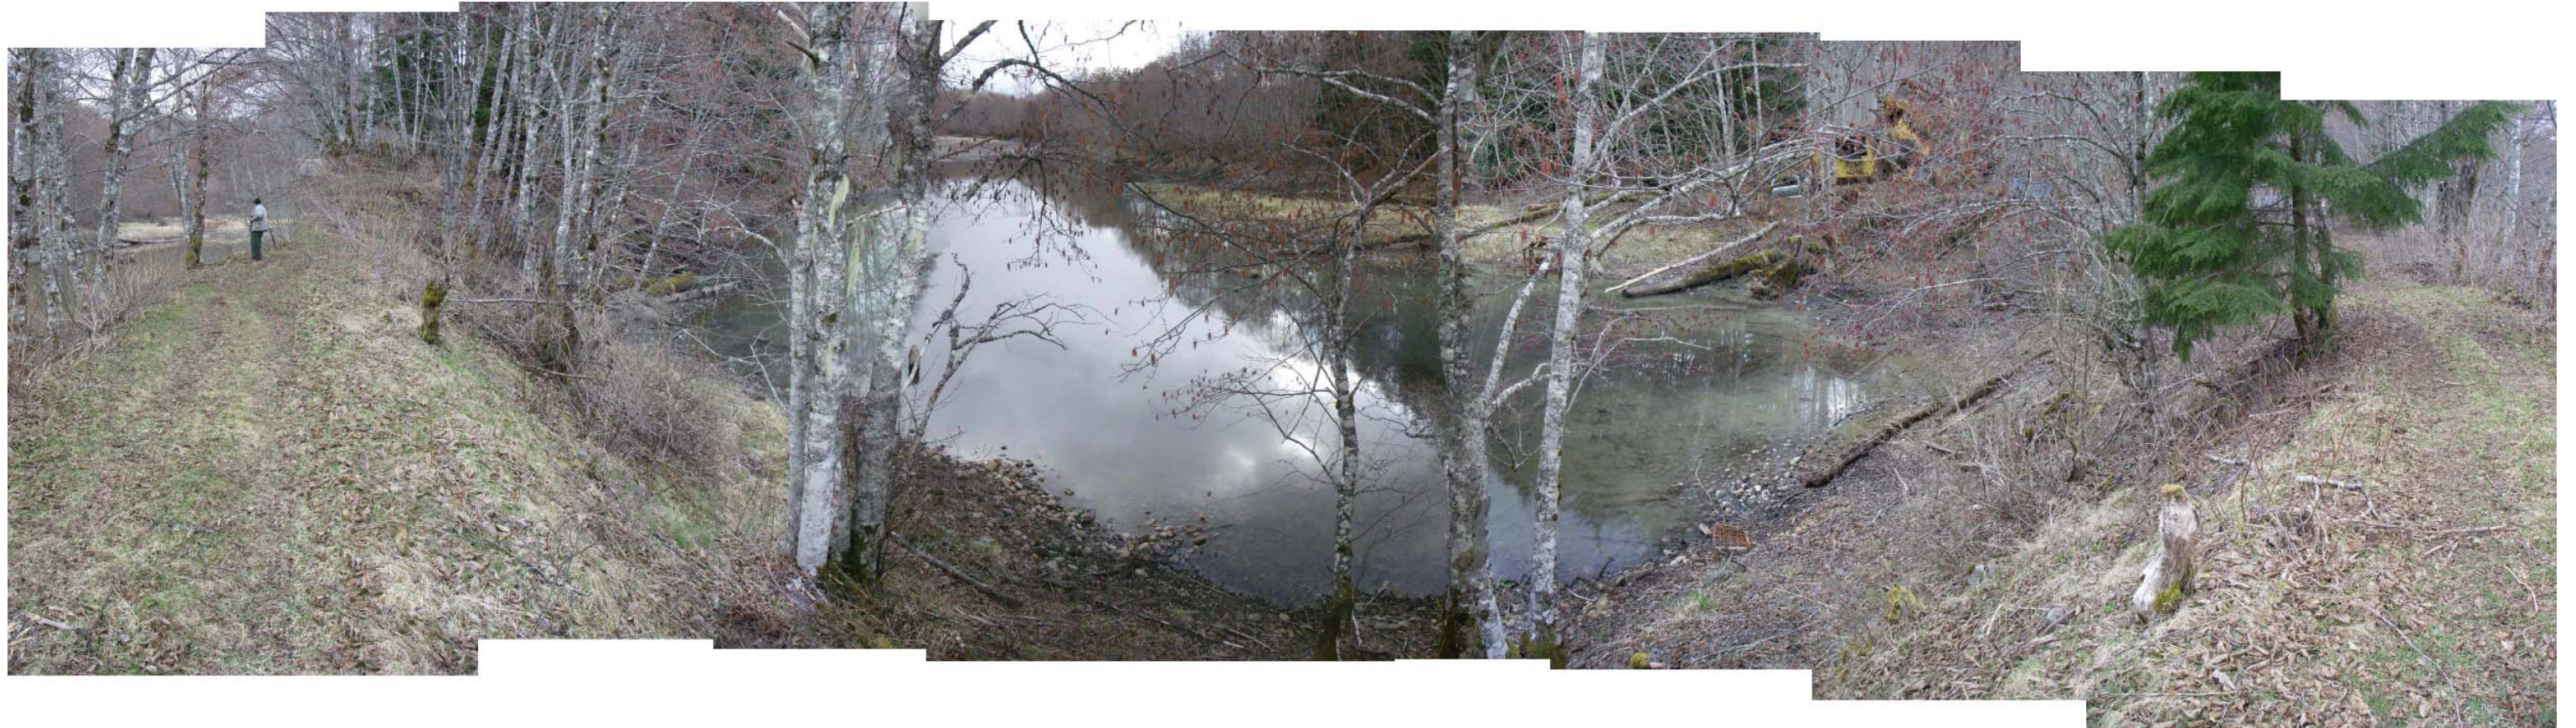
MM 09 5432 to 5441

Panorama looking upstream on the channel with Don standing with the shovel on the left bank. At this point the channel is constricted to about 3 to 4 m in width with a maximum depth of about 30 cm. There is fine sediment and organic material on the channel bed. Some skunk cabbage is beginning to grow so there may have been some water in this area prior to road construction.

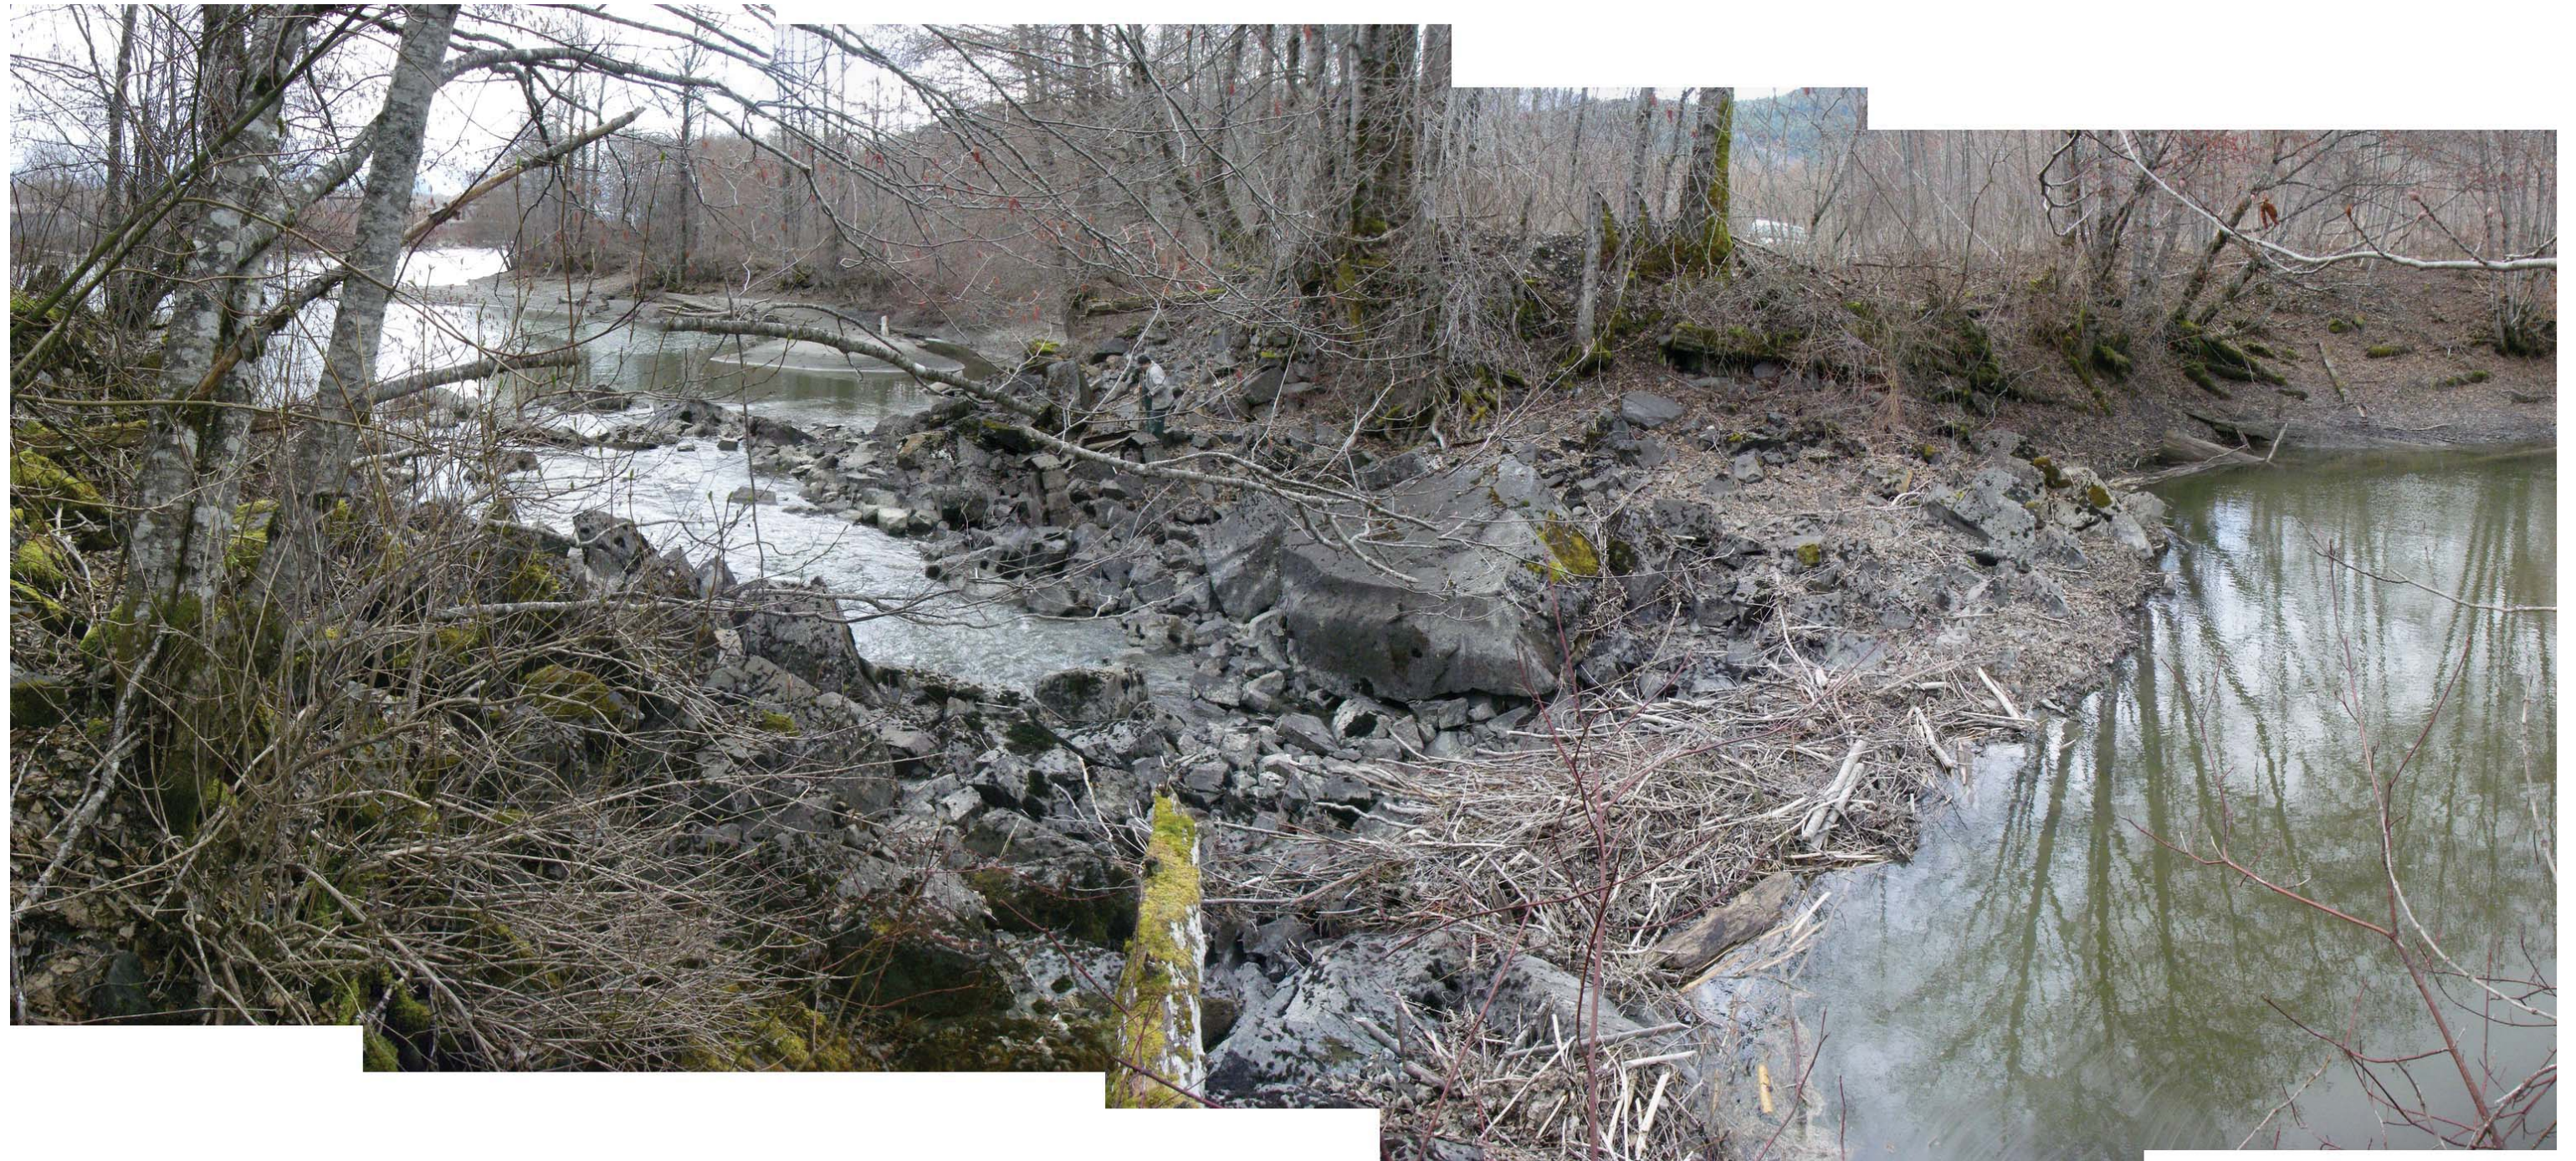
MM 09 5460 to 5465

Panorama looking upstream over the pond, showing sediment and woody debris deposition. Don mentioned that this area is filling in quite rapidly. Much of the upstream pond surface is now equivalent to the outlet elevation.

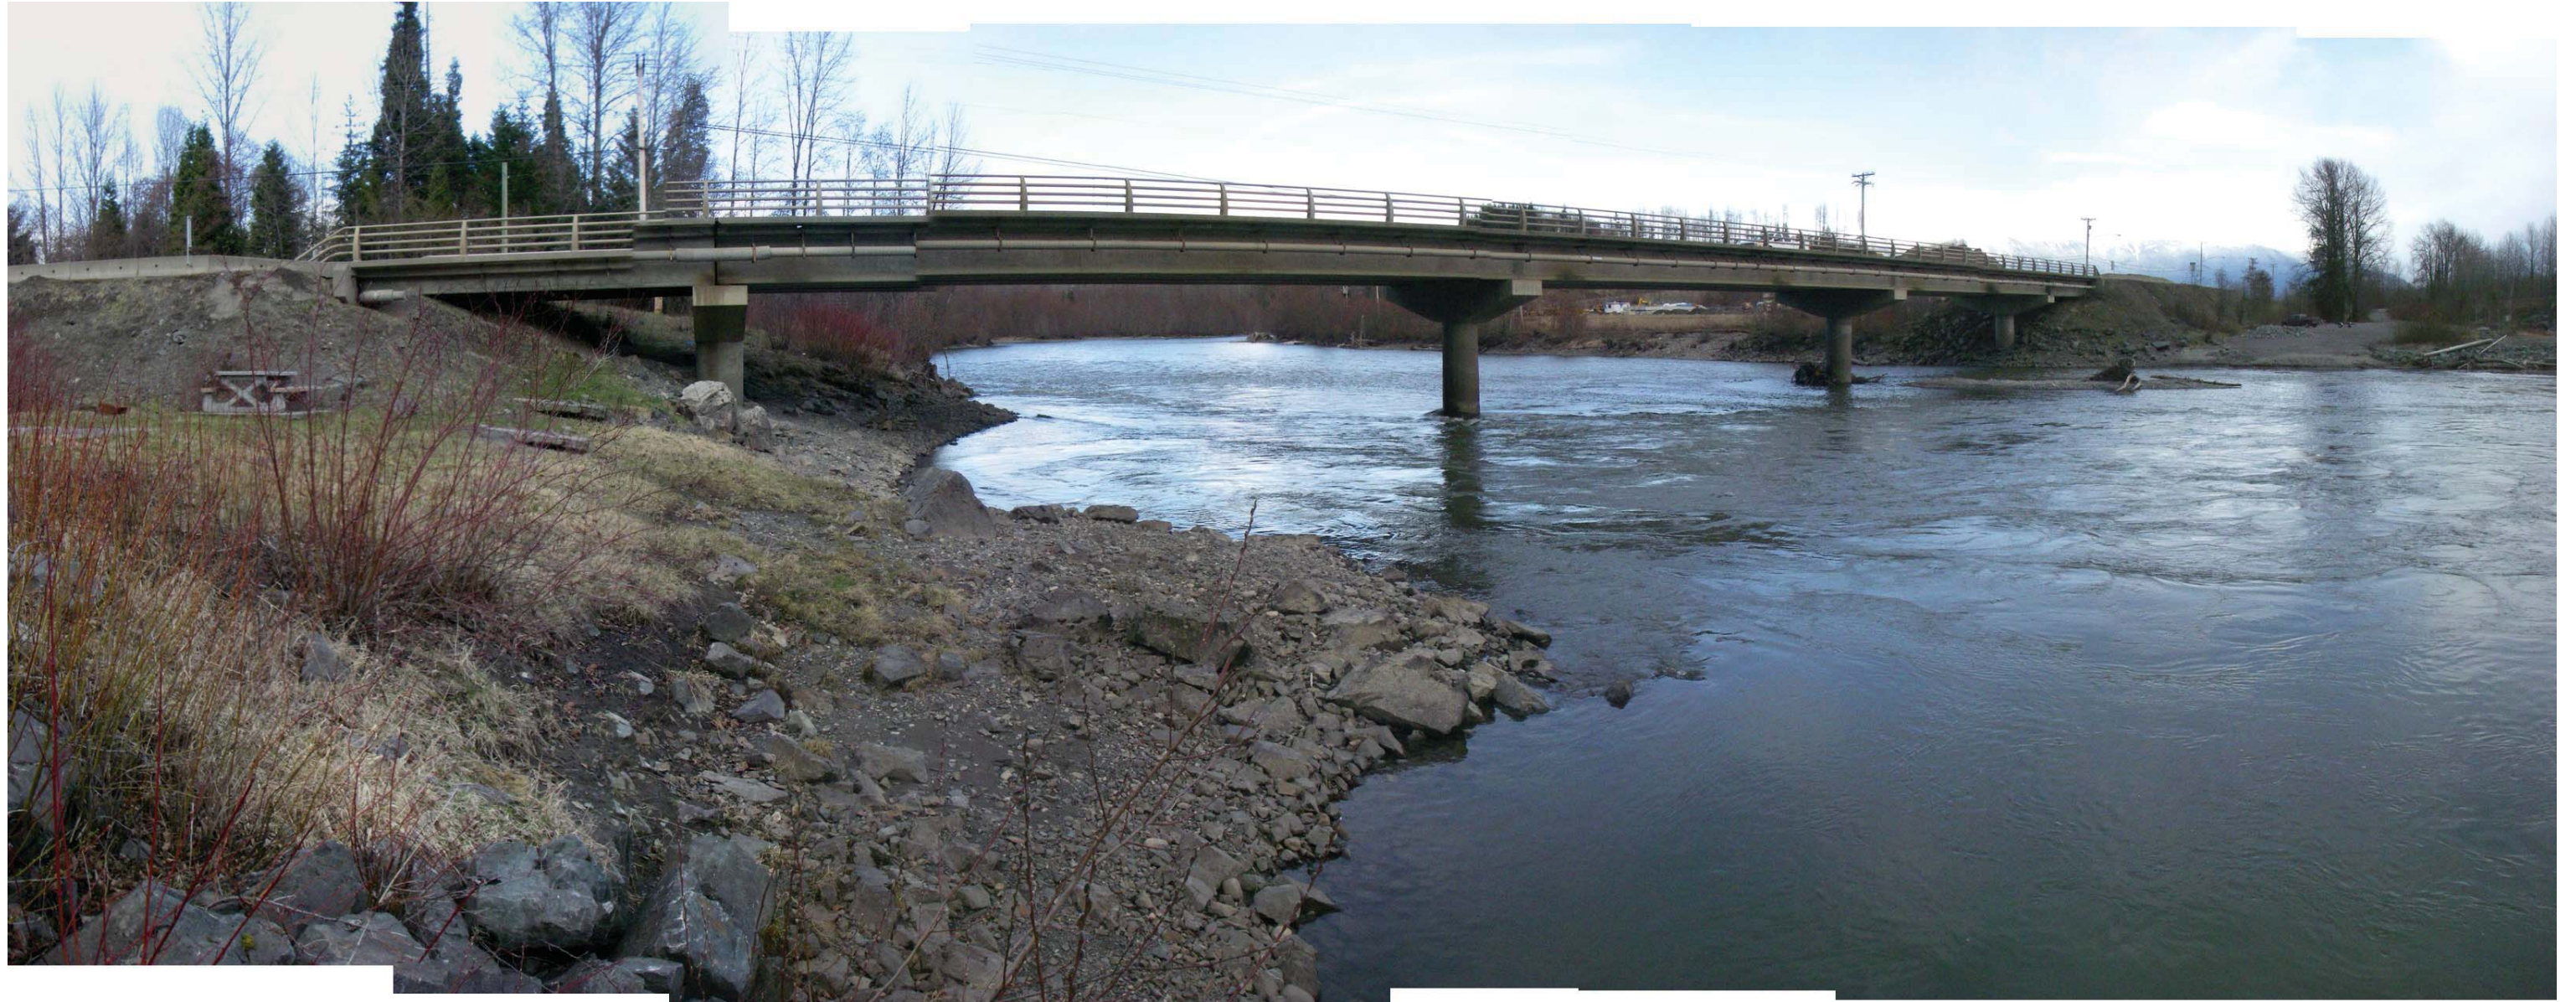
MM 09 5481 to 5487

Now on the right bank between the highway and the railway bridges.

Panorama looking upstream to the Highway Bridge.

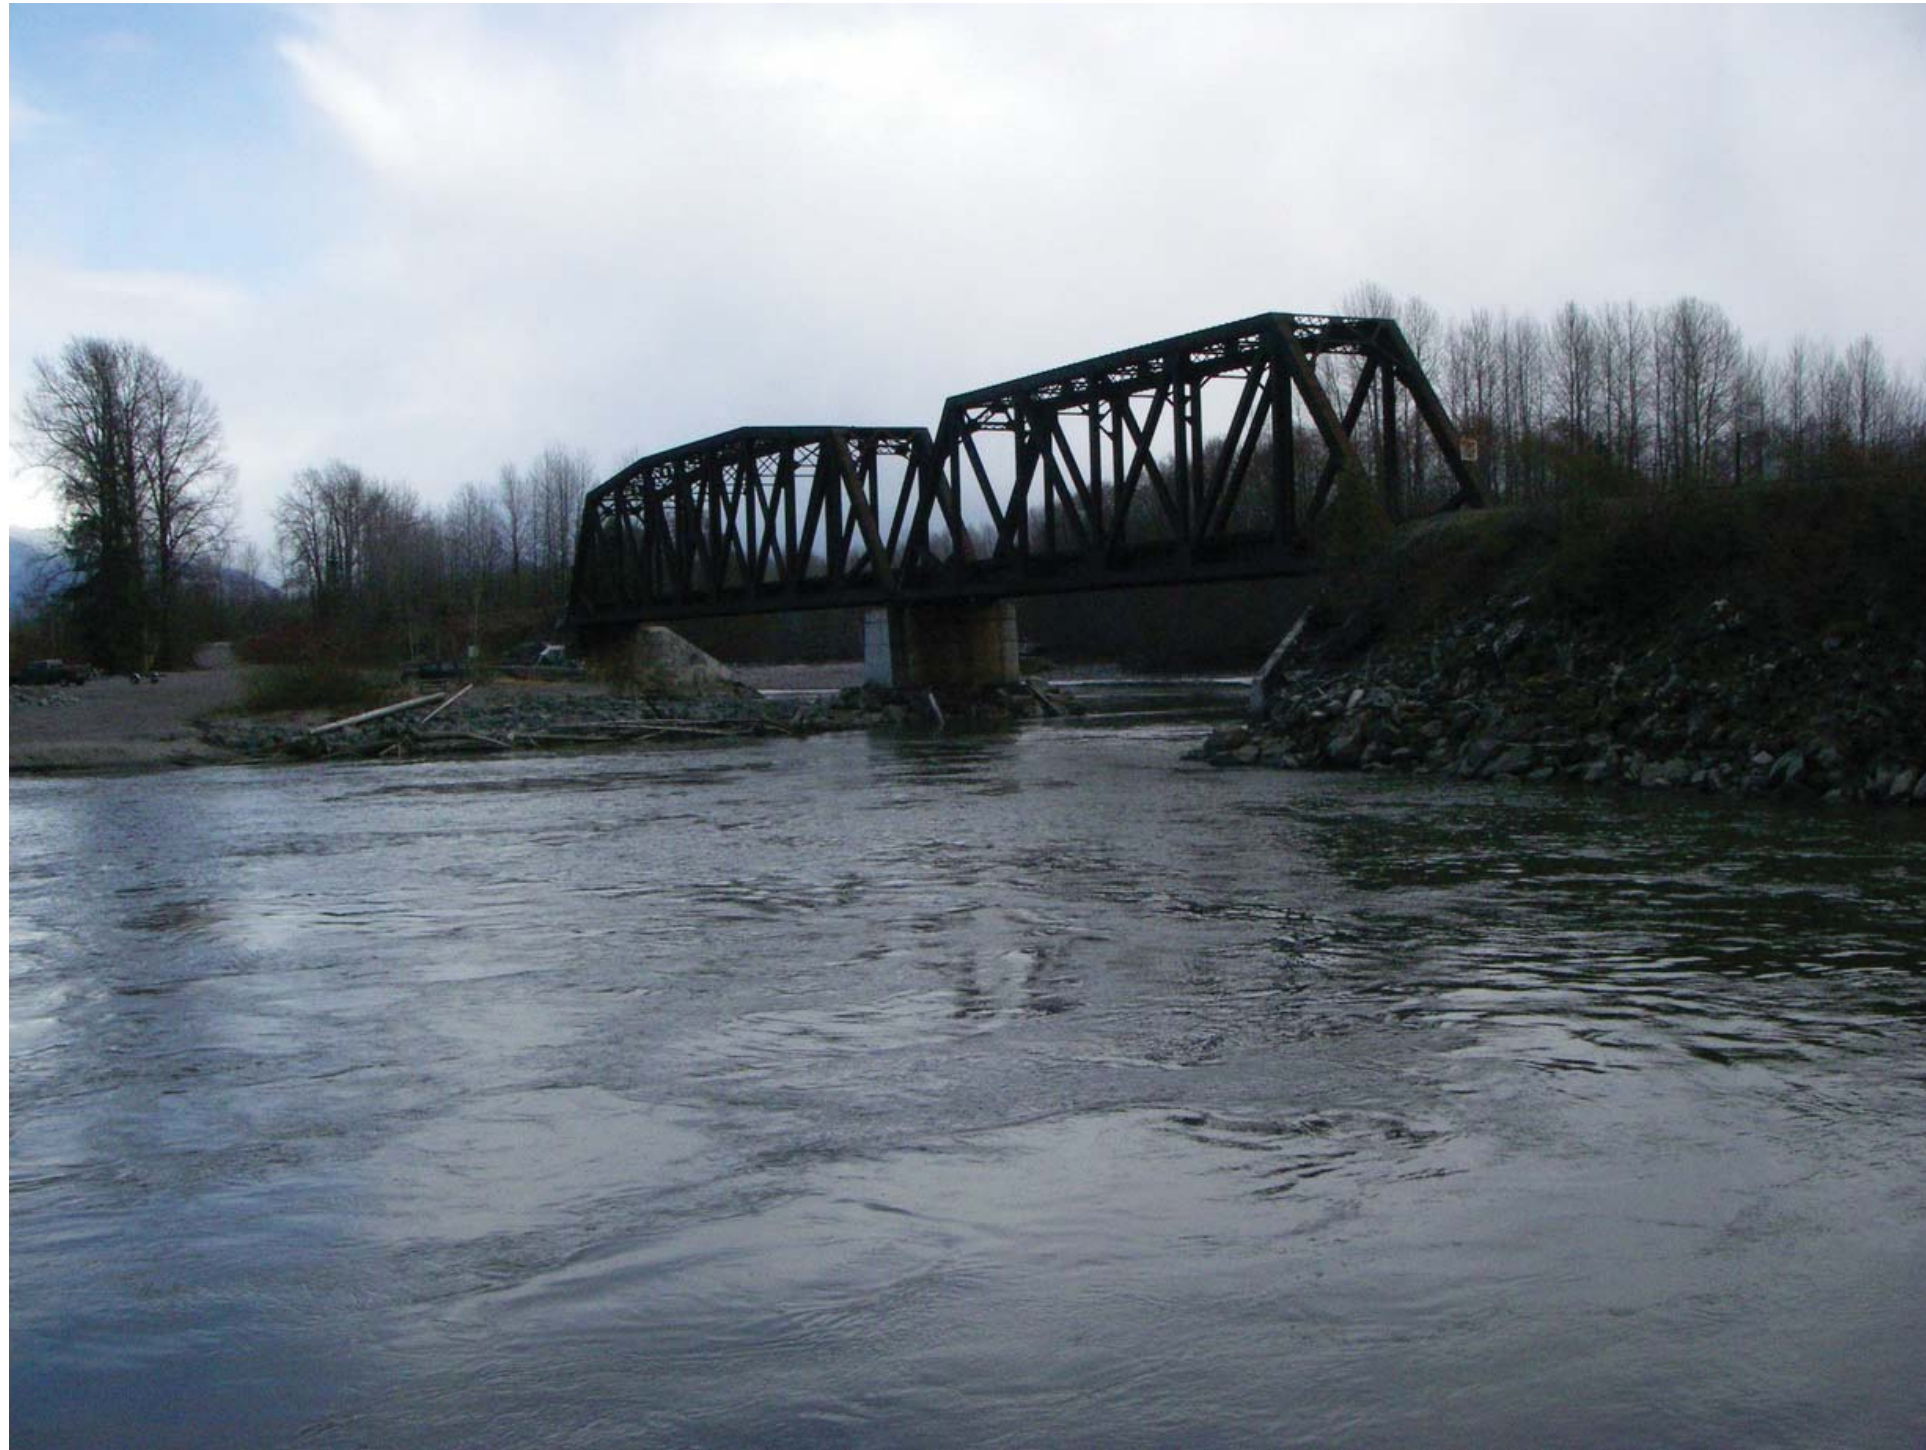
MM 09 5488

Single photo looking downstream to the railway bridge.

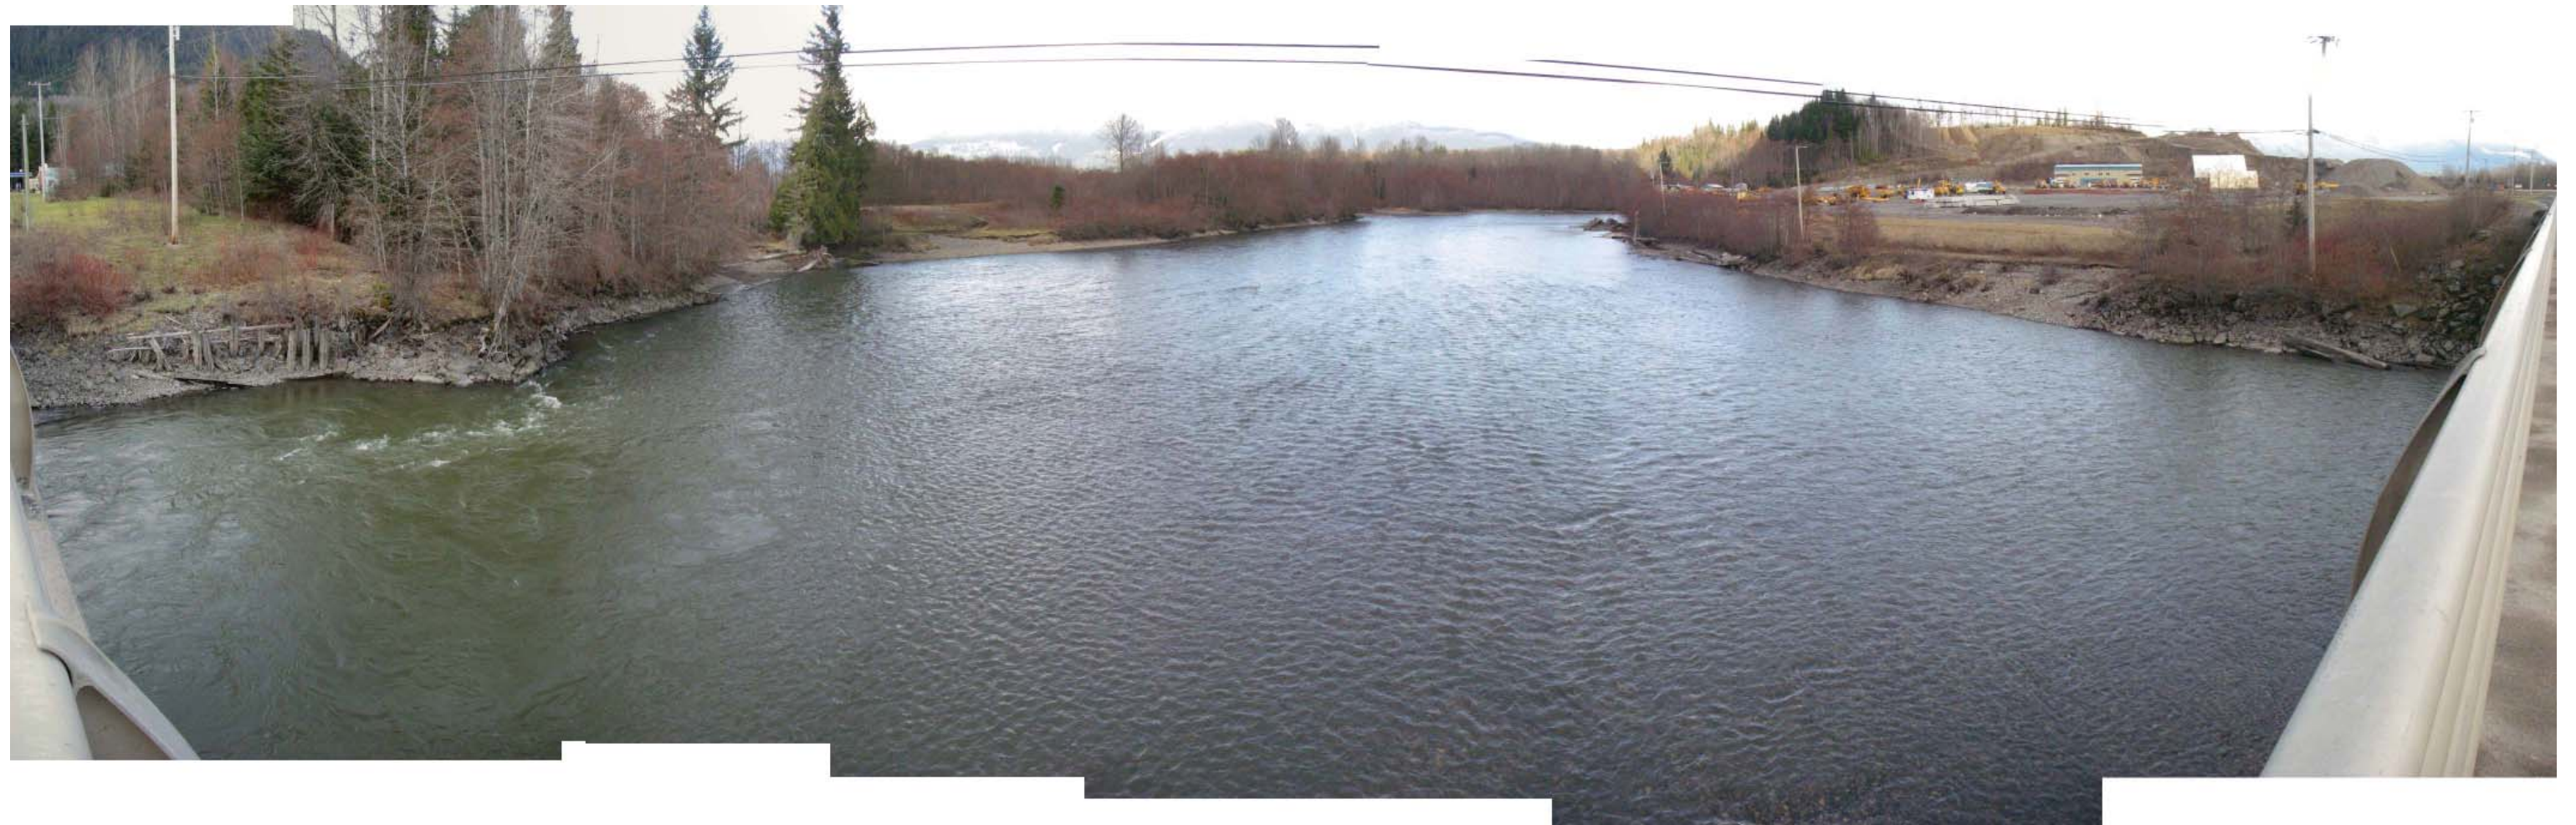
MM 09 5489 to 5497

Panorama looking upstream from the center of the Highway Bridge to the upstream channel on Kitsumkalum River.
